### Riparian Restoration along the Mimbres River in Southwestern, NM

By John Moeny, SWQB Environmental Scientist - NM Field Team, Silver City

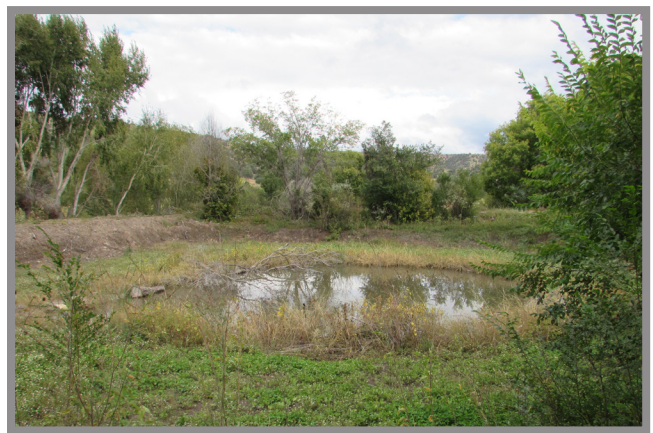
*Habitat restoration projects for Chihuahua chub and Chiricahua leopard frog along the Mimbres River in Grant County. Top left map - Rafter D Bar project area. Bottom left photo - wetland pool conversion approximately 60' diameter by 4' deep (at center) created from a historic dry stock tank at the Rafter D Bar property.*

The first project completed in May 2015 at the Rafter D Bar property included a wetland pool conversion, removal of a dozen Siberian elm trees, and plantings of approximately 100 willow and cottonwood poles. This project improved an existing, but long defunct, stock tank pond by increasing the capacity and adding a waterproof liner to eliminate water losses by infiltration. The pond is fed by an acequia from the Mimbres River. In one month following completion of the pond, leopard frogs had found their new home.

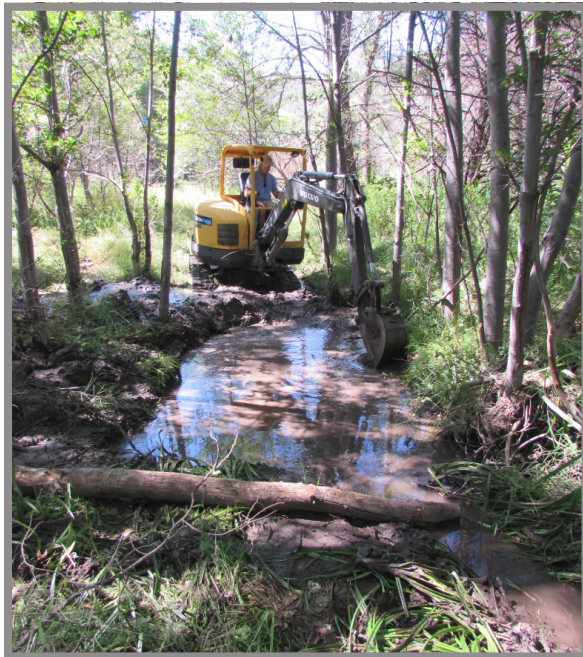
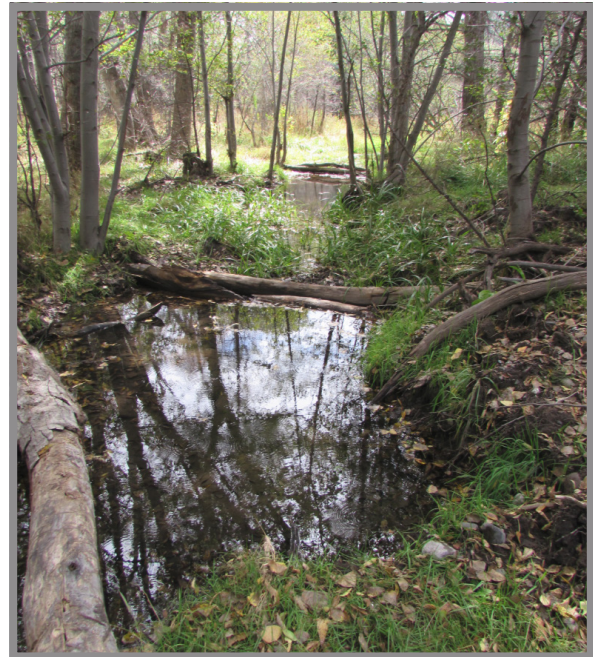
*Rio Milagro property  
Photo on left during construction removing sediment.  
Photo on right of post construction condition.*

At the same time, further upstream at “Rio Milagro”, spring fed wetlands were being restored. The Rio Milagro property owners, Brian Myers and Jennifer Douglass raise Navajo Churro sheep on their 40 acre property with an eye toward the long term health of the land and their animals. Planned grazing, permaculture and wetland restoration all have a place on their property which includes ¼ mile of river frontage.

The Mimbres River here is atypical compared to nearby reaches. The valley necks down, concentrating both surface and ground water in the narrowed floodplain. The river flows perennially and the riparian vegetation of Arizona alder and walnut trees line the river bottom casting deep shade. At the edges of the floodplain where the river meets the hillslope, ground water discharges into small seeps and springs. In 2013, the 139,000 acre Silver Fire burned through the upper Mimbres Watershed—a watershed that hadn’t seen significant wildfire in over 100 years. The immediate results were severe—massive flooding events during multiple monsoon seasons inundated the floodplain at Rio Milagro and buried many of the seeps and springs feet deep in ash and silt. The ONRT habitat restoration grant provided the means to repair the damage and even improve the streamside wetlands by removing the sediment and excavating swales and depressions to link several isolated seeps into a functioning whole, providing travel corridors for amphibians and other water dependent species.

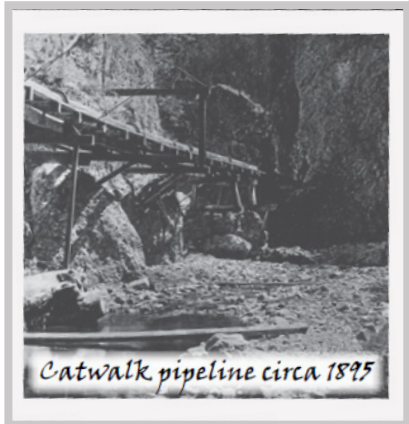
*Catwalk pipeline circa 1895*

Whitewater Creek has also been one of the most easily accessible trout streams in the Gila region, requiring a short, scenic drive from Glenwood, and a walk up the canyon on the fabled “Catwalk”, a national recreation trail (NRT). The Catwalk NRT was originally just wooden planks placed on a water pipeline that had been bolted to the steep canyon walls. The pipeline was constructed in 1893 to supply water to the town of Graham and an ore processing mill at the mouth of the canyon. Little remains of the town, but remnants of the old mill can still be seen near the present-day picnic area. In the 1930s, the Civilian Conservation Corps formalized the Catwalk NRT by hanging decking from the canyon walls along the original pipeline alignment. The suspended trail ran for one mile up the canyon and allowed forest visitors to safely travel up the narrow canyon and access trails deeper in the Gila wilderness. The US Forest Service rebuilt the trail in 1961, 1978 and again in 2003—upgrading the trail to universal accessibility standards. However, visitors have been unable to access Whitewater Creek and the Catwalk trail above the picnic area for the majority of the past 3 years due to damage sustained to the Catwalk following the Whitewater-Baldy Fire in 2012.

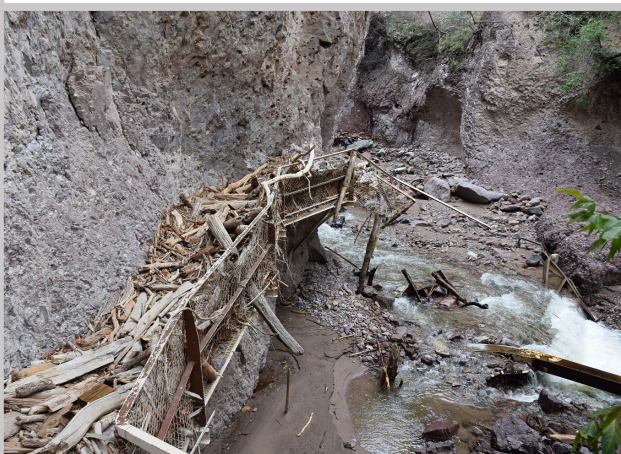
The fire burned 70% of the watershed, with 43% the of the high elevations burning at high and moderate burn severity. With little groundcover to capture and slow rainfall, the Whitewater Creek watershed was highly vulnerable to flooding. Post-fire flooding is typical and expected, but the Whitewater Creek watershed experienced an unprecedented amount of rainfall one year after the fire. During a one-week period in September 2013, over 10 inches of rain fell in the watershed, sending an estimated 20 foot wall of water and debris down the canyon (see photo on left).

A stream gauge in the canyon recorded a peak discharge of 16,100 cfs on September 14th—5 to 6 times the highest recorded flow for the creek. Given the confined nature of the canyon, it is probable that debris blocked the channel and then flushed out, resulting in the massive, yet short duration, discharge seen at the gauge. Further downstream, the San Francisco River was running at 29,900 cfs with a stage height of 18.7 feet. This was the second highest discharge recorded for that stream. Although the trail decking had been removed prior to the flooding, the other trail infrastructure was destroyed or transported downstream. Reopening the Catwalk NRT into Whitewater Canyon now requires a complete redesign and rebuild of the original trail.
