CLEARING THE WATERS

A newsletter by the Surface Water Quality Bureau

Spring 2024

Cleaning Up Cold Springs Creek

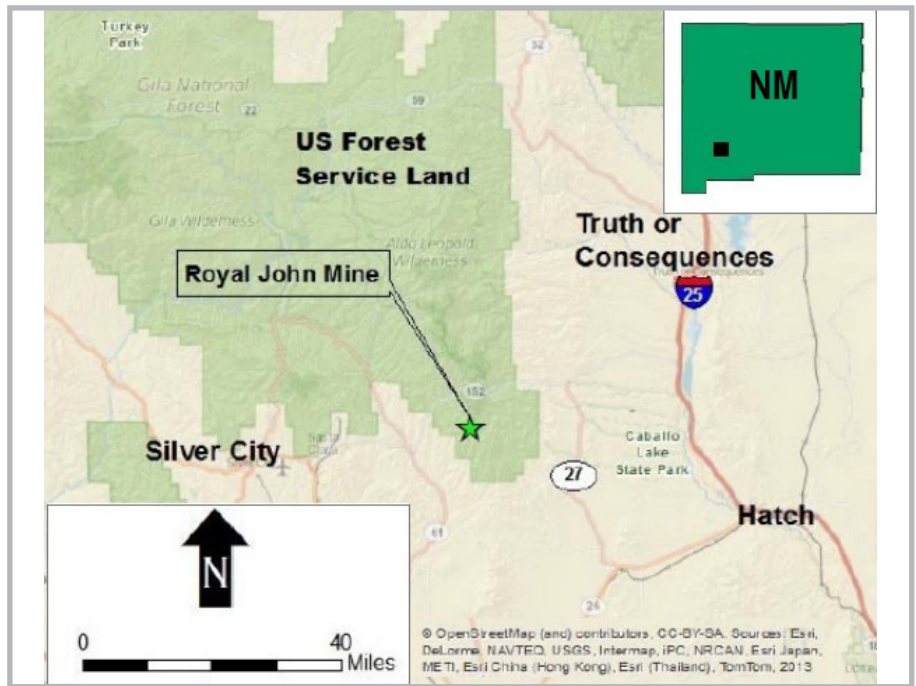
Figure 1. The historical Royal John Mine affected Cold Springs Creek in southern New Mexico.

Mining activities dating from 1916 to 1969 at the Royal John Mine and Mill site in southern New Mexico polluted Cold Springs Creek, a tributary to Hot Springs Creek and the Mimbres River (Figure 1). The approximately 2,000-acre mine site contained numerous adits, cuts, and waste rock piles from the historical mining operations. Mine tailings were piled on both the banks and the channel of the creek, at the on-site mill, and at a depository about a half mile downstream. Water quality samples collected in 2009 detected elevated levels

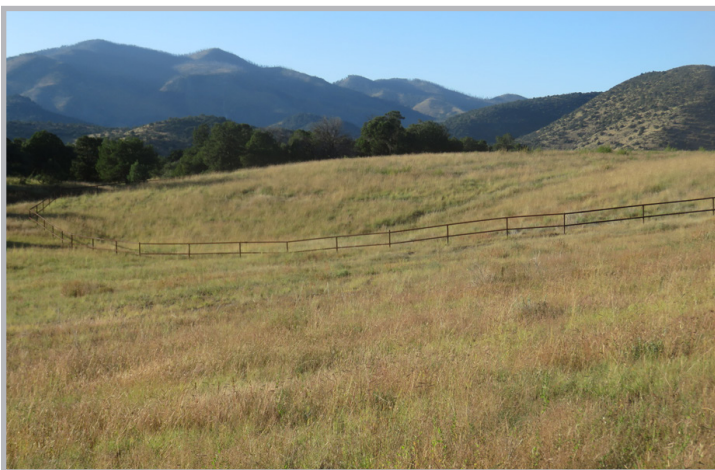
Figure 2. Mine waste was buried under a vegetated earthen cap at the Cowboy Flat Repository.

the 1920s. Heavy equipment transported the mine and mill waste to the repository, where it was buried under an earthen cap with a silty clay layer and the topsoil to support native plants. This cap was designed to keep the underlying waste material mostly dry and minimize contaminant transport. A total of 24,476 cubic yards of contaminated mill tailings were removed from the banks of Cold Springs Creek. An additional 22,070 cubic yards of waste rock with elevated lead levels were removed from other areas of the mine. The waste materials were buried safely in Cowboy Flat Repository, thus greatly reducing the risk of exposure to hazardous materials (Figure 2). Some of the mine adits were sealed off completely; other adits were identified as important habitat for bats and were closed off with bat-friendly grates.

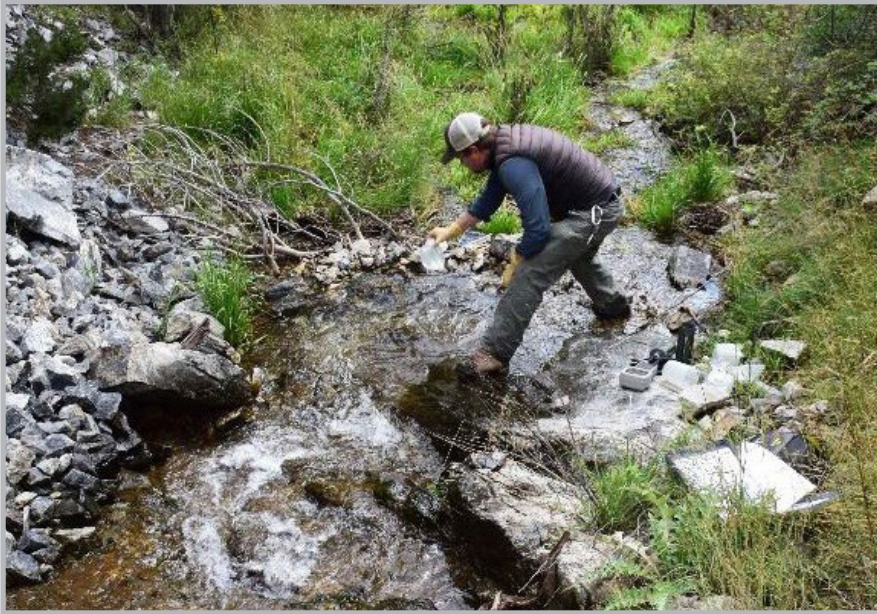
Figure 3 (left). An NMED staff member collects samples from Cold Springs Creek, after reclamation.

NMED staff sampled Cold Springs Creek for metals downstream of the Royal John Mine before and after reclamation (Figure 3; Table 1). After reclamation, samples from 2019 and 2020 showed a decrease in lead, and no cadmium was detected. In 2021, both cadmium and lead levels were below detection. Therefore, the NMED Surface Water Quality Bureau (SWQB) removed cadmium as a cause of water quality impairment in the 2022–2024 Integrated Report. Based on current data trends, it appears likely that the lead impairment could also be removed in the next reporting cycle.

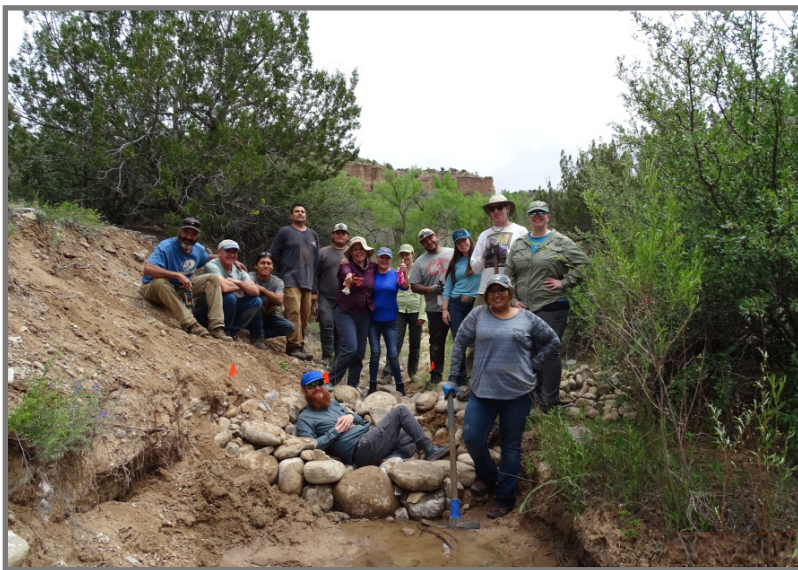
NM State Land Office staff and Wood Sharks crew members pose at the end of a workday around a large Zuni bowl.

Public Lands Stephanie Garcia Richard), and other volunteers learned about and built one-rock dams, Zuni bowls, wicker weirs, and log racks to slow stormwater runoff in small gullies and on slopes, to encourage sediment to settle and fill gullies, and to slow, spread, and sink storm flows into the sediment. We also covered the soil with slash to create a micro-climate that reduces erosion by the raindrops and stimulates plant regeneration and growth, and as a result, we worked to build living soil, keep more soil in place, hold more water in place, improve habitat for wildlife and plants, and reduce flash flood risks and sedimentation problems downstream. The Wood Sharks, LLC, a Taos-based forestry contractor with employees from several nearby communities had been working on the project for five weeks, and helped with logistics and training aspects of the workshops and built many more structures.

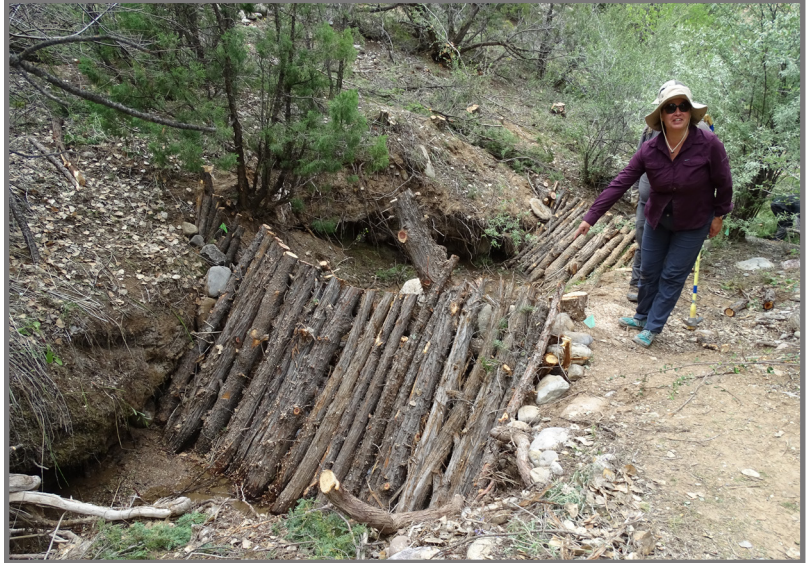
NM State Land Commissioner Stephanie Garcia Richard presents a log rack built during a workday in the Labyrinth Spring canyon on State Trust Land.

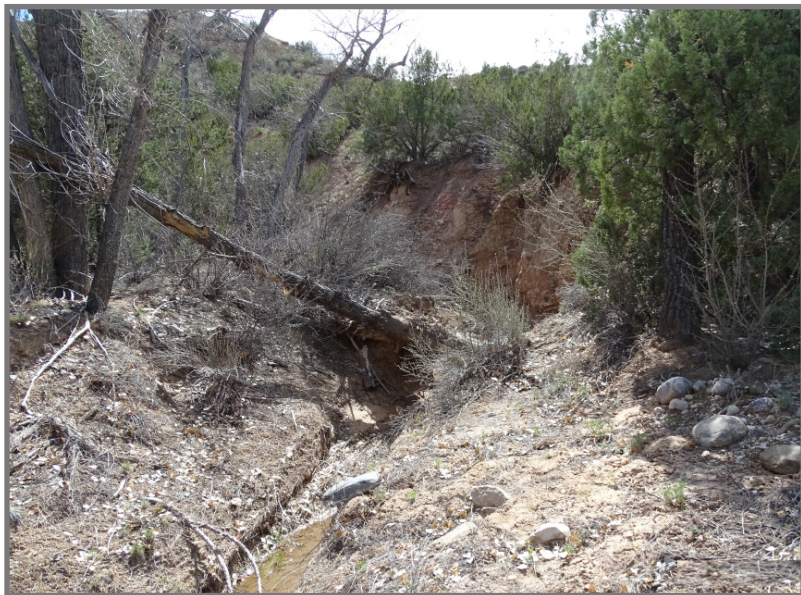
Wetland channel that eroded and became entrenched, leaving cottonwoods and willows high and dry and dying.

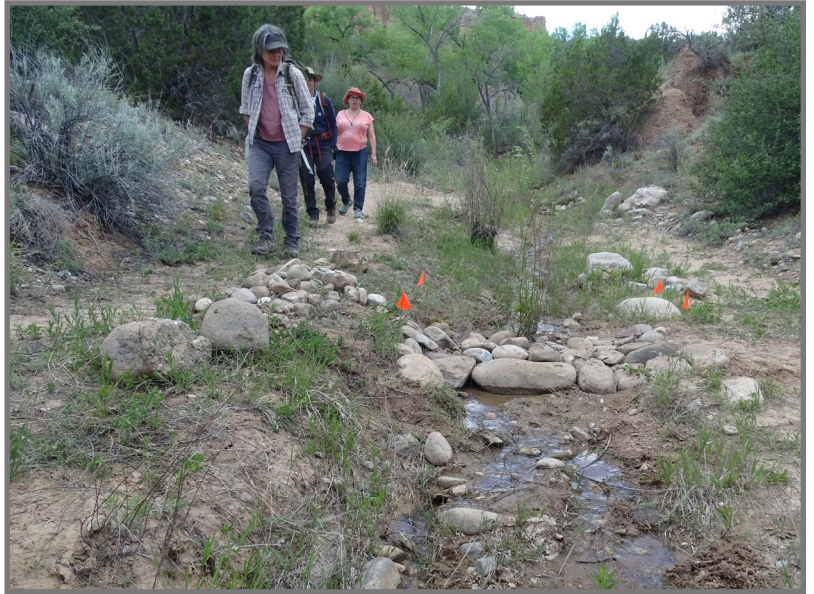
Workshop participants inspect their work at the end of the day building one-rock-dams and wicker weirs in the Labyrinth Spring canyon.
