Re: Minor Municipal, SIC 4952, NPDES Compliance Evaluation Inspection, Village of Hatch Wastewater Treatment Plant, NM0020010, February 24, 2015

**Village of Hatch Wastewater Treatment Plant
Compliance Evaluation Inspection
NPDES Permit No. NM0020010
February 24, 2015**

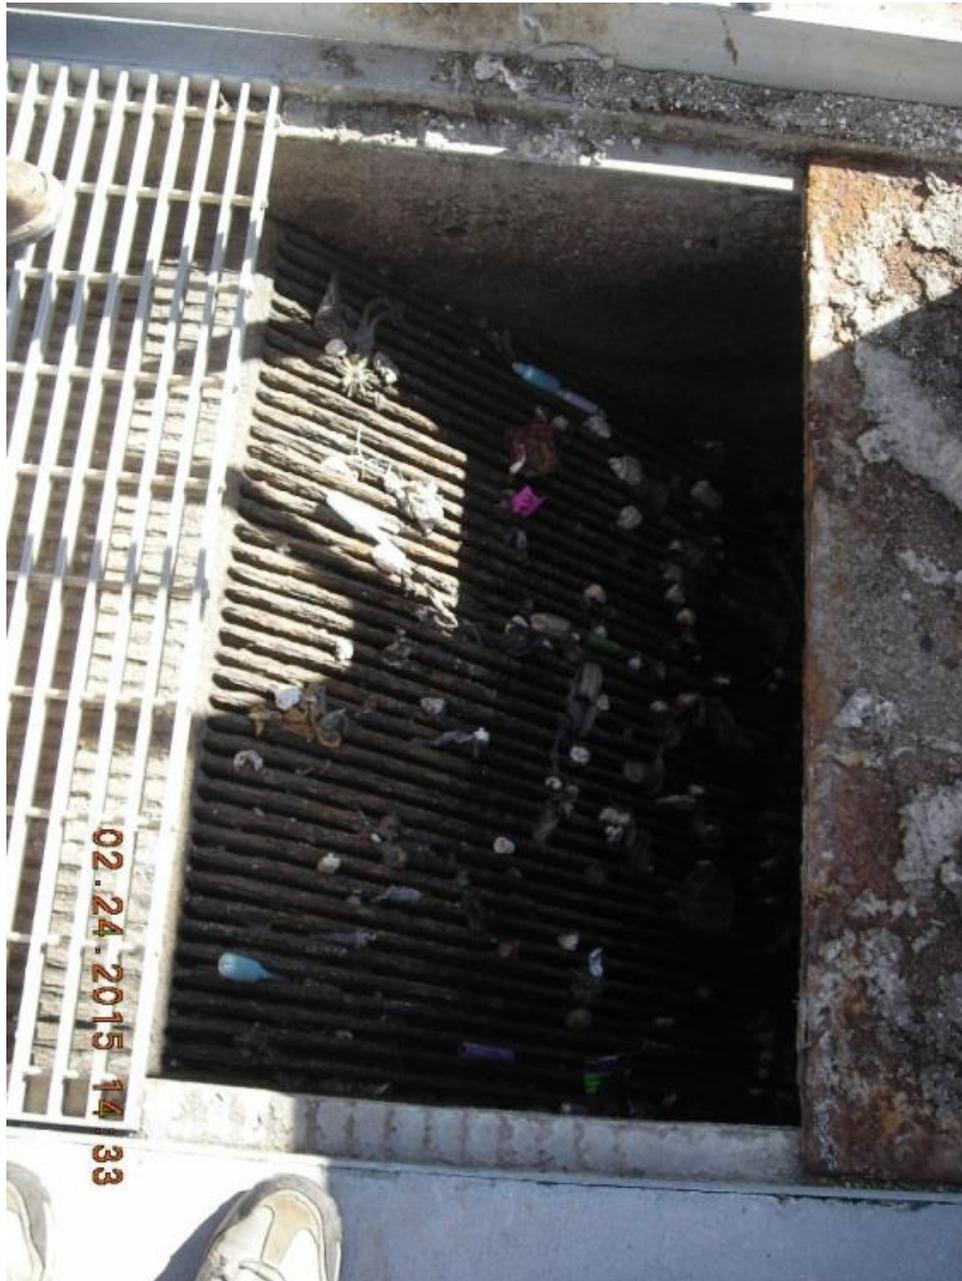
Official Photograph Log
Photo #1

The bar screen had rags and debris on the bars – it was obvious that the bar screen had not been cleaned since the time of the previous inflow (see Photo #1). Also, excessive foam was observed on the surface of the sequencing batch reactor (see Photo #2). Excess foam in a SBR may be caused by several different things including excessive filamentous bacteria, denitrification, too low or too high solids retention time, fats, oil, or grease, and/or over-aeration. However, stable, dark chocolate foam like the foam that was observed is due to aged systems operating with high MLSS concentration. To correct the problem, it is recommended that the operator increase the sludge wasting rate while constantly monitoring the MLSS drop and do a microscopic examination to evaluate any shifts in microbe composition (the presence of rotifers or worms signifies that the sludge is too old).

Photographer: Shelly Lemon	Date: 02-24-2015	Time: 14:33 hours
City/County: Hatch/Dona Ana County		
Location: Hatch WWTP		
Subject: Bar screen.

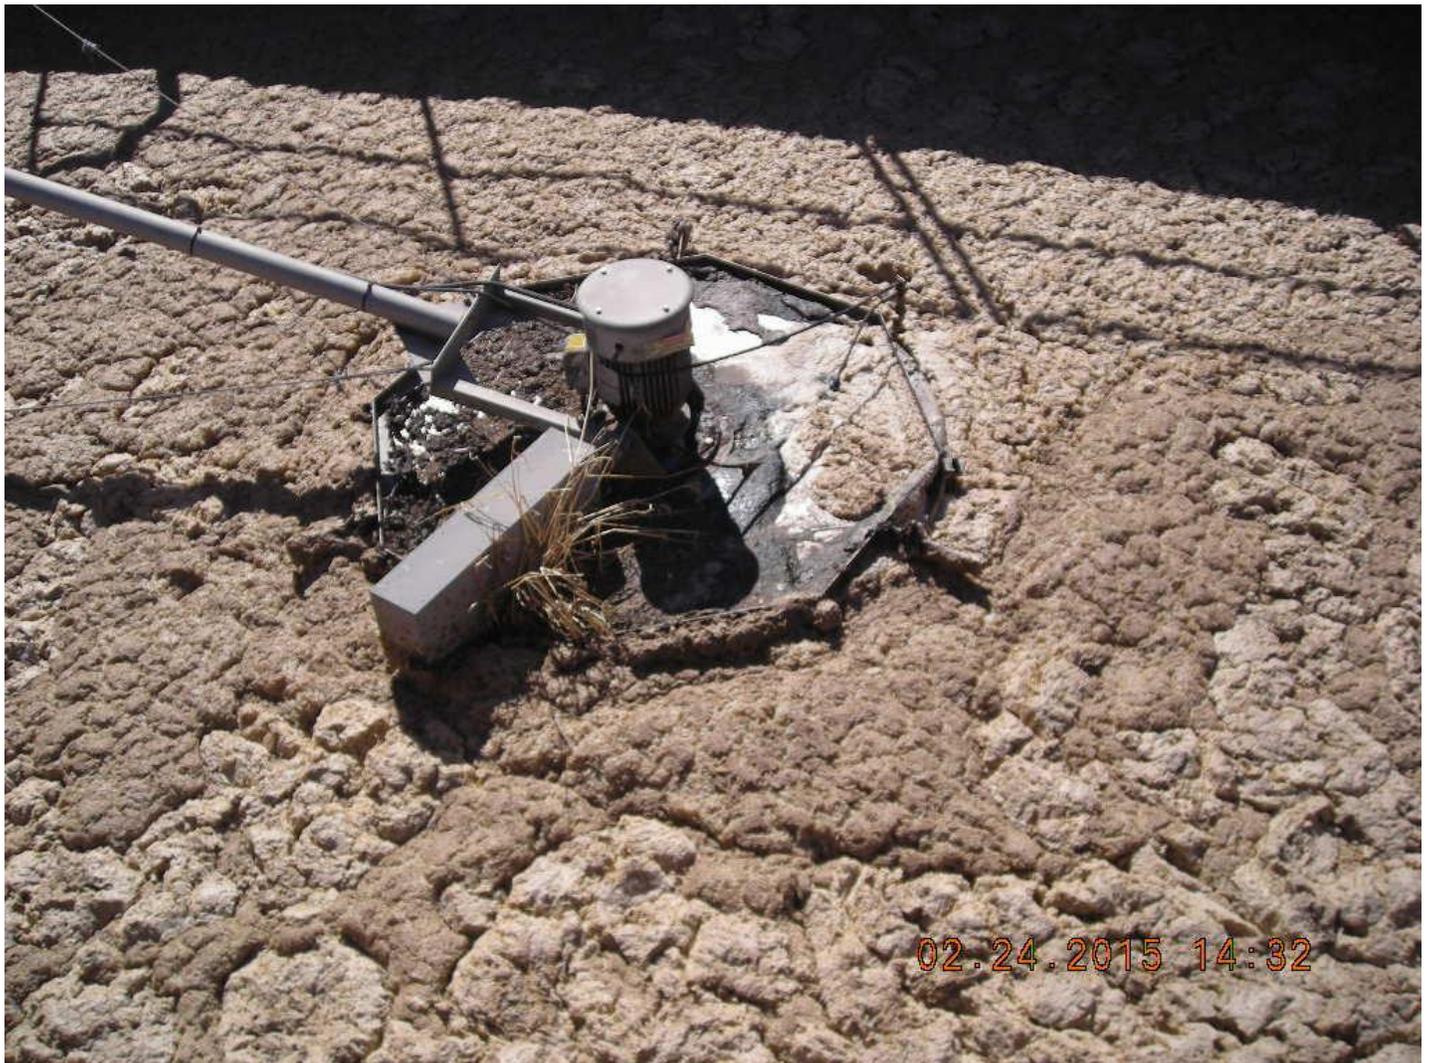
Official Photograph Log
Photo #2

Photographer: Shelly Lemon	Date: 02-24-2015	Time: 14:32 hours
City/County: Hatch/Dona Ana County		
Location: Hatch WWTP		
Subject: Foam on surface of Sequencing Batch Reactor.

If foam continues to be a problem, other control actions that can be taken include identifying the conditions contributing to filamentous growth and correcting; optimizing nitrification/denitrification by switching blowers (oxygen) on and off during fill phase; continuing to adjust sludge wasting to achieve optimal solids retention

time; optimizing pretreatment removal of oil and grease; and closely monitoring dissolved oxygen levels and adjust aeration cycles as needed.

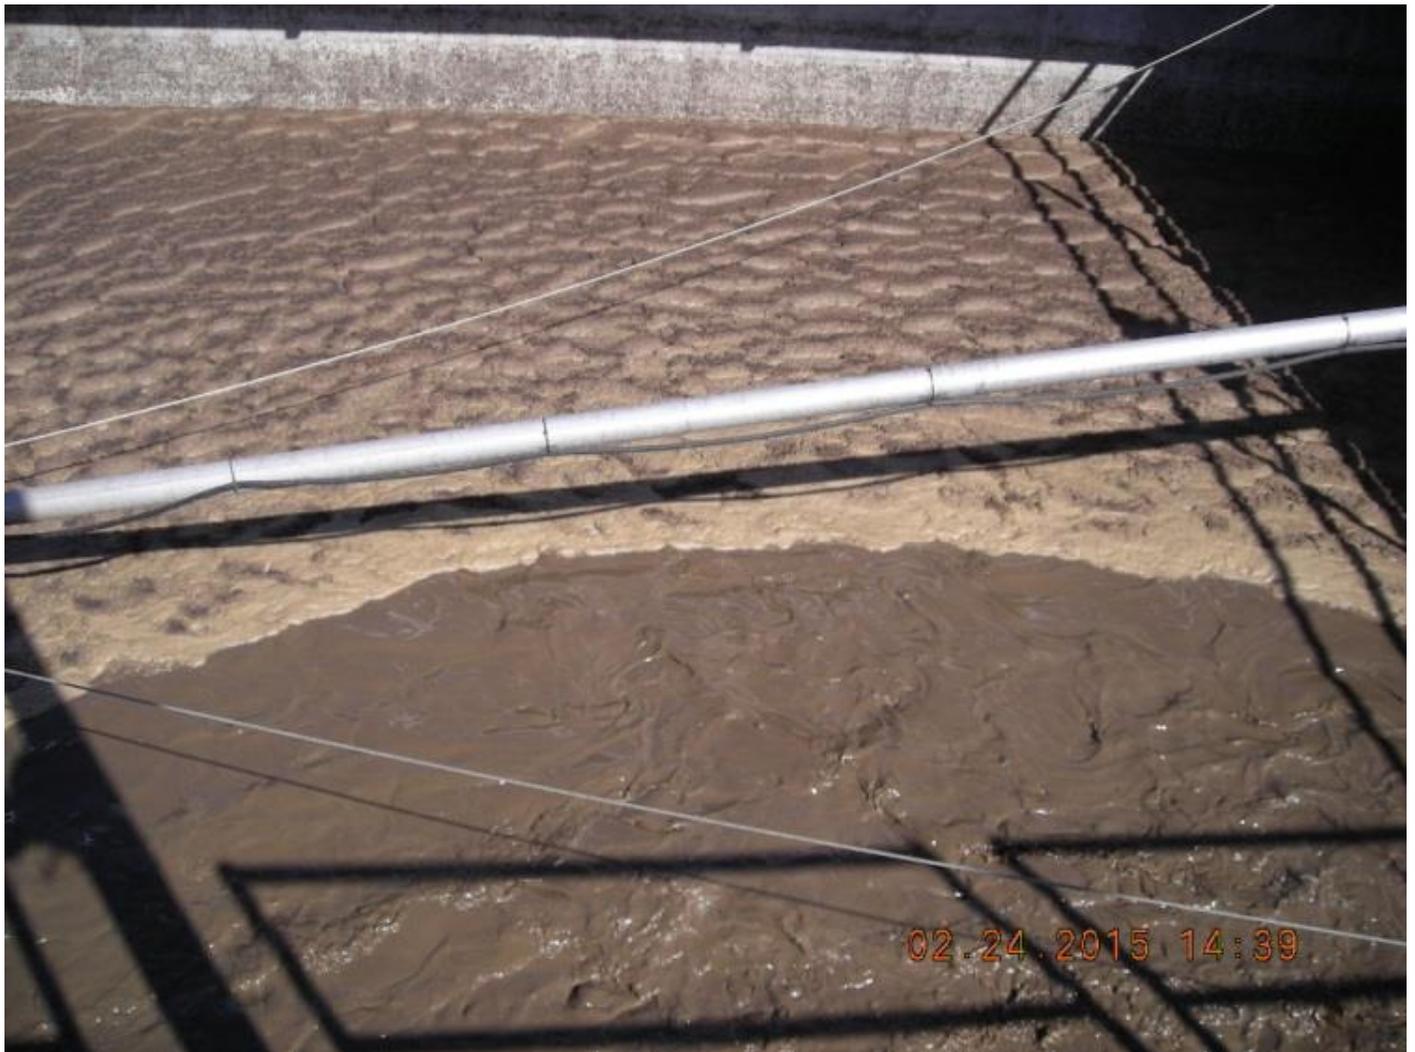
Official Photograph Log
Photo #3

Photographer: Shelly Lemon	Date: 02-24-2015	Time: 14:39 hours
City/County: Hatch/Dona Ana County		
Location: Hatch WWTP		
Subject: Aerobic digester.

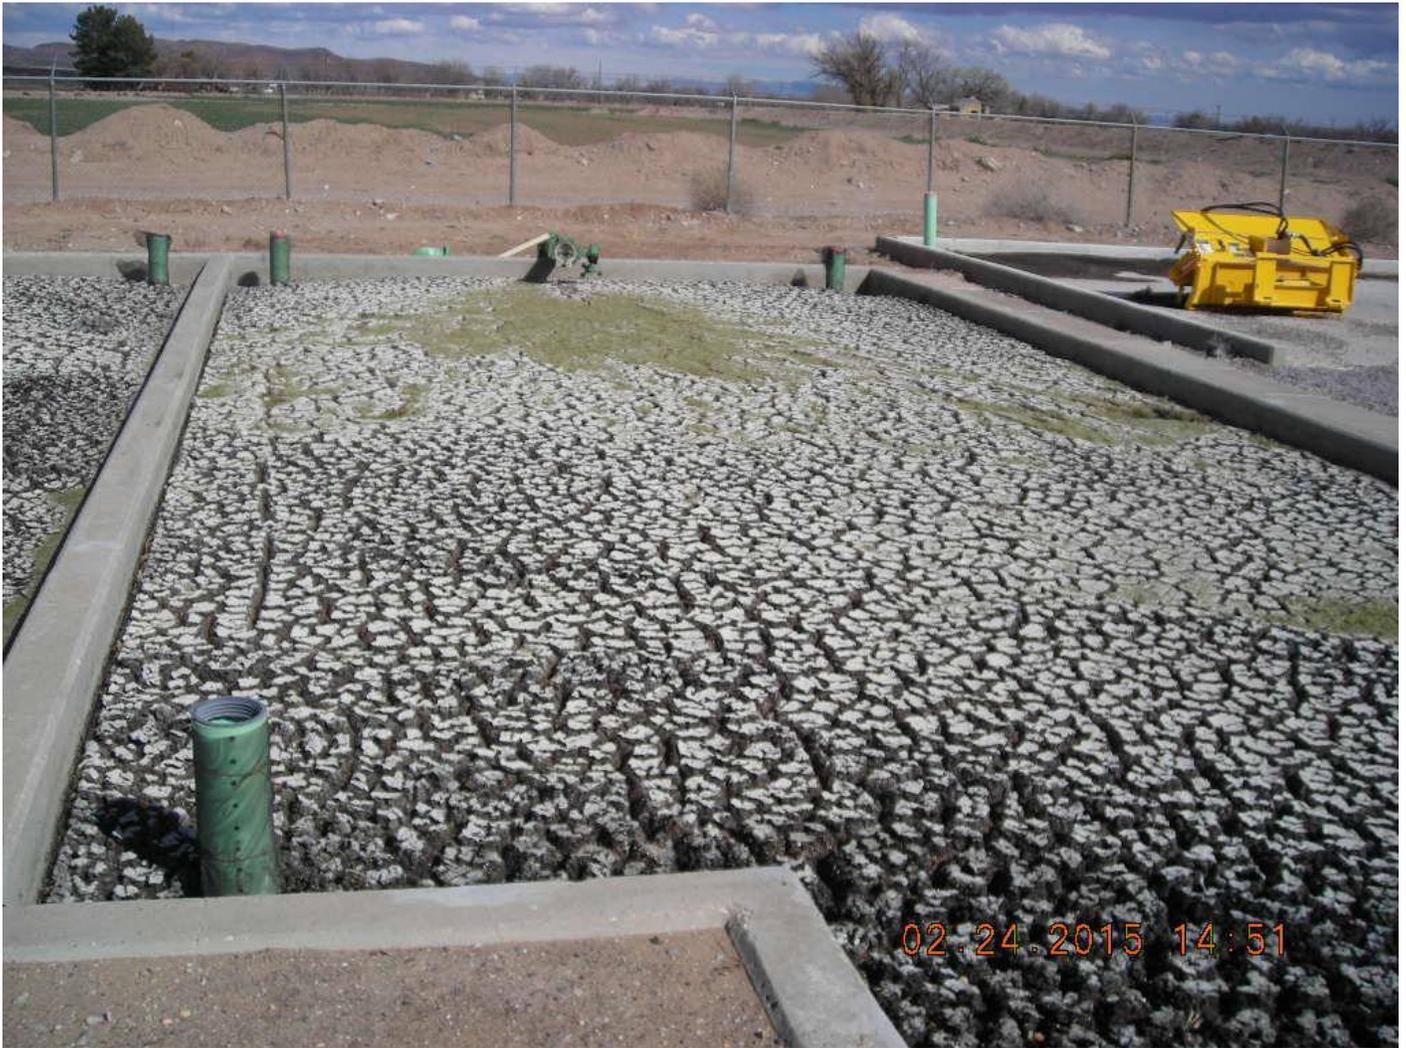
Official Photograph Log
Photo #4

Photographer: Shelly Lemon	Date: 02-24-2015	Time: 14:51 hours
City/County: Hatch/Dona Ana County		
Location: Hatch WWTP		
Subject: Sludge drying beds.
