Re: Major Municipal, SIC 4952, NPDES Compliance Evaluation Inspection, Belen WWTP, Belen, New Mexico, NM0020150, November 29, 2012

NPDES Compliance Inspection Report

**Compliance Evaluation Inspection
Belen Wastewater Treatment Plant
NPDES Permit No. NM0020150
November 29, 2012**

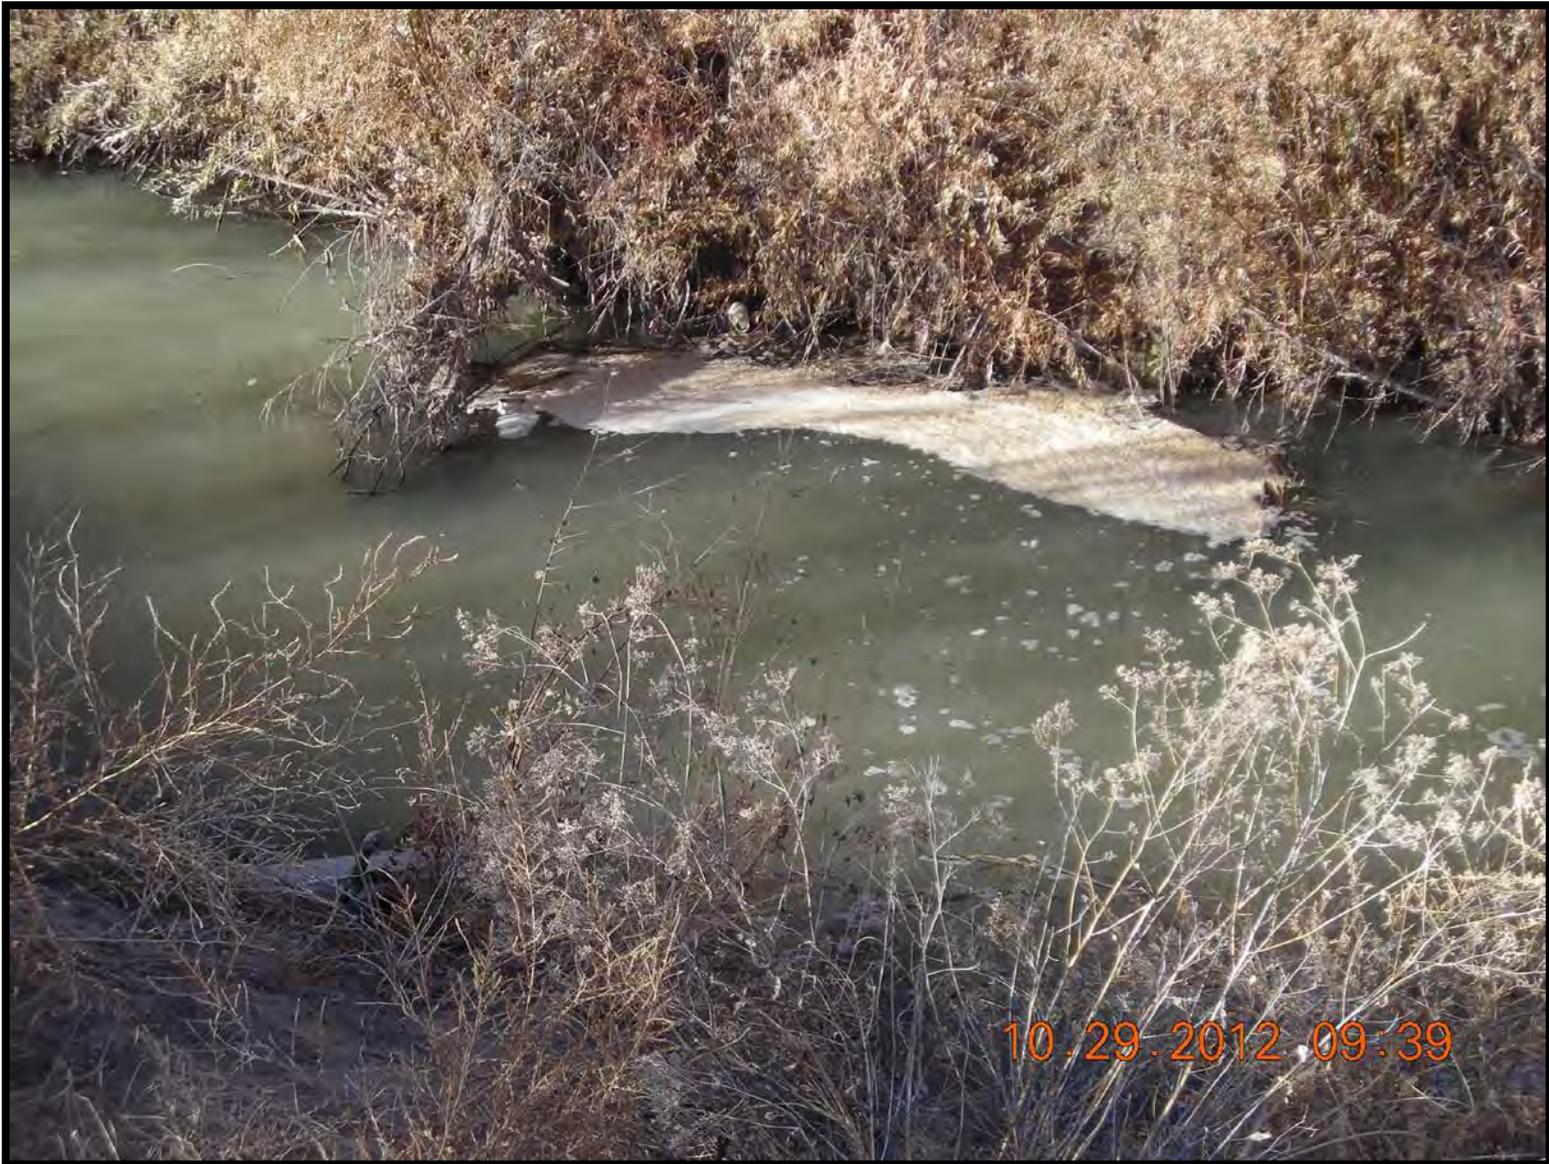
Photo # 1

There was a large residual of foam at the outfall of the treatment plant into the irrigation drain. The permittee’s representative indicated that this is a routine occurrence at the change of the season in both spring and fall. Please see Photo #1.

Photographer: Sarah Holcomb	Date: 11-29-2012 (date stamp on photo is incorrect)	Time: 0939 hours
City/County: Belen/Valencia County		
Location: Belen Wastewater Treatment Plant		
Subject: Outfall from the WWTP; Please note accumulated foam in drainage canal downstream from WWTP discharge.
