**Re: Town of Taos Wastewater Treatment Plant; Major; Individual Permit; SIC 4952;  
Compliance Evaluation Inspection; NPDES Permit NM0024066; March 19, 2015**

### NPDES Compliance Inspection Report

**Town of Taos Wastewater Treatment Plant (WWTP)**  
**Compliance Evaluation Inspection**  
**NPDES Permit No. NM0024066**  
**Inspection Date: March 19, 2015**

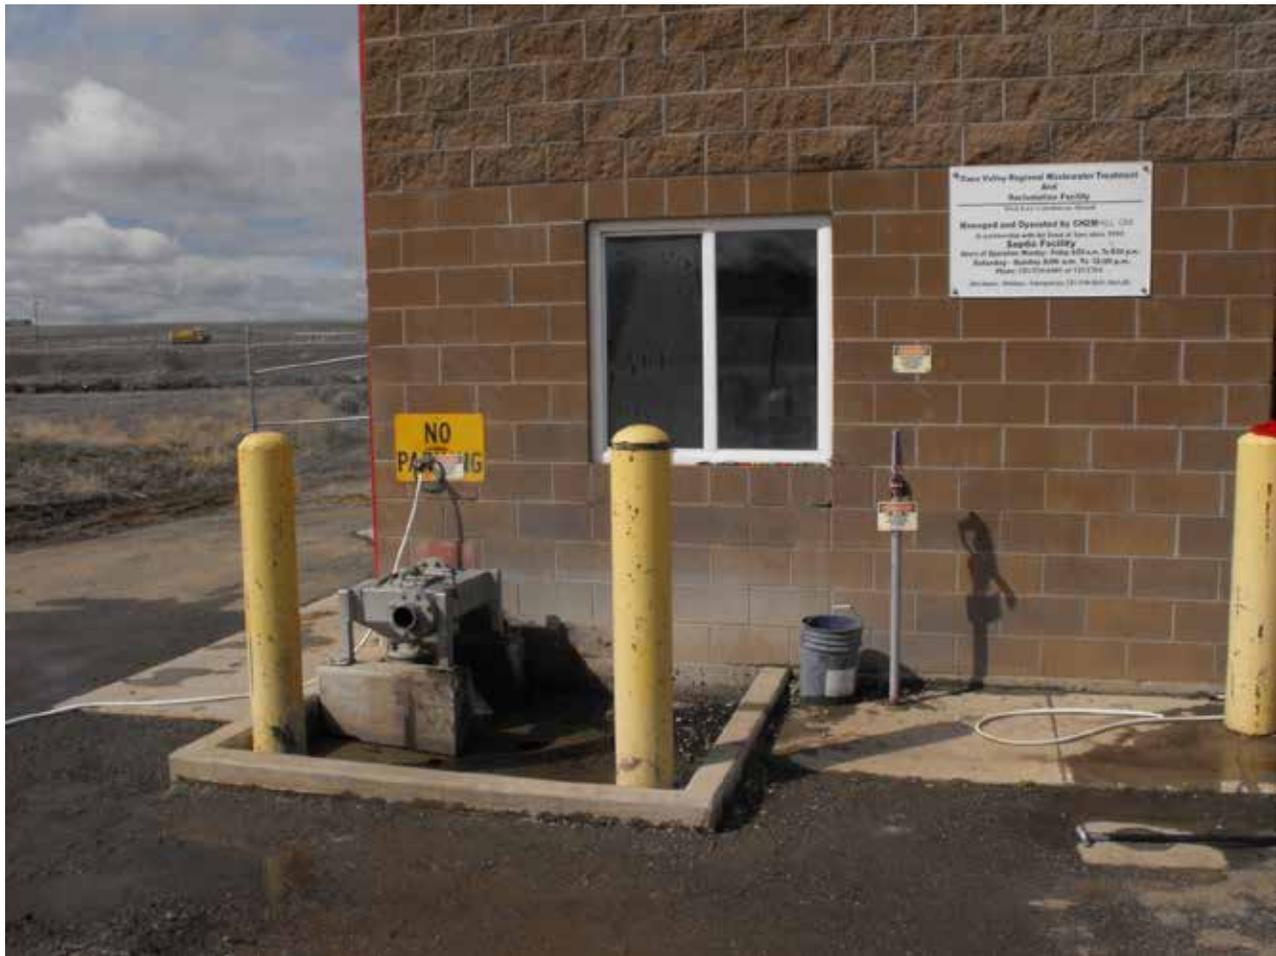
**NMED/SWQB  
Official Photograph Log  
Photo # 1**

Photographer: Daniel Valenta	Date: 03/19/2015	Time: 1056 Hours
City/County: Taos/Taos County		State: New Mexico
Location: Taos WWTP		
Subject: Septage haulers receiving station at the entrance works of the WWTP

A septage receiving station is located at the head works. In order to protect the WWTP process, septage haulers must test their loads for pH before being allowed to dump the waste at the treatment plant. A log is kept of these loads and is also used for billing by the Town of Taos.

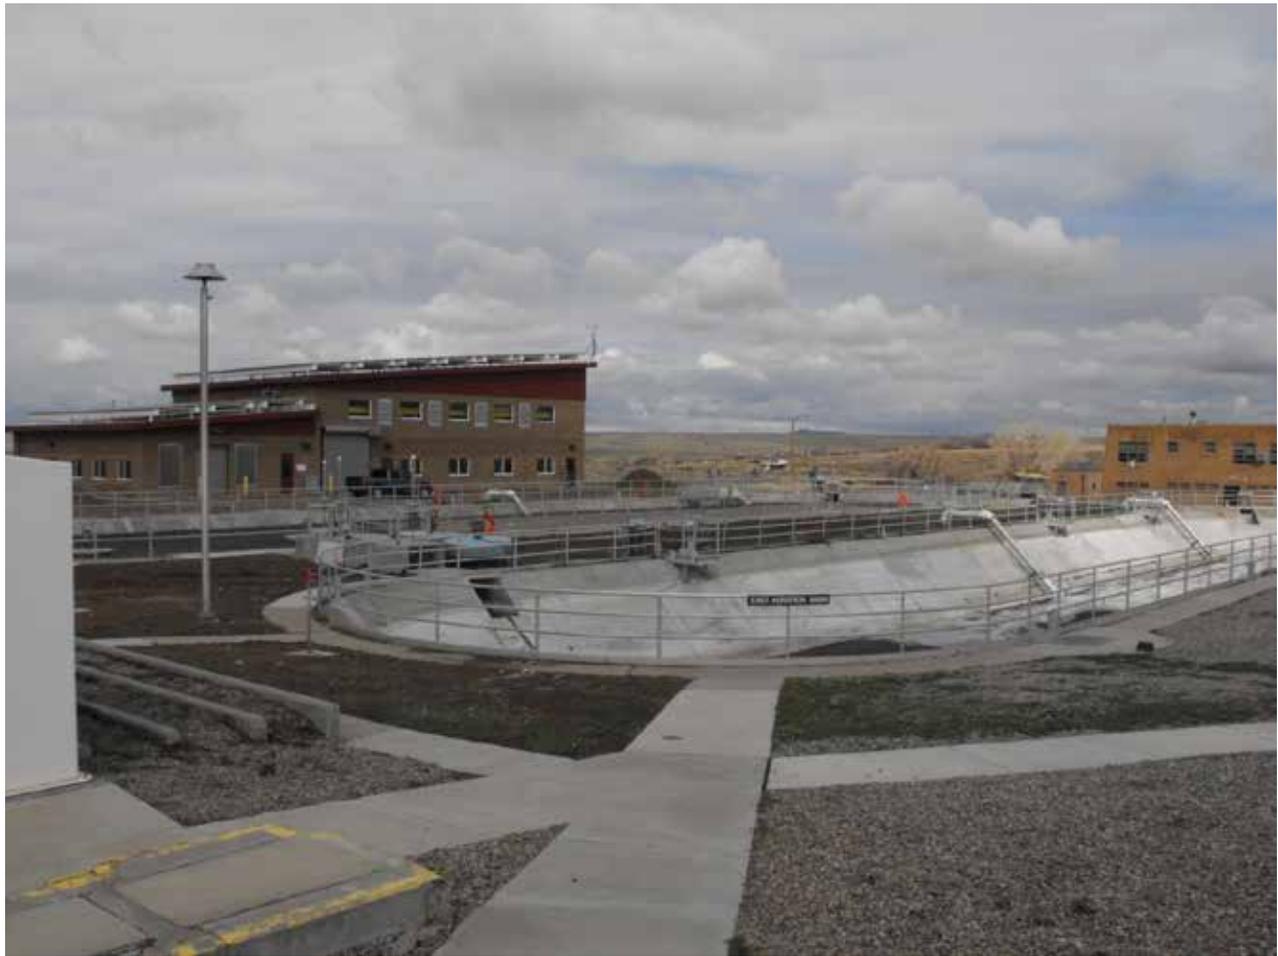
**NMED/SWQB**  
**Official Photograph Log**  
**Photo # 2**

The east aeration basin is having some diffused aerators fixed. The basin is currently offline.

Photographer: Daniel Valenta	Date: 03/19/2015	Time: 1101 Hours
City/County: Taos/Taos County		State: New Mexico
Location: Taos WWTP		
Subject: East Aeration Basin, currently offline

Flow is then directed through a splitter box that sends the wastewater to either the East or West aeration basin. The basins are from the old treatment plant. They have been reconfigured so that ½ of each basin has a series of fine bubble diffusers to create an aerated zone, and the other ½ of each basin has mixers only that constitute the anoxic zone. The water enters the basins in the anoxic zone and exits the basin past the aerobic zone. The east basin is currently off line due to some fine bubble diffusers inoperable at this time. The facility is working on repair of the diffusers at this time.

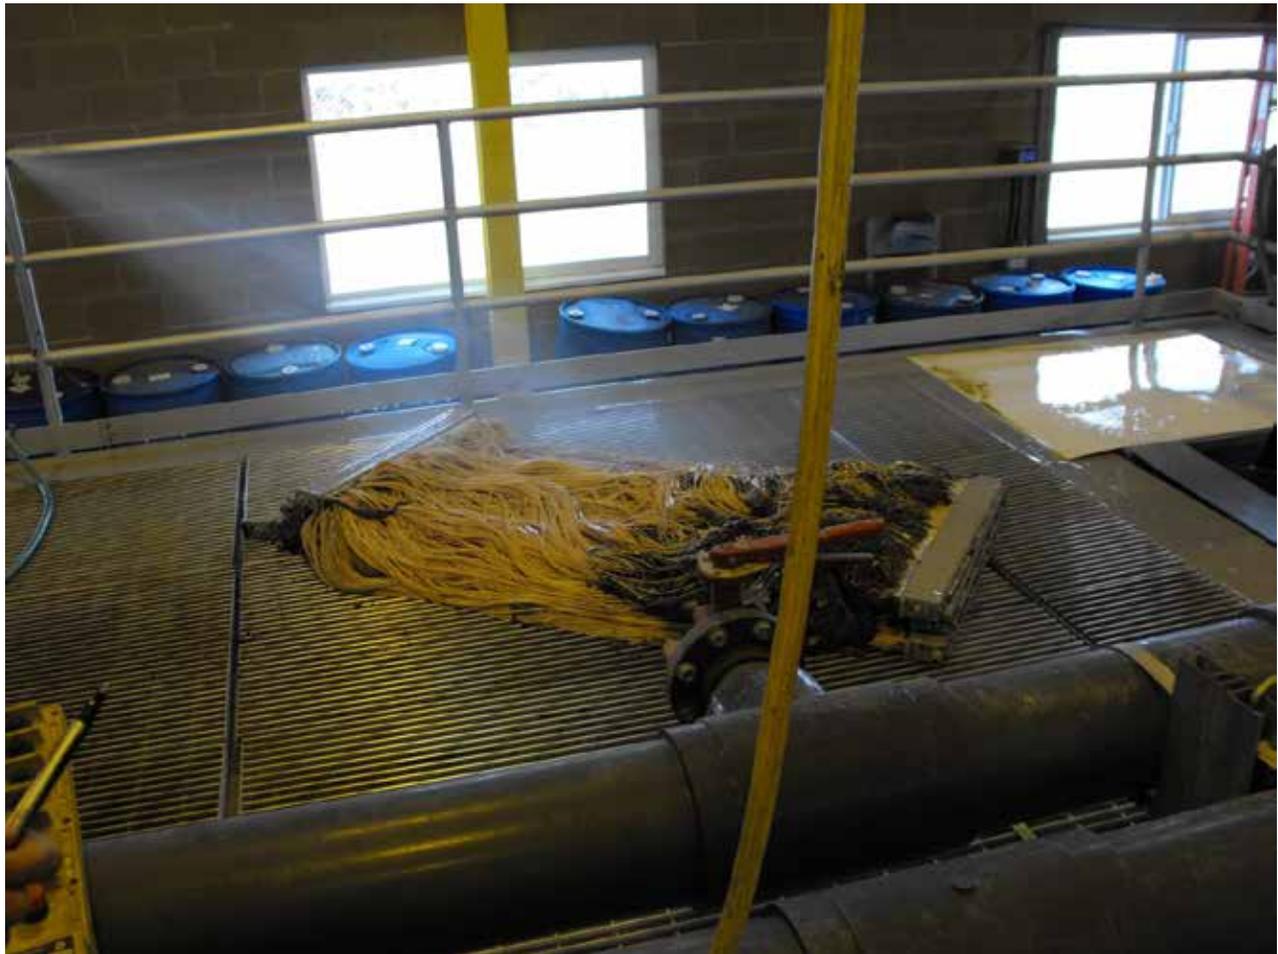
**NMED/SWQB**  
**Official Photograph Log**  
**Photo # 3**

The permittee has had a manufacturing issue with their membranes elements. The membranes have broken consistently in the same location. Currently, approximately 20 membranes have had to be removed because of broken brackets. These spaces within the Membrane Bioreactor are left "blank", which decreases the efficiency of the MBR. The WWTP has contacted the manufacturer and they are in negotiations to get this issue resolved.

Photographer: Daniel Valenta	Date: 03/19/2015	Time: 1130 Hours
City/County: Taos/Taos County		State: New Mexico
Location: Taos WWTP		
Subject: Membrane element

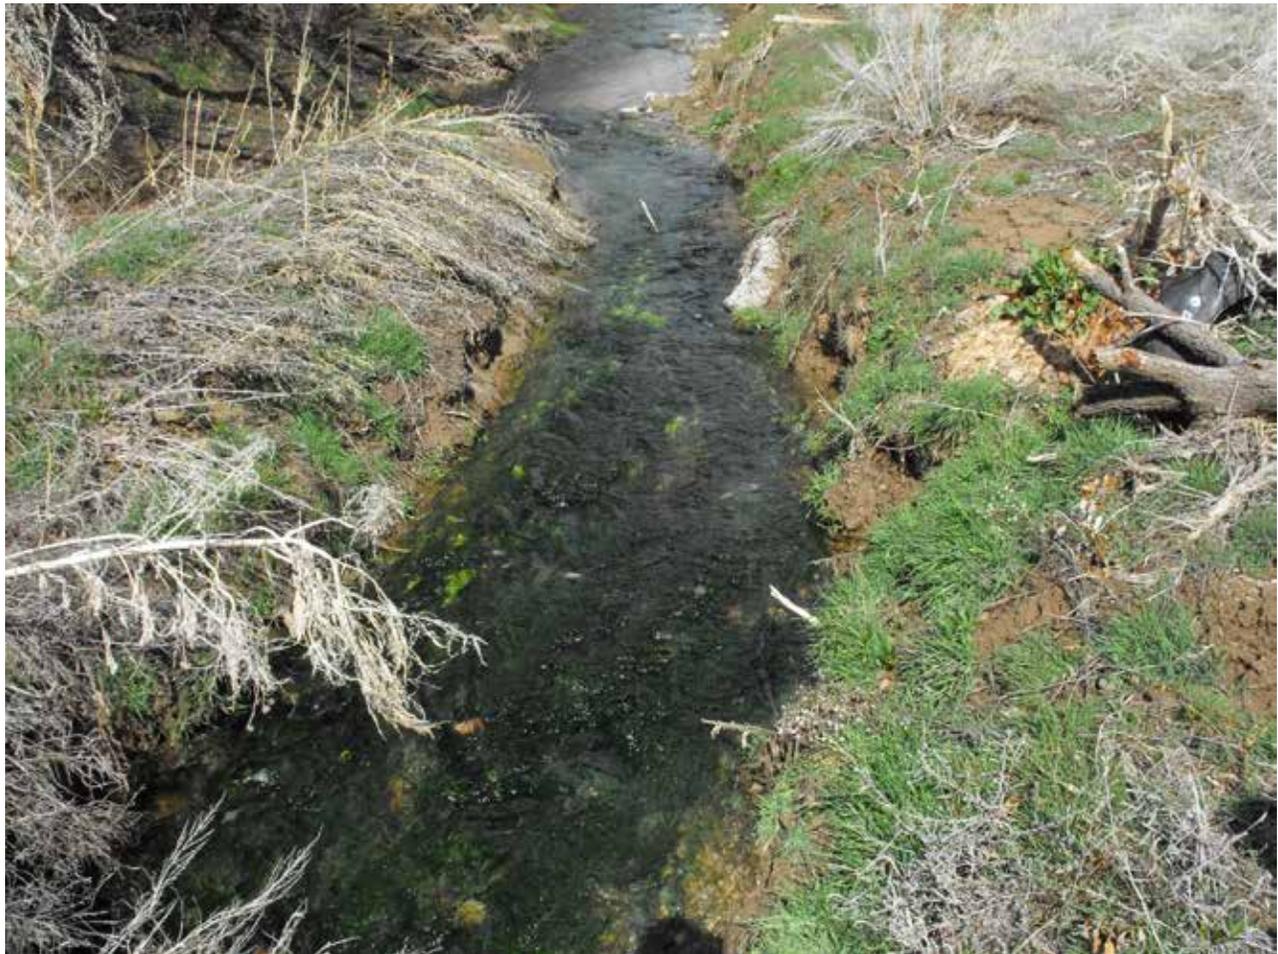
**NMED/SWQB**  
**Official Photograph Log**  
**Photo # 4**

RECEIVING WATER OBSERVATIONS Receiving water is clear at discharge; however, at the ditch there is a lot of algal growth. time. No TMDL has been approved for limitations on Nitrogen or Phosphorus in this segment.

Photographer: Daniel Valenta	Date: 03/19/2015	Time: 1151 Hours
City/County: Taos/Taos County		State: New Mexico
Location: Taos WWTP		
Subject: Discharge to unnamed ditch
