**RE: Town of Springer Wastewater Treatment Plant; Minor; Individual Permit; SIC 4952; NPDES Compliance Evaluation Inspection; NPDES # NM0030295; November 14, 2013**

**Town of Springer Wastewater Treatment Plant**  
**NPDES Permit No. NM0030295**  
**Compliance Evaluation Inspection**  
**November 14, 2013**

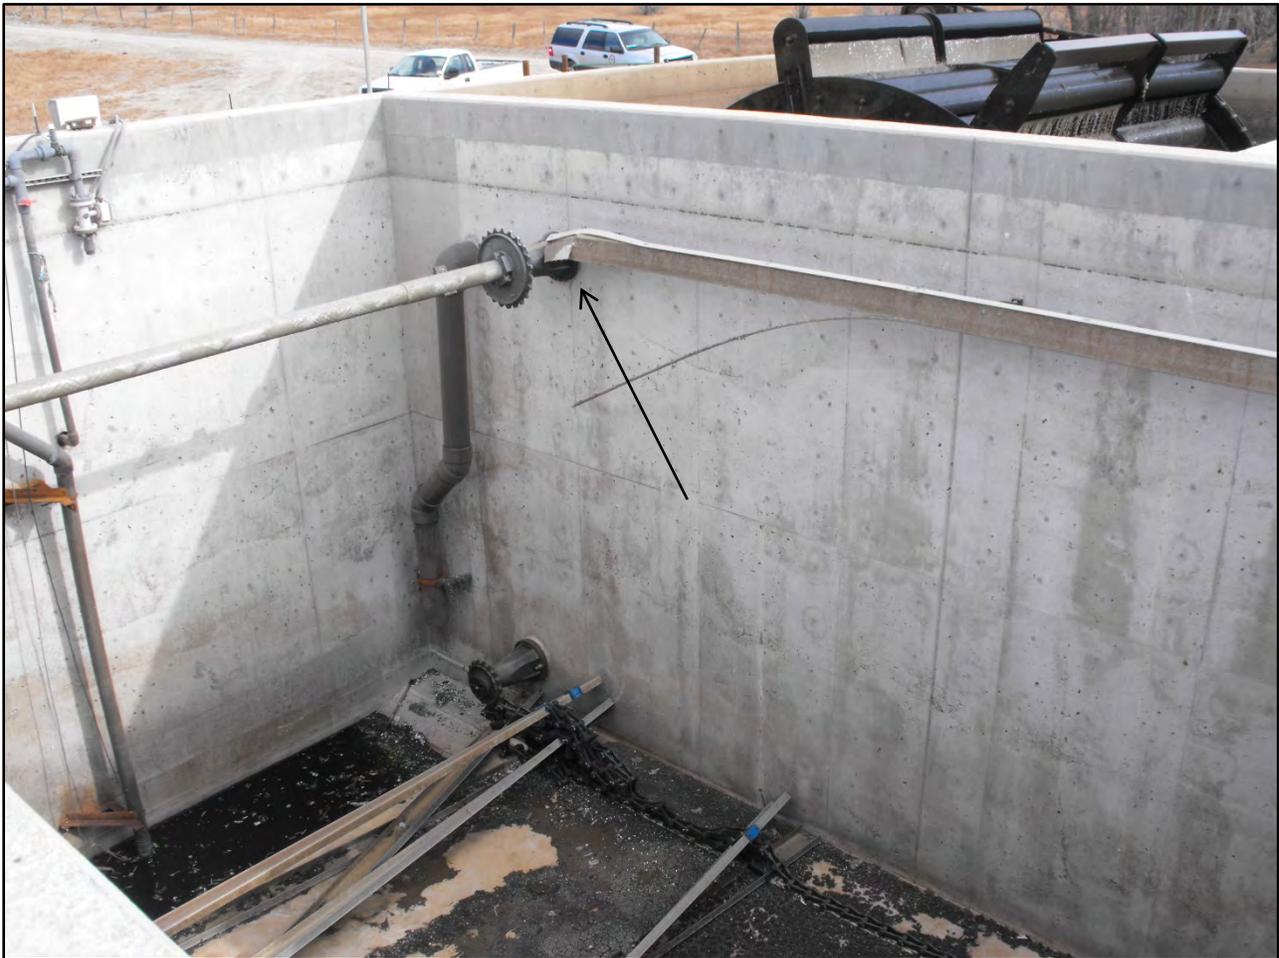
**NMED/SWQB  
Official Photograph Log  
Photo # 1**

Photographer: Daniel Valenta	Date: 11-14-2013	Time: 1015 Hours
City/County: Town of Springer / Colfax County		State: New Mexico
Location: Town of Springer WWTP, facing northeast.		
Subject: Clarifier chamber is not functional; drive chain hit the guide rail and broke. The STM Aerator unit is operating; the fixed film on the aerator is black in color.

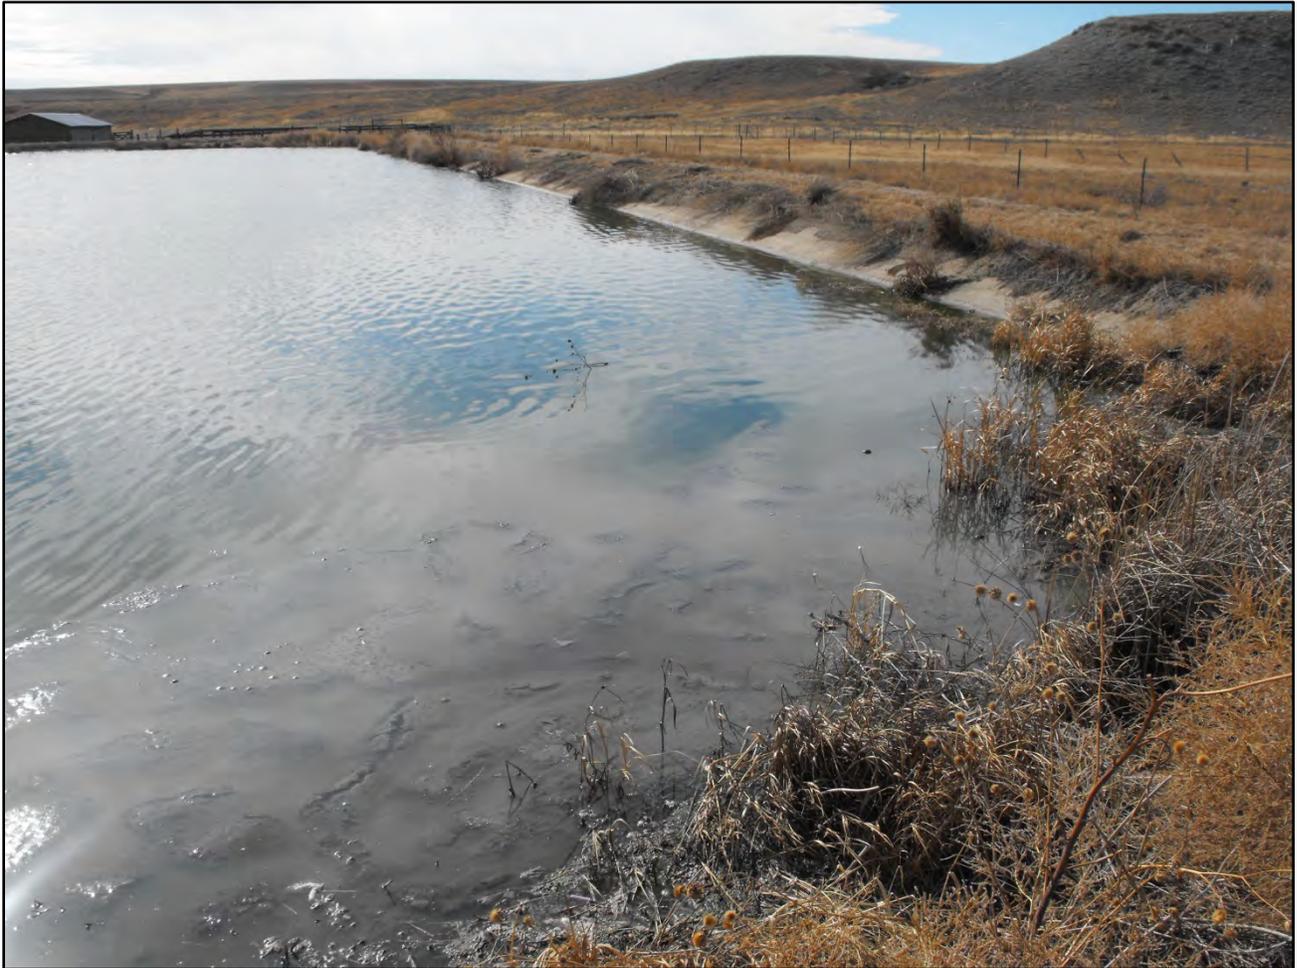
**NMED/SWQB  
Official Photograph Log  
Photo # 2**

The Town of Springer has a population of approximately 1,047 (2010 Census). The Springer Correctional Facility has an inmate population of 296. The Town of Springer WWTP has not been fully or consistently operational since initial construction of the package plant was completed in January of 2007. **Effluent at the time of the inspection is bypassing the treatment plant completely and being discharged to the lagoons, (see photo 1).**

Photographer: Daniel Valenta	Date: 11-14-2013	Time: 1015 Hours
City/County: Town of Springer / Colfax County		State: New Mexico
Location: Town of Springer WWTP, facing south west.		
Subject: Raw effluent is bypassing the WWTP and discharging into the lagoon.
