Re: Mora Independent School District; Minor Industrial; Individual Permit; SIC 8299: NPDES Compliance Evaluation Inspection; NPDES # NM0031097; March 6, 2014

NPDES Compliance Inspection Report

**Compliance Evaluation Inspection
Mora Independent School District
NPDES Permit No. NM0031097
March 6, 2014**

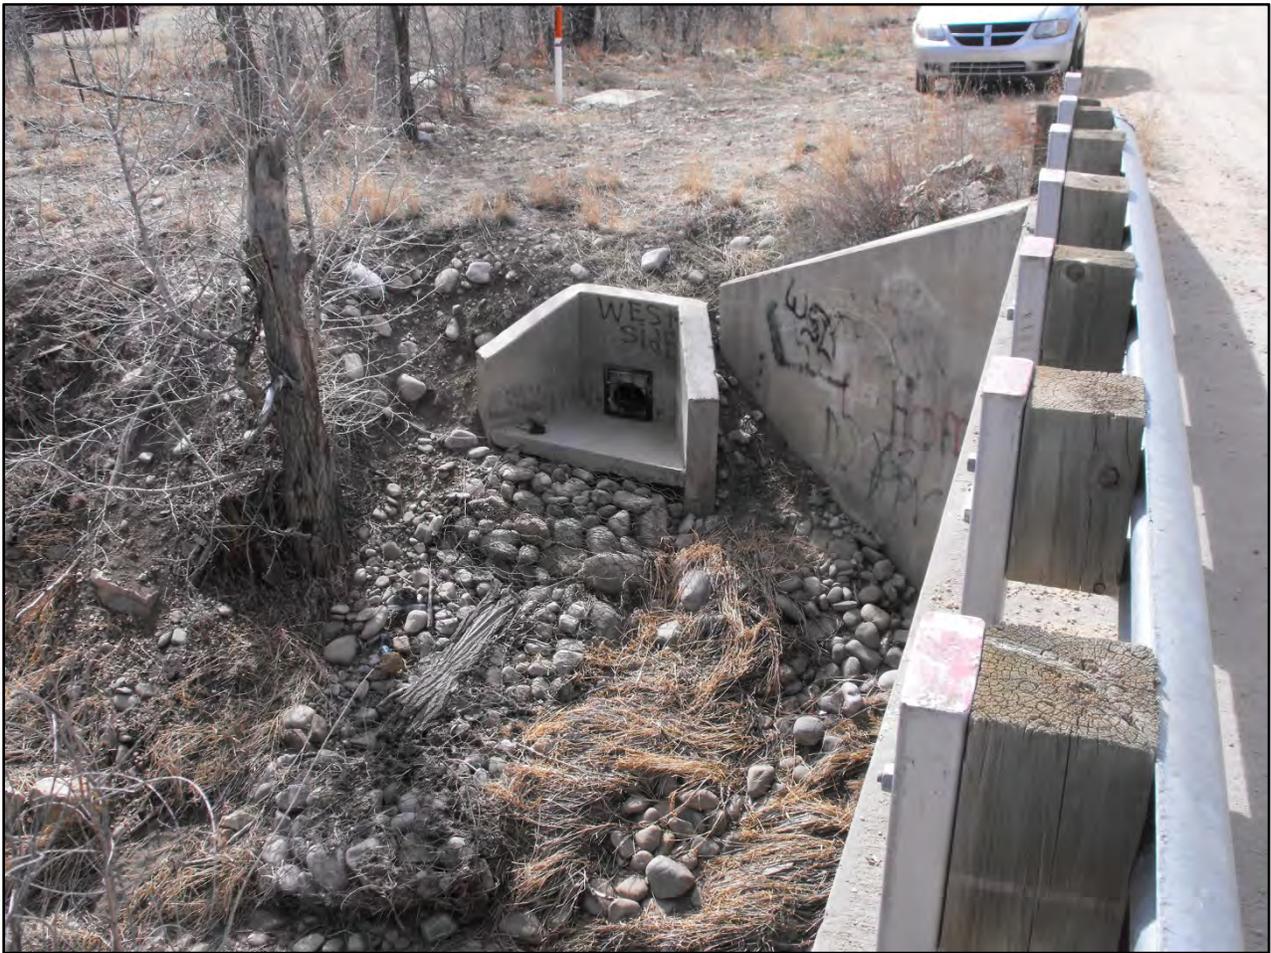
Photo # 1

Photographer: Daniel Valenta	Date: 4/6/2014	Time: 1148 hours
City/County: Mora, Mora County		
Location: North of Mora High School on unnamed road that crosses the Mora River, facing south.		
Subject: Discharge outfall 001 if the groundwater pumps engaged.

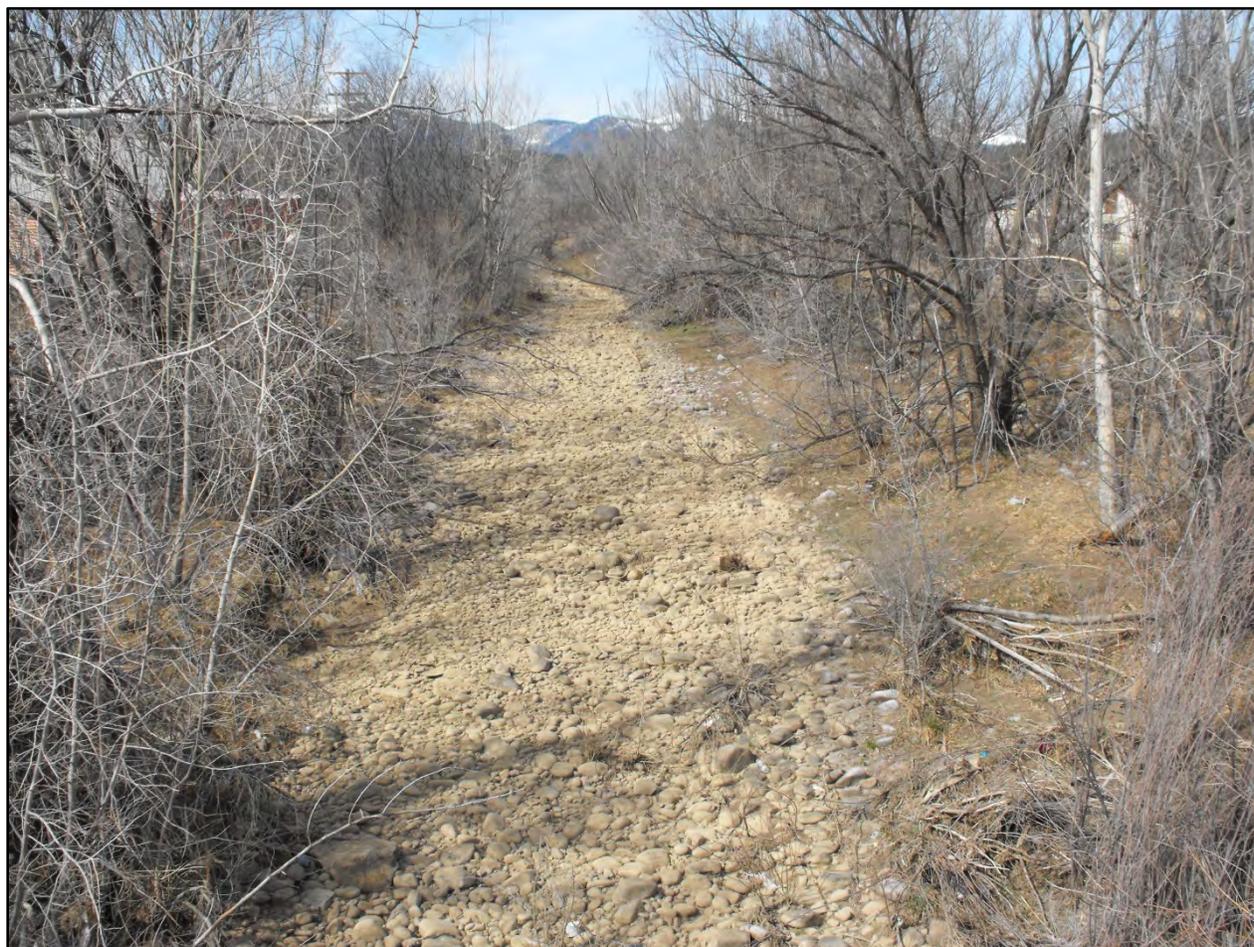
Photo # 2

Photographer: Daniel Valenta	Date: 4/6/2014	Time: 1149 hours
City/County: Mora, Mora County		
Location: North of Mora High School on unnamed road that crosses the Mora River, facing west.		
Subject: Mora river upstream of outfall 001.

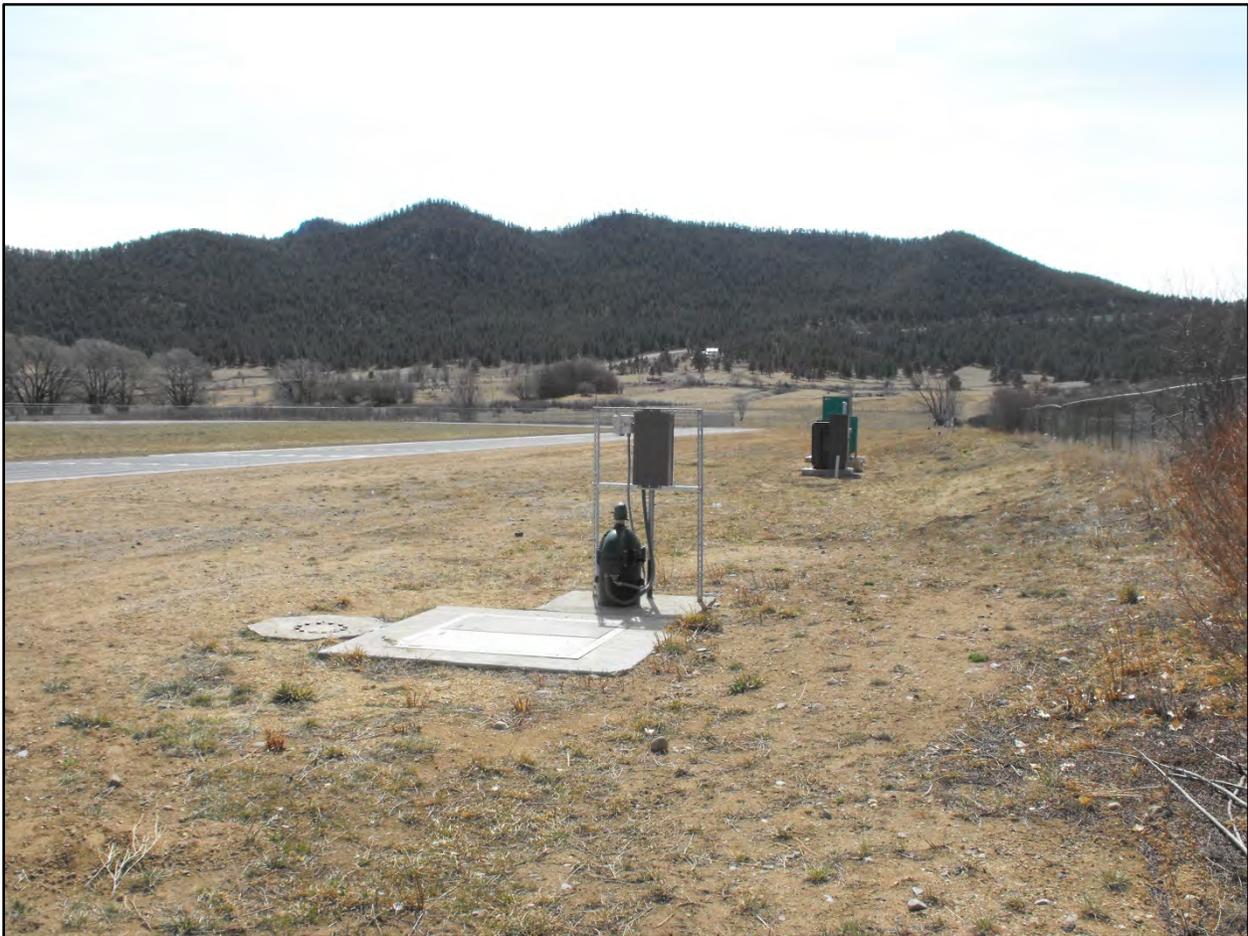
Photo # 3

Photographer: Daniel Valenta	Date: 4/6/2014	Time: 1310 hours
City/County: Mora, Mora County		
Location: Mora High School track field, facing south.		
Subject: Groundwater well and generator next to field track.
