RE: Industrial Storm Water; SIC 5093; NPDES Compliance Evaluation Inspection; Amado Recycling; NMU001783; January 4, 2012

NPDES Compliance Inspection Report

Amado Recycling
NMU001783
January 4, 2012

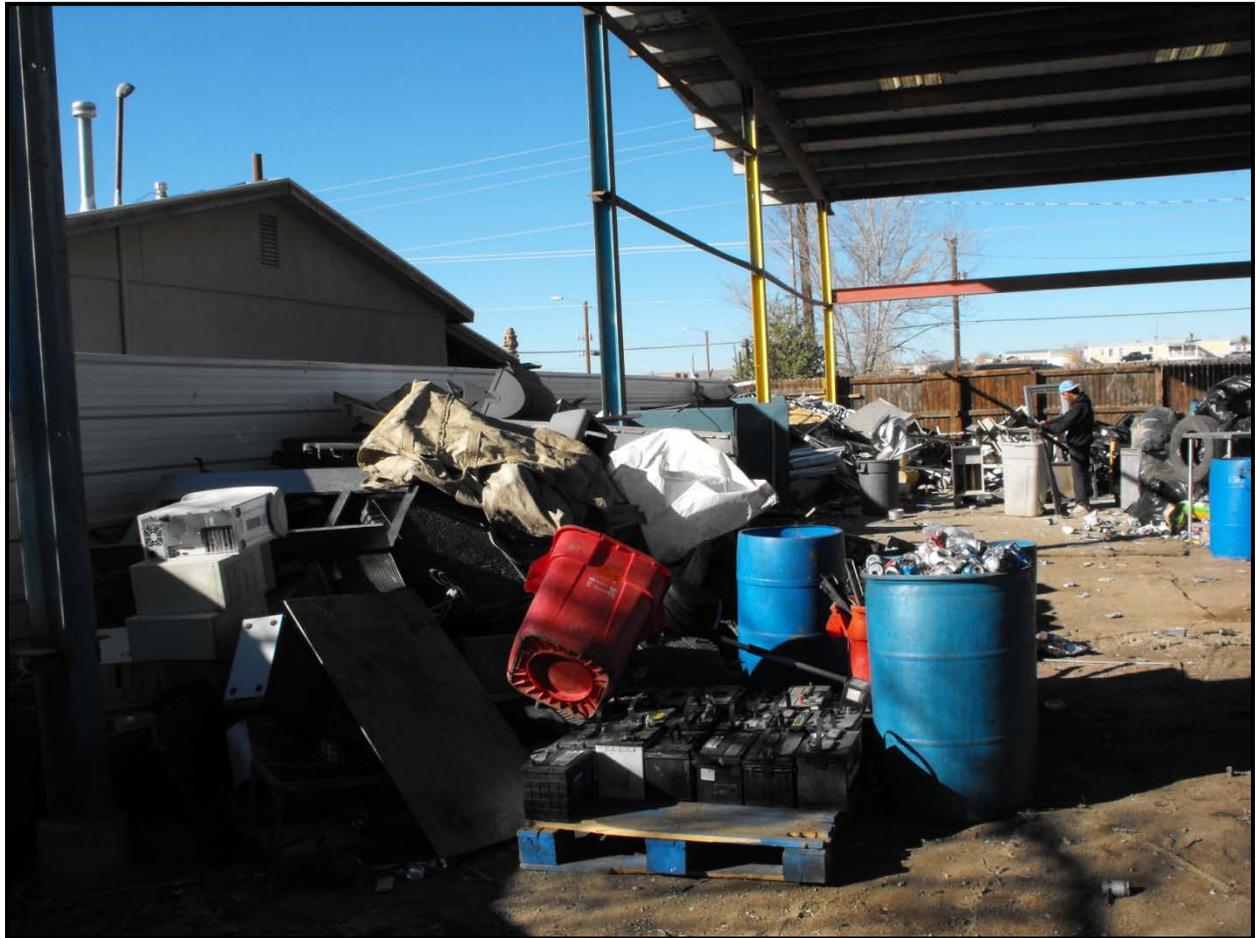
Photo # 2

Photographer: Daniel Valenta	Date: 1/4/2012	Time: 1020 hours
City/County: Albuquerque/Bernalillo		
Location: Amado Recycling, 2522 Coors Blvd, Albuquerque, New Mexico, facing west.		
Subject: Assorted scrap in storage area.

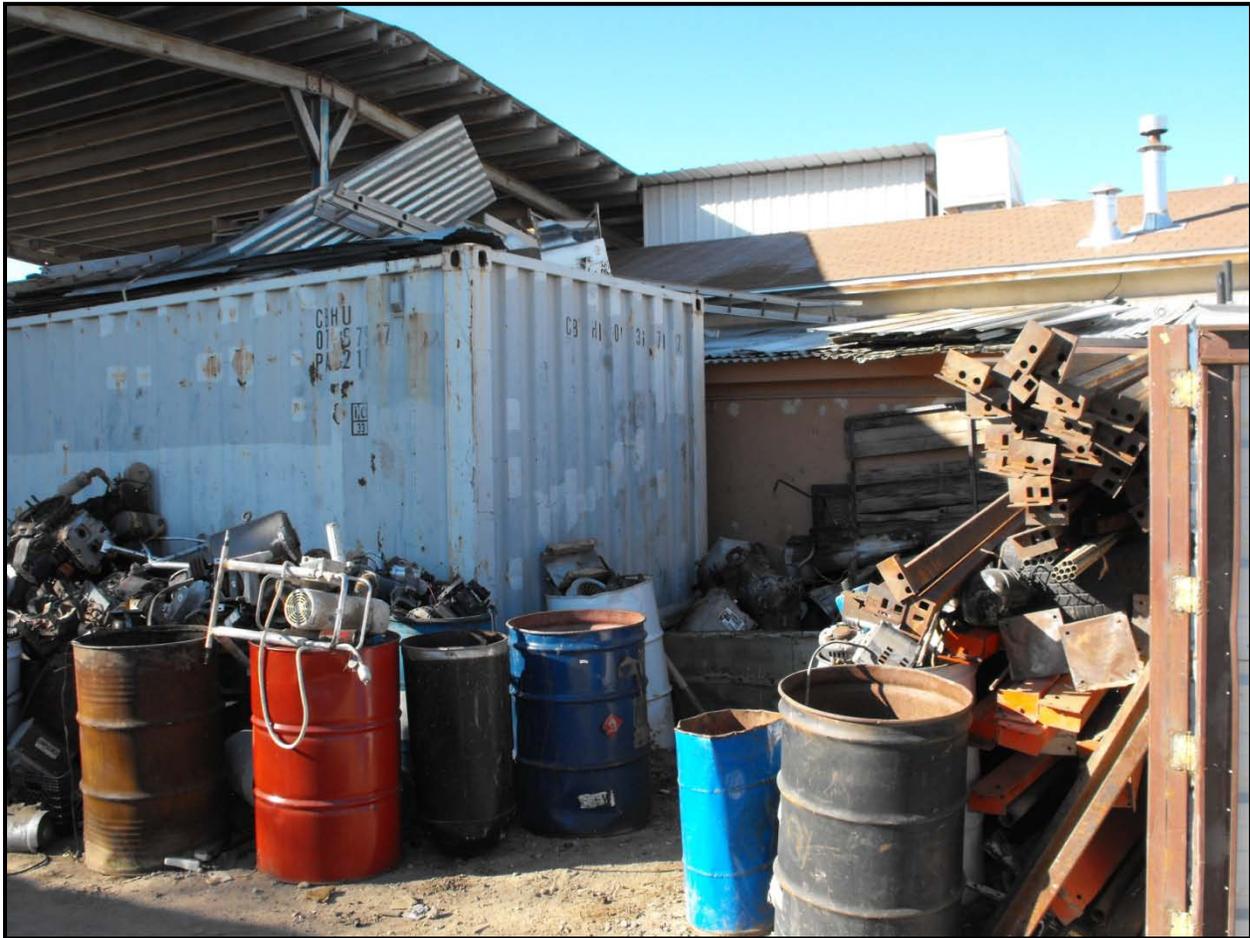
Photo # 3

Photographer: Daniel Valenta	Date: 1/4/2012	Time: 1022 hours
City/County: Albuquerque/Bernalillo		
Location: Amado Recycling, 2522 Coors Blvd, Albuquerque, New Mexico, facing west.		
Subject: Assorted scrap in storage area, not all scrap material is stored under shelter.
