Re: Lots 4A & 5A, Block 2, Sunrise Subdivision No. 12, Farmington; Construction Stormwater; SIC 1531; NPDES Compliance Evaluation Inspection; NMU001875; March 18, 2014

NPDES Compliance Inspection Report

King's Primo Quality Construction, Inc.
Lots 4A & 5A, Block 2, Sunrise Subdivision No. 12
NPDES Tracking No. NM001874
Compliance Evaluation Inspection
March 18, 2014

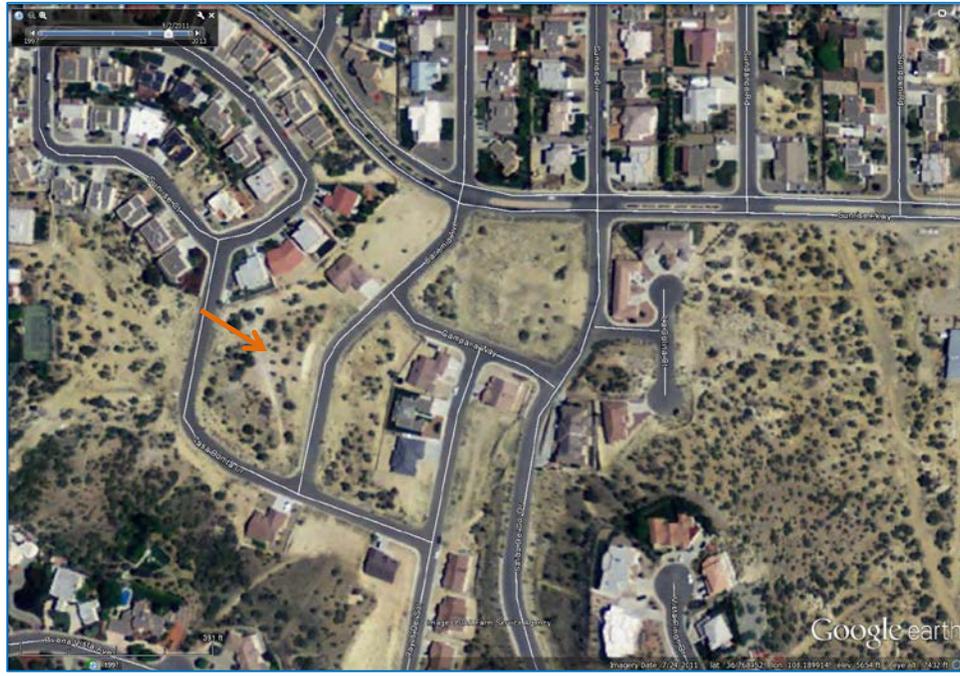
Images Reviewed by: Erin S. Trujillo	Image Dates: 08/02/2011 and 11/17/2013	Source: Google™ earth
City/County: Farmington / San Juan County	State: New Mexico	
Location: Lots 4A thru 8, Block 2, Sunrise Subdivision No. 12		
Subject: Image dated 08/02/2011 shows constructed subdivision streets, including Calle Mio, with some disturbance on Lots 4A thru 8 that appear to be dirt trails/roads. Image dated 11/17/2013 shows more disturbance with a few trees and vegetation along site borders along streets remaining on Lots 4A thru 8.

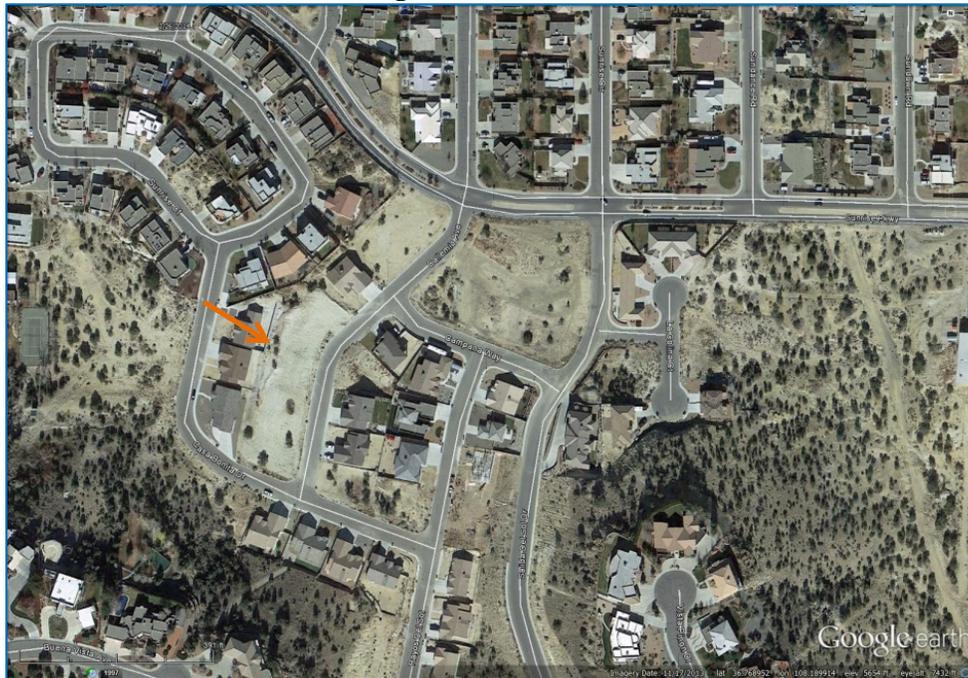
Image dated 11/17/2013

Based on on-line photographic images, Lots 4A thru 8 were disturbed (cleared, grubbed and/or excavated) prior to or by November 17, 2013. Additional owners/operators may have had operational control of construction activities in the subdivision and/or on Lots 4A thru 8 according to Mr. Gould. Mr. Gould indicated that he provided some requirements for earth disturbance on lots owned by Teton Development; however, he indicated that he did not supervisor or direct staff of other contractors. According to Mr. King, Tommy Ray King and/or King's Primo Quality Construction, Inc., was a subcontractor to another general contractor for earth disturbance (excavation or grubbing) conducted on Lots 4A thru 8 prior to single-family residence construction on Lots 6 and 7 in December in 2013.

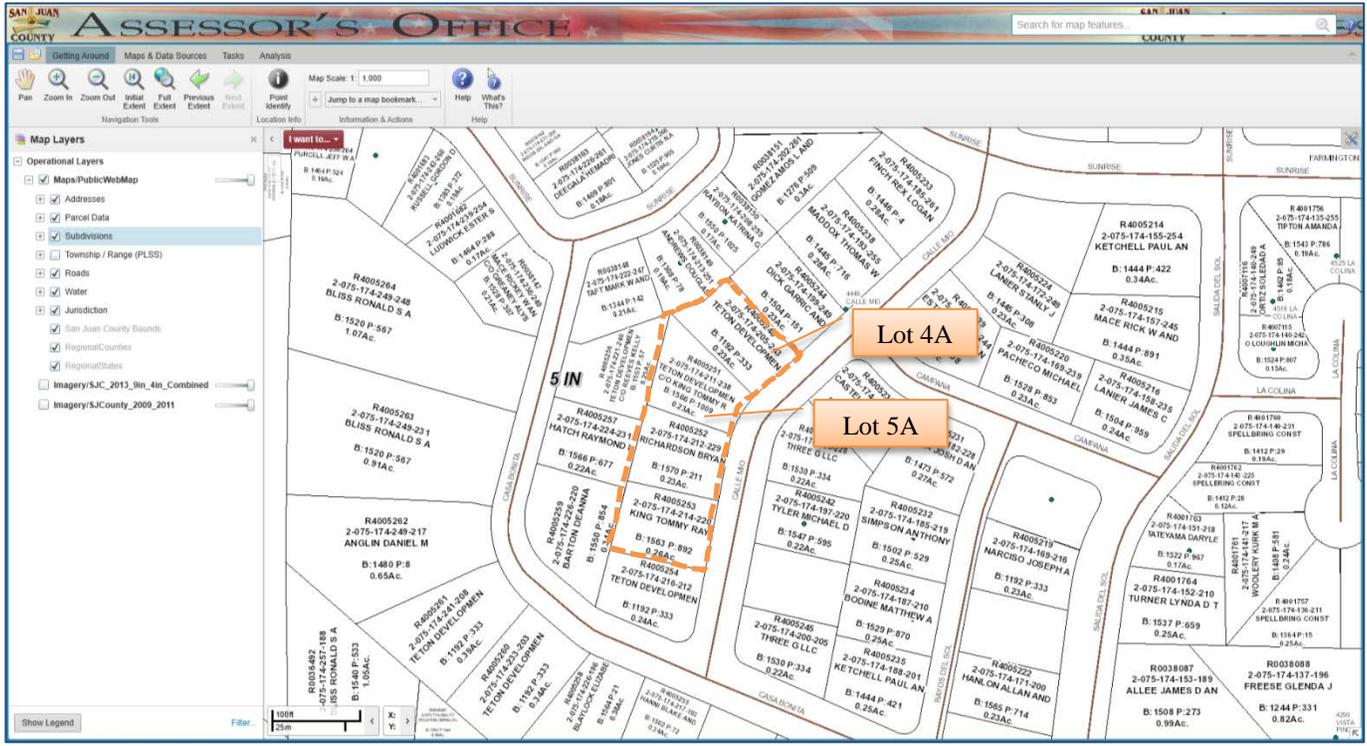
Site Map

Images Reviewed by: Erin S. Trujillo	Source: San Juan County Assessor
City/County: Farmington / San Juan County	State: New Mexico
Location: Lots 4A & 5A, Block 2, Sunrise Subdivision No. 12

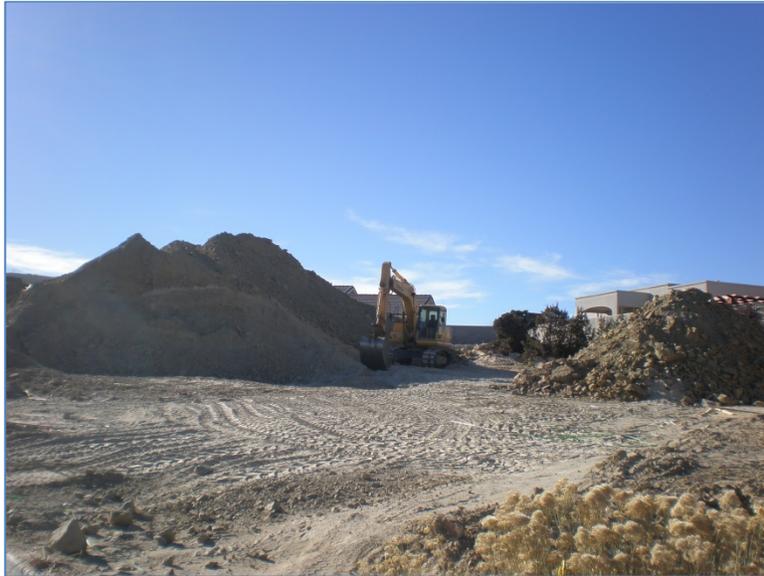
**City of Farmington
E-mailed Photographs
Photo # 1a and 1b**

Photographer: Not Documented	Date: Not Documented (file info below)	Time: Not Documented (file info below)
City/County: Farmington / San Juan County		State: New Mexico
Location: Lots 4A & 5A, Block 2, Sunrise Subdivision No. 12		
Subject: Photographs of stockpiles on portion of Lot 4A and Lot 5A provided by City of Farmington MS4 staff e-mail to NMED on 02/19/2014

1a (Stockpile on Lots 4A & 5A): File Information P1270026.jpg, Date 1/27/2014, 4:21 pm

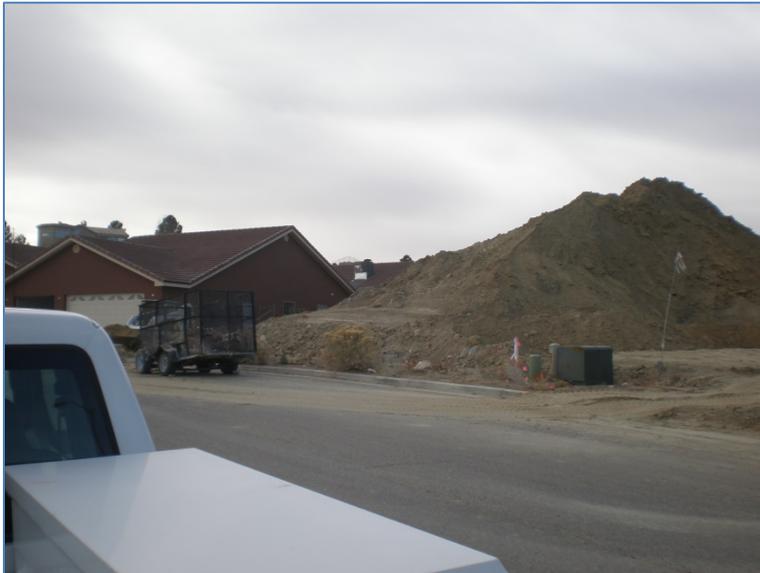
1b (Stockpile on Lot 5A): File Information P1270025.jpg, File Date 2/12/2014, 3:37 pm

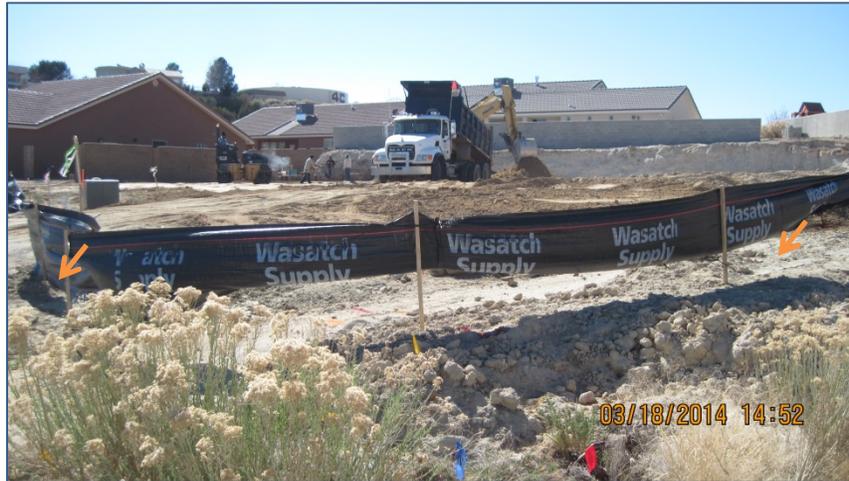
**NMED/SWQB
Official Photograph Log
Photo # 1**

Photographer: Erin S. Trujillo	Date: 03/18/2014	Time: 1552 hours (incorrect time displayed on photo)
City/County: Farmington / San Juan County		State: New Mexico
Location: Lots 4A & 5A, Block 2, Sunrise Subdivision No. 12		
Subject: Looking southwest at portion of Lot 4A and Lot 5A, heavy equipment was in use on day of this inspection. Staked fabric along site boundaries and disturbed areas is not trenched into the soil. Arrows points to a gap between fabric and soil.

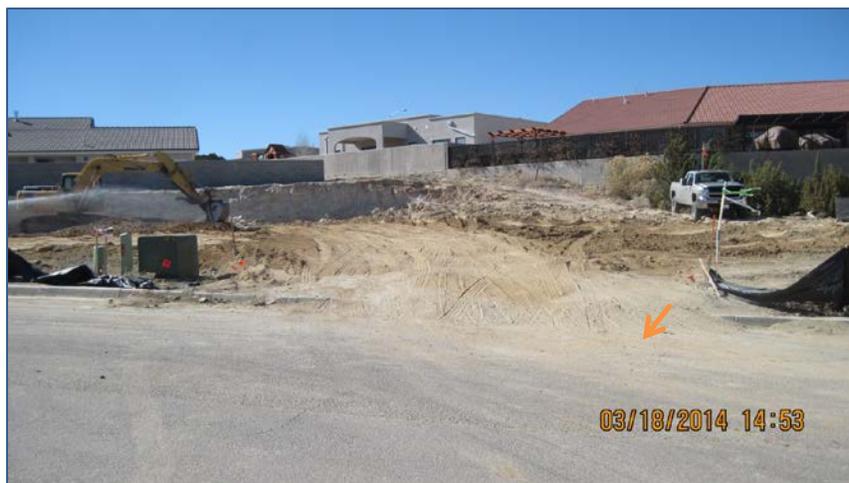
**NMED/SWQB
Official Photograph Log
Photo # 2**

Photographer: Erin S. Trujillo	Date: 03/18/2014	Time: 1553 hours (incorrect time displayed on photo)
City/County: Farmington / San Juan County		State: New Mexico
Location: Lots 4A & 5A, Block 2, Sunrise Subdivision No. 12		
Subject: Looking at portion of Lot 4A and Lot 5A, water was applied by on-site worker to disturbance from track hoe activities. Arrow points to dirt observed on Calle Mio.

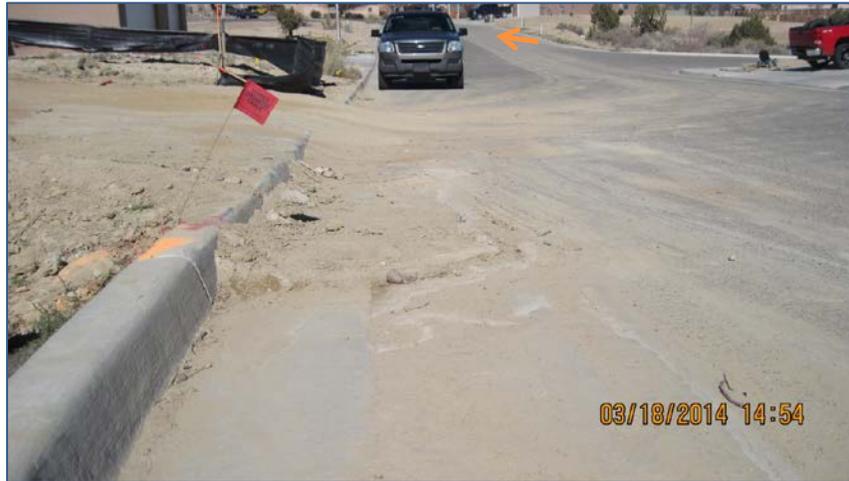
**NMED/SWQB
Official Photograph Log
Photo # 3**

Photographer: Erin S. Trujillo	Date: 03/18/2014	Time: 1454 hours (incorrect time displayed on photo)
City/County: Farmington / San Juan County		State: New Mexico
Location: Lots 4A & 5A, Block 2, Sunrise Subdivision No. 12		
Subject: Looking north on Calle Mio, dirt was in gutter at area where heavy equipment was observed entering site on day of this inspection. Arrow points to tracking that continues north on Calle Mio.

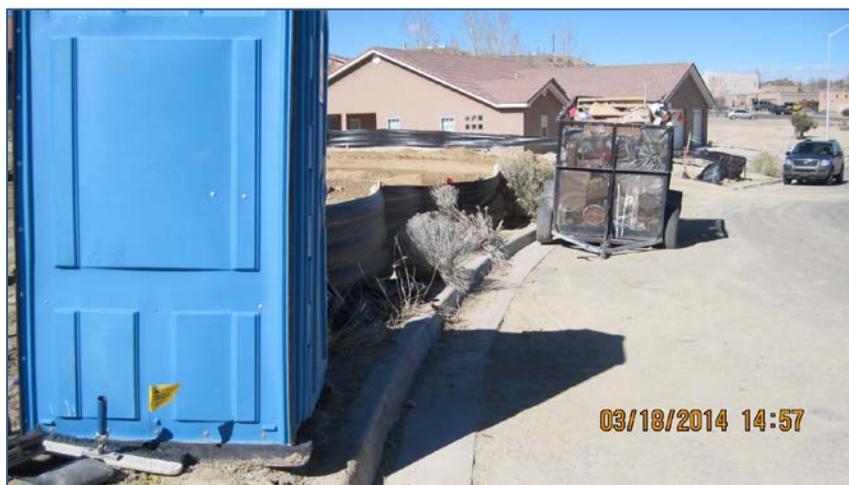
**NMED/SWQB
Official Photograph Log
Photo # 4**

Photographer: Erin S. Trujillo	Date: 03/18/2014	Time: 1557 hours (incorrect time displayed on photo)
City/County: Farmington / San Juan County		State: New Mexico
Location: Lots 4A & 5A, Block 2, Sunrise Subdivision No. 12		
Subject: Trash bin and sanitary toilet was located near construction activities on Lots 4A & 5A.
