RE: Minor Municipal, SIC 4952, NPDES Compliance Evaluation Inspection, Chama Wastewater Treatment Plant (WWTP), NPDES Permit No. NM0027731, April 28, 2011

### NPDES Compliance Inspection Report

Village of Chama Wastewater Treatment Plant  
Compliance Evaluation Inspection  
NPDES Permit No. NM 0027731  
April 28, 2011

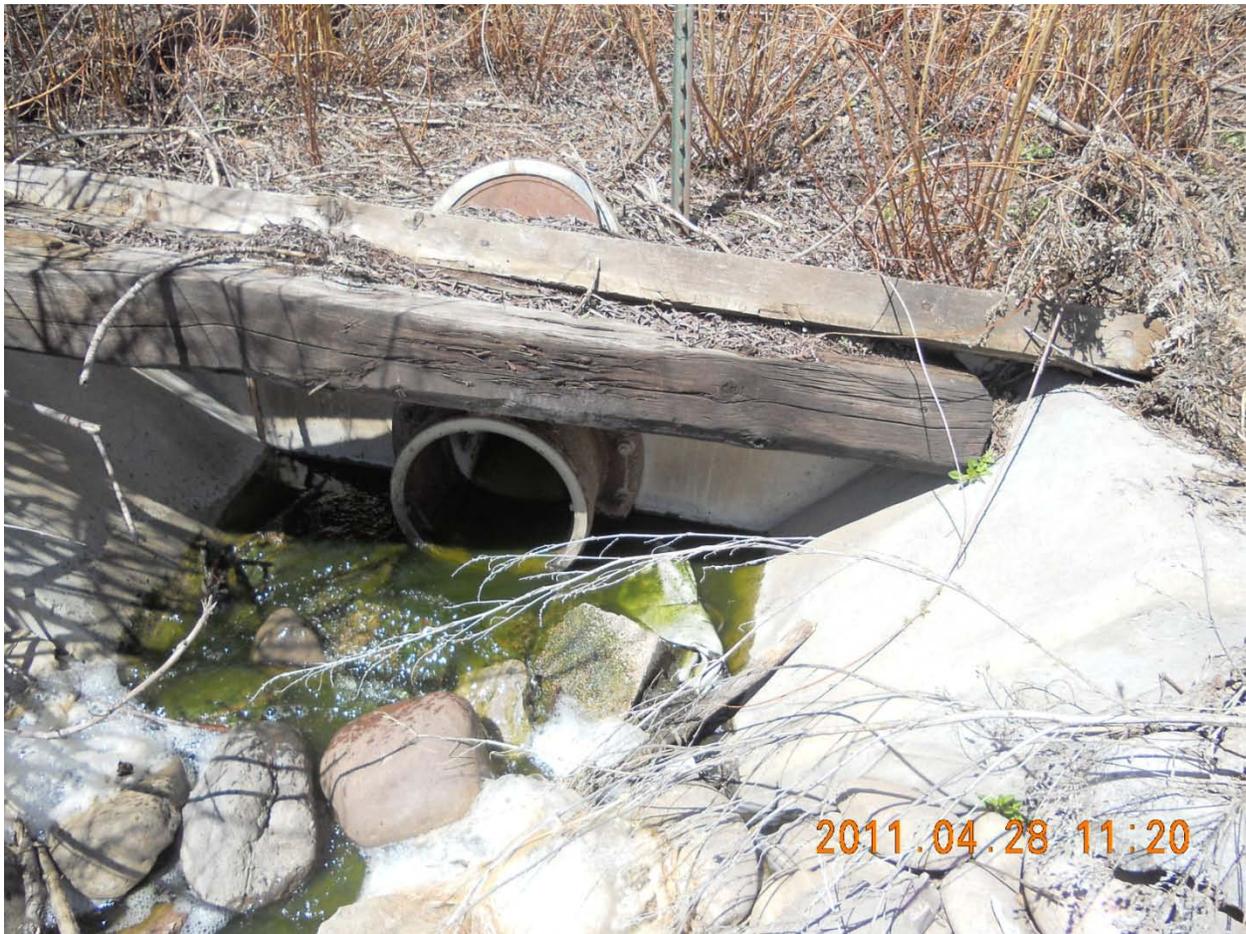
**NMED/SWQB**  
**Official Photograph Log**  
**Photo # 1**

Photographer: Sandra Gabaldón	Date: 04/28/2011	Time: 1120 Hours
City/County: Chama / Rio Arriba		State: New Mexico
Location: Chama Wastewater Treatment Plant		
Subject: Discharge pipe into Rio Chamita from Chama WWTP.
