RE: Minor-Non-Municipal, SIC 8211, NPDES Compliance Evaluation Inspection, Gadsden Independent School District #16, Waste Water Treatment Facility, NM0028487, Anthony, New Mexico, August 26, 2010

NPDES Compliance Inspection Report

Gadsden Independent School District #16
NPDES Permit No. NM0028487
Compliance Evaluation Inspection
August 26, 2010

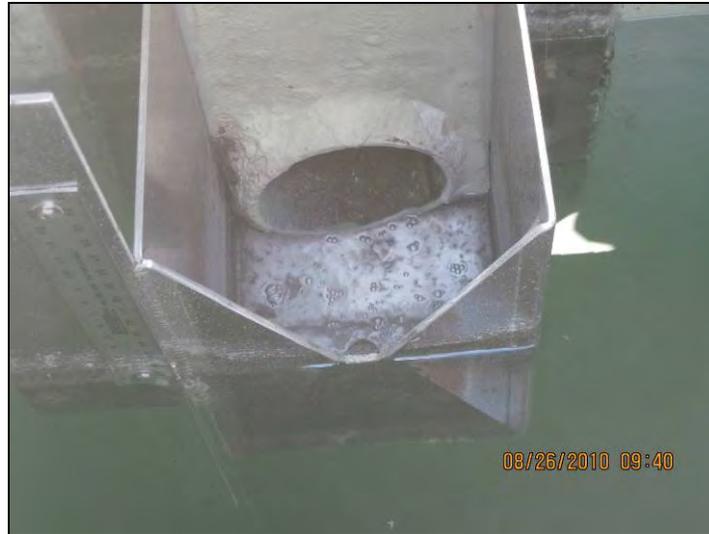
**NMED/SWQB
 Official Photograph Log
 Photo # 1**

Photographer: Erin S. Trujillo	Date: 08/26/2010	Time: 0940 hours
City/County: Anthony / Doña Ana		State: New Mexico
Location: Gadsden Independent School District #16 WWTF		
Subject: MS WWTP "Trapezoid" Weir

Neither flow measurement devices had been calibrated in over a year. **Inadequate flow calibration frequency is a Repeat Finding.** As discussed above, flow measurement devices at the Middle School WWTP did not appear properly installed and the secondary flow meter was down. A complete flow measurement system inspection, repair and calibration was needed. A check that correct flow measurement tables for the weir notch are used needs to be documented in the calibration report. Accumulated solids in the High School WWTP weir may alter the stable hydraulic conditions required for accurate discharge measurement. Weir box surfaces should be wiped down to remove slimes or other coatings and solids removed periodically.

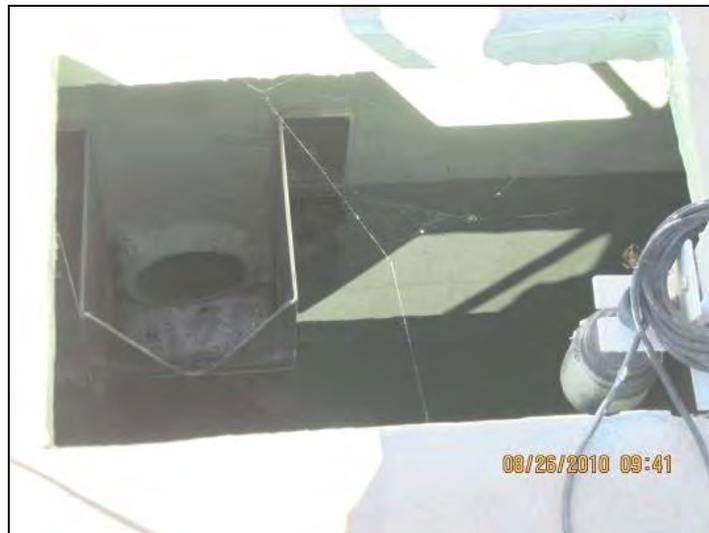
**NMED/SWQB
 Official Photograph Log
 Photo # 2**

Photographer: Erin S. Trujillo	Date: 08/26/2010	Time: 0941 hours
City/County: Anthony / Doña Ana		State: New Mexico
Location: Gadsden ISD (Middle School)		
Subject: MS WWTP flow measurement transducer located off to the side in the basin. Brightness of the photo has been increased for this report.

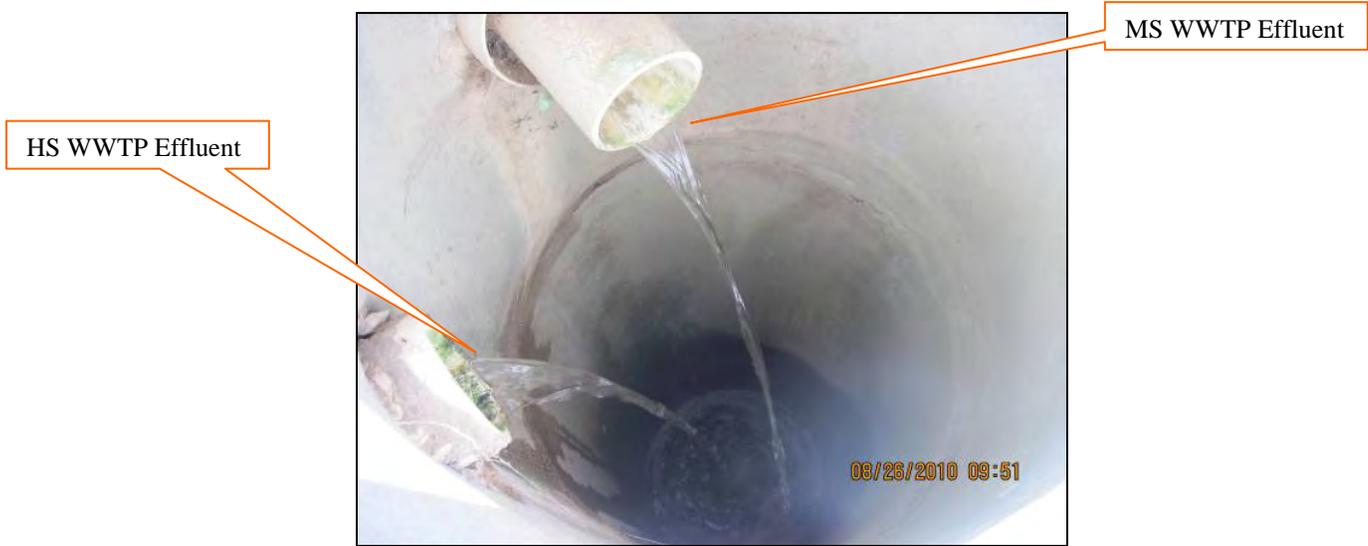
**NMED/SWQB
 Official Photograph Log
 Photo # 3**

Photographer: Erin S. Trujillo	Date: 08/26/2010	Time: 0951 hours
City/County: Anthony / Doña Ana		State: New Mexico
Location: Gadsden ISD		
Subject: Looking into vertical concrete pipe at treated effluent from MS WWTP and HS WWTP

Grab samples as required by the permit were not obtained for pH, TRC and E.coli bacteria effluent monitoring for Outfall 001. Based on information from the permittee representative, samples were collected for monitoring pH, TRC and E.coli bacteria when both Outfall 01A and Outfall 01B discharge. The operator adjusts similar flow rates for Outfalls 01A and 01B, then a composite sample is made from discharge from the two outfalls inside the facility--half from Outfall 01A and half from Outfall 01B. In addition to being composite samples, flow adjustments for sampling purposes may not be representative of the end of pipe discharge from Outfall 001.

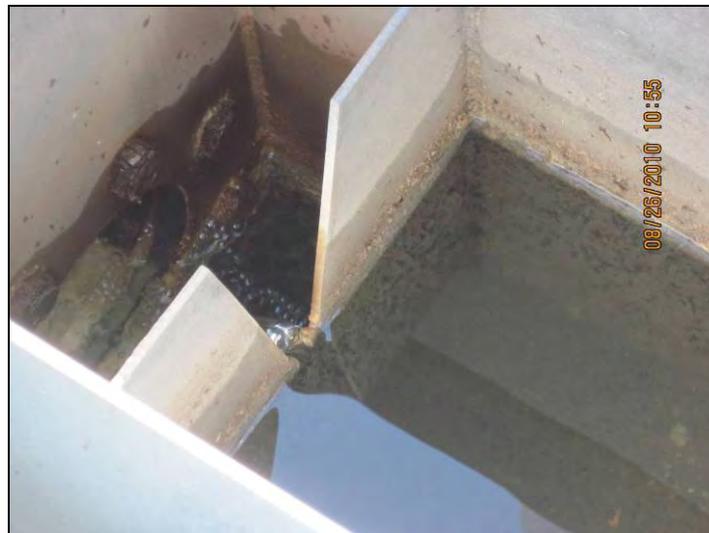
**NMED/SWQB
 Official Photograph Log
 Photo # 4**

Photographer: Erin S. Trujillo	Date: 08/26/2010	Time: 1055 hours
City/County: Anthony / Doña Ana		State: New Mexico
Location: Gadsden ISD		
Subject: HS WWTP open channel weir. Solids had settled in base of weir channel box below transducer, accumulated on sides of channel box, and in notch.
