RE: Minor Non-Municipal, SIC 1222, NPDES Compliance Evaluation Inspection, BHP Billiton San Juan Coal Company / San Juan Mine, NM0028746, May 23, 2013

NPDES Compliance Inspection Report

San Juan Coal Company / San Juan Mine
NPDES Permit No. NM0028746
Compliance Evaluation Inspection
May 23, 2013

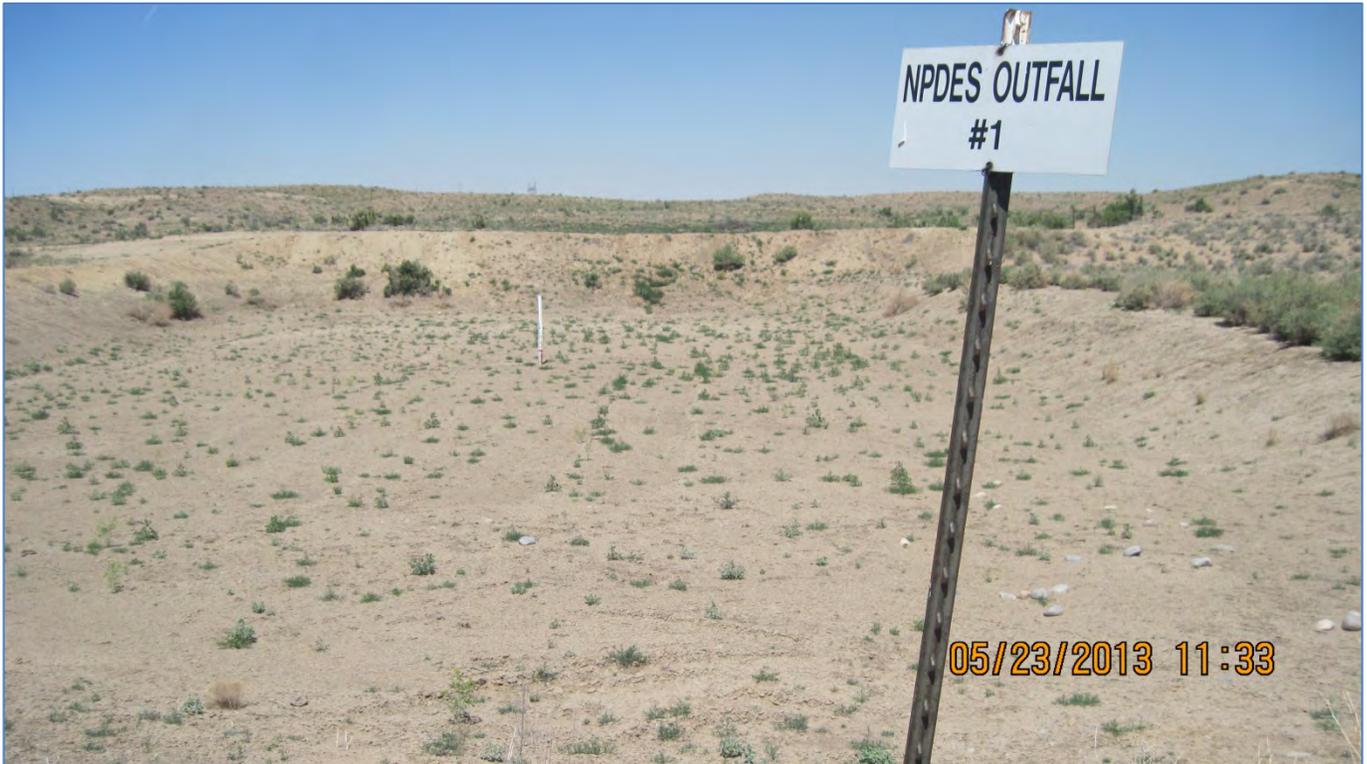
NMED/SWQB
Official Photograph Log
Photo # 1

Photographer: Erin S. Trujillo	Date: 05/23/2013	Time: 1133 hours
City/County: Near Waterflow / San Juan County	State: New Mexico	
Location: San Juan Coal Company, San Juan Mine, NM0028746		
Subject: Pond 33 associated with Outfall 001.

S M U NA (FURTHER EXPLANATION ATTACHED No)DETAILS: **No WWTP operator on site during CEI, but O & M evaluation includes info described by contracted operators after CEI. Design review of berm at Pond 33 (associated w/Outfall 001) appears needed (see Photos 1&2).**

Permittee’s on-site representative indicated that the design and installation of a berm at the entrance to Pond 33 associated with Outfall 001 would be reviewed as part of the redesign (see Photos 1 & 2).

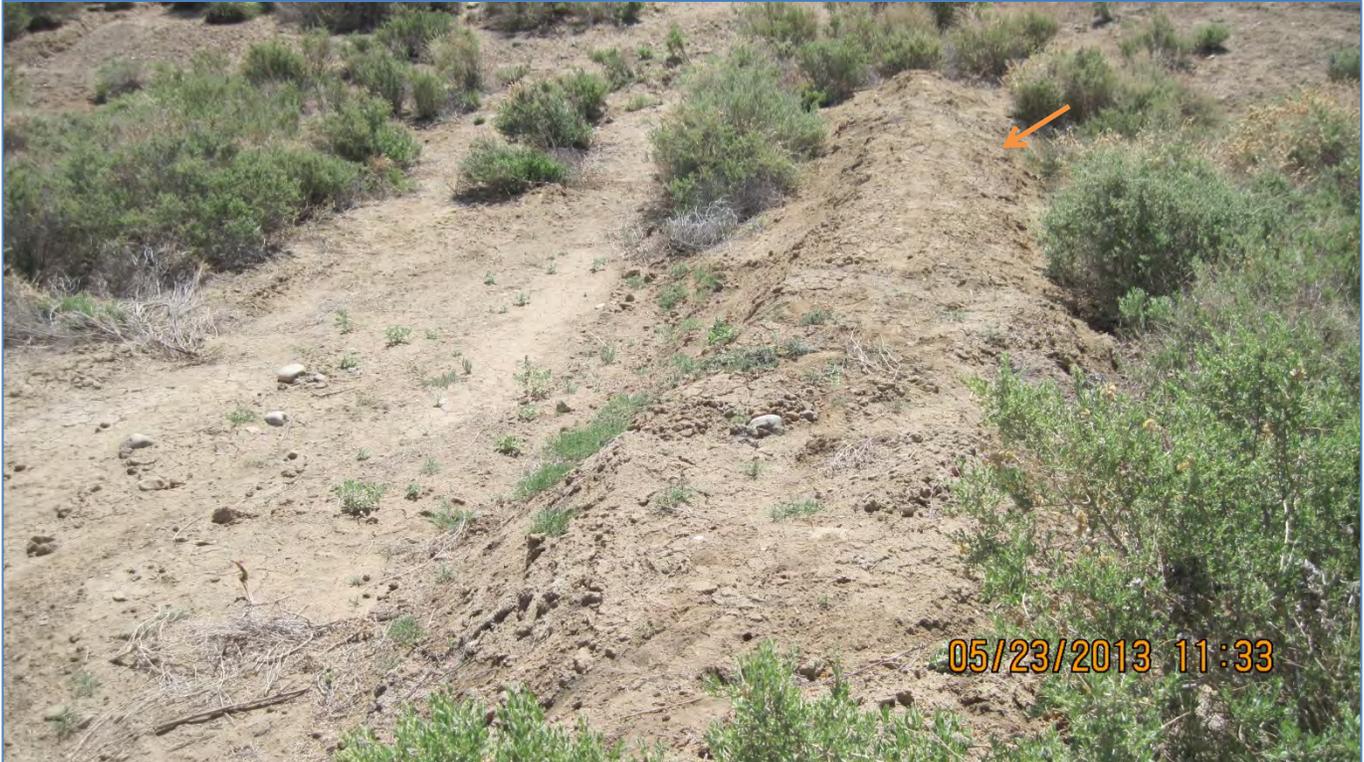
**NMED/SWQB
Official Photograph Log
Photo # 2**

Photographer: Erin S. Trujillo	Date: 05/23/2013	Time: 1133 hours
City/County: Near Waterflow / San Juan County		State: New Mexico
Location: San Juan Coal Company, San Juan Mine, NM0028746		
Subject: Arrow points to berm that crosses a swale on east side of pond shown in previous photo (Pond 33). Berm appeared to be only control to direct runoff flow into pond. Berm appeared to be in good condition on day of this inspection. But, a review of berm design (dimensions), materials, and installation for anticipated runoff volumes and rates at this location appeared needed.
