**NEW MEXICO
ENVIRONMENT DEPARTMENT**

Surface Water Quality Bureau

Re: Minor Municipal, SIC 4952, NPDES Compliance Evaluation Inspection, Maxwell Wastewater Treatment Plant, NM0029149, October 20, 2011

**Compliance Evaluation Inspection
Maxwell Wastewater Treatment Plant
NPDES Permit No. NM0029149
October 20, 2011**

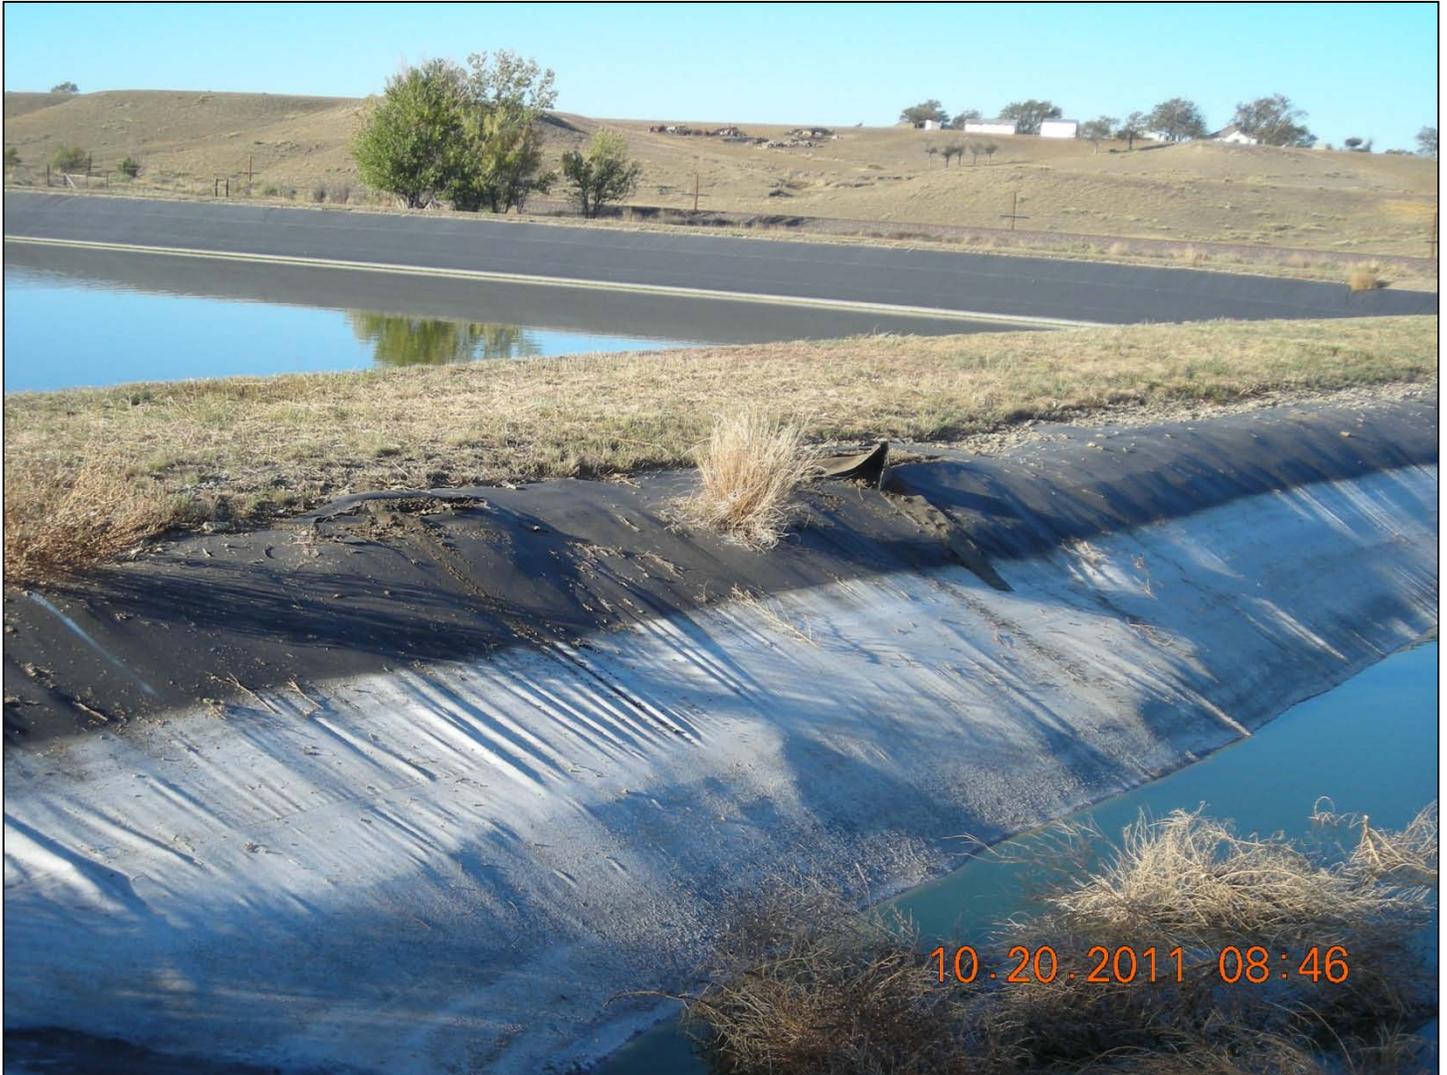
NMED/SWQB
Official Photograph Log
Photo # 1

During the tour of the facility's ponds, at least two tears were noted in the lagoon liners. This was an issue during the last NPDES inspection of the site. The inspector recommended that the tears be fixed as soon as possible.

Photographer: Heidi Henderson	Date: 10-20-2011	Time: 0846 hours
City/County: Maxwell/Colfax County		
Location: Maxwell WWTP		
Subject: Tears in the lagoon liner. The tears have existed since before the last NPDES inspection in 2009.
