Re: Minor Non-Municipal, SIC 9224, NPDES Compliance Evaluation Inspection, New Mexico Firefighters Training Academy, NM0029726, November 7, 2012

NPDES Compliance Inspection Report

**Compliance Evaluation Inspection
New Mexico Firefighters Training Academy
NPDES Permit #NM0029726, November 7, 2012**

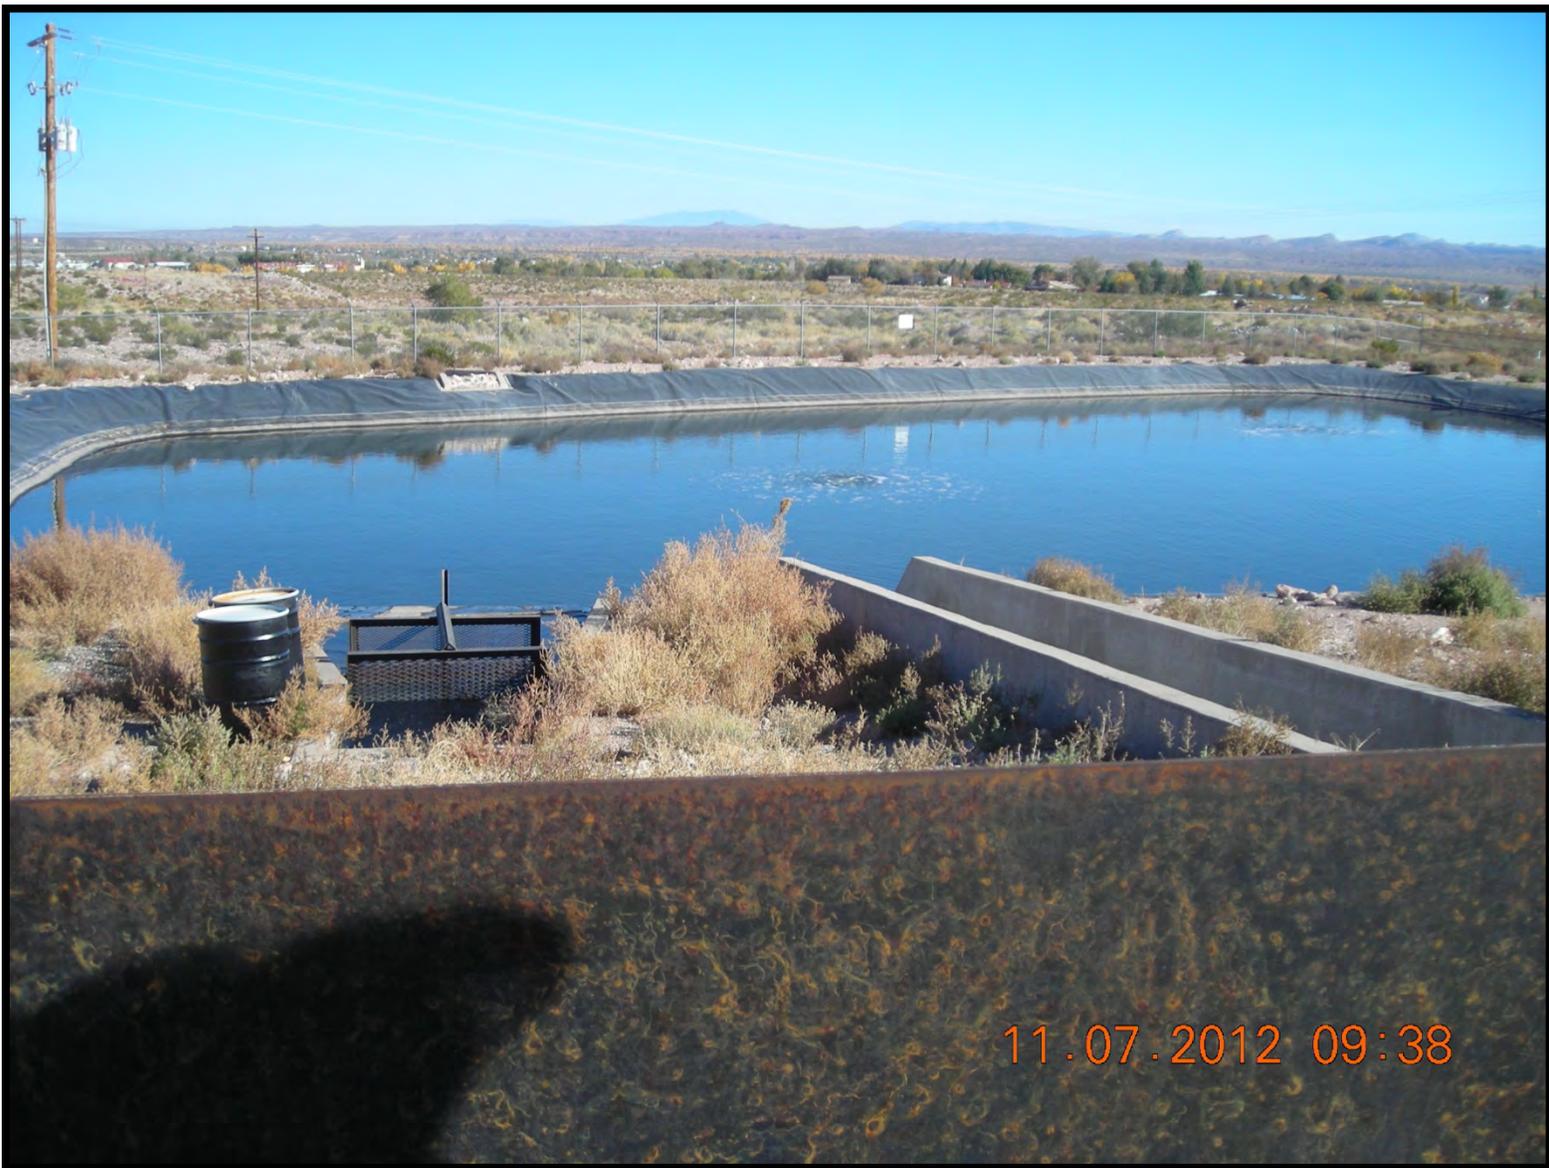
Photo # 1

Photographer: Sarah Holcomb	Date: 11-7-2012	Time: 0938 hours
City/County: Socorro/Socorro County		
Location: NM Firefighters Training Academy, 600 Aspen Rd., Socorro, NM		
Subject: Primary lagoon which receives wastewater from the firefighting activities. View is from one of the burn pads, showing the concrete ditch conveying water from the pad to the lagoon.

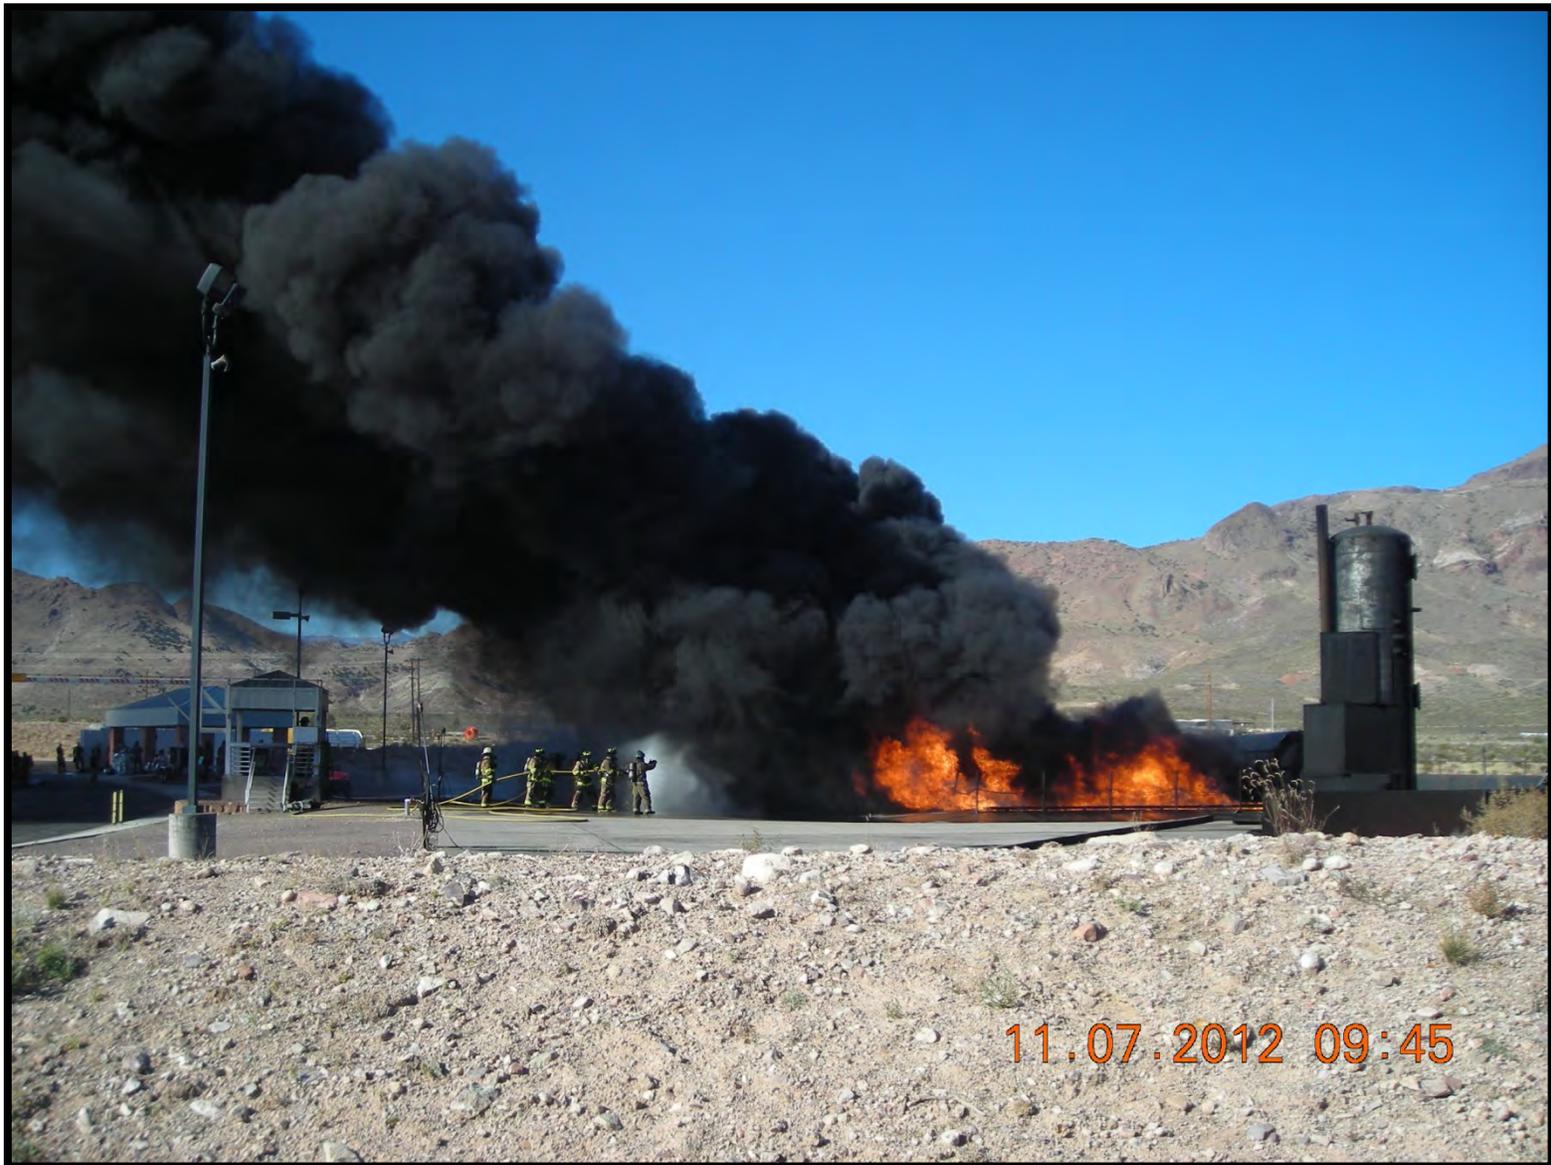
Photo # 2

Photographer: Sarah Holcomb	Date: 11-7-2012	Time: 0945 hours
City/County: Socorro/Socorro County		
Location: NM Firefighters Training Academy, 600 Aspen Rd., Socorro, NM		
Subject: ARFF (Aircraft Rescue and Fire Fighting) burn certification conducted on the day of this inspection. Diesel is used as the accelerant and the firefighters were using water (not foam) to put out the fire. The drain is located at the back (right side) of the burn pad.
