**NEW MEXICO
ENVIRONMENT DEPARTMENT**

Re: Minor Non-Municipal, SIC 4941, Raton Water Works Water Treatment Plant, NPDES Compliance Evaluation Inspection, NM0029891. August 6, 2012

NPDES Compliance Inspection Report

Introduction

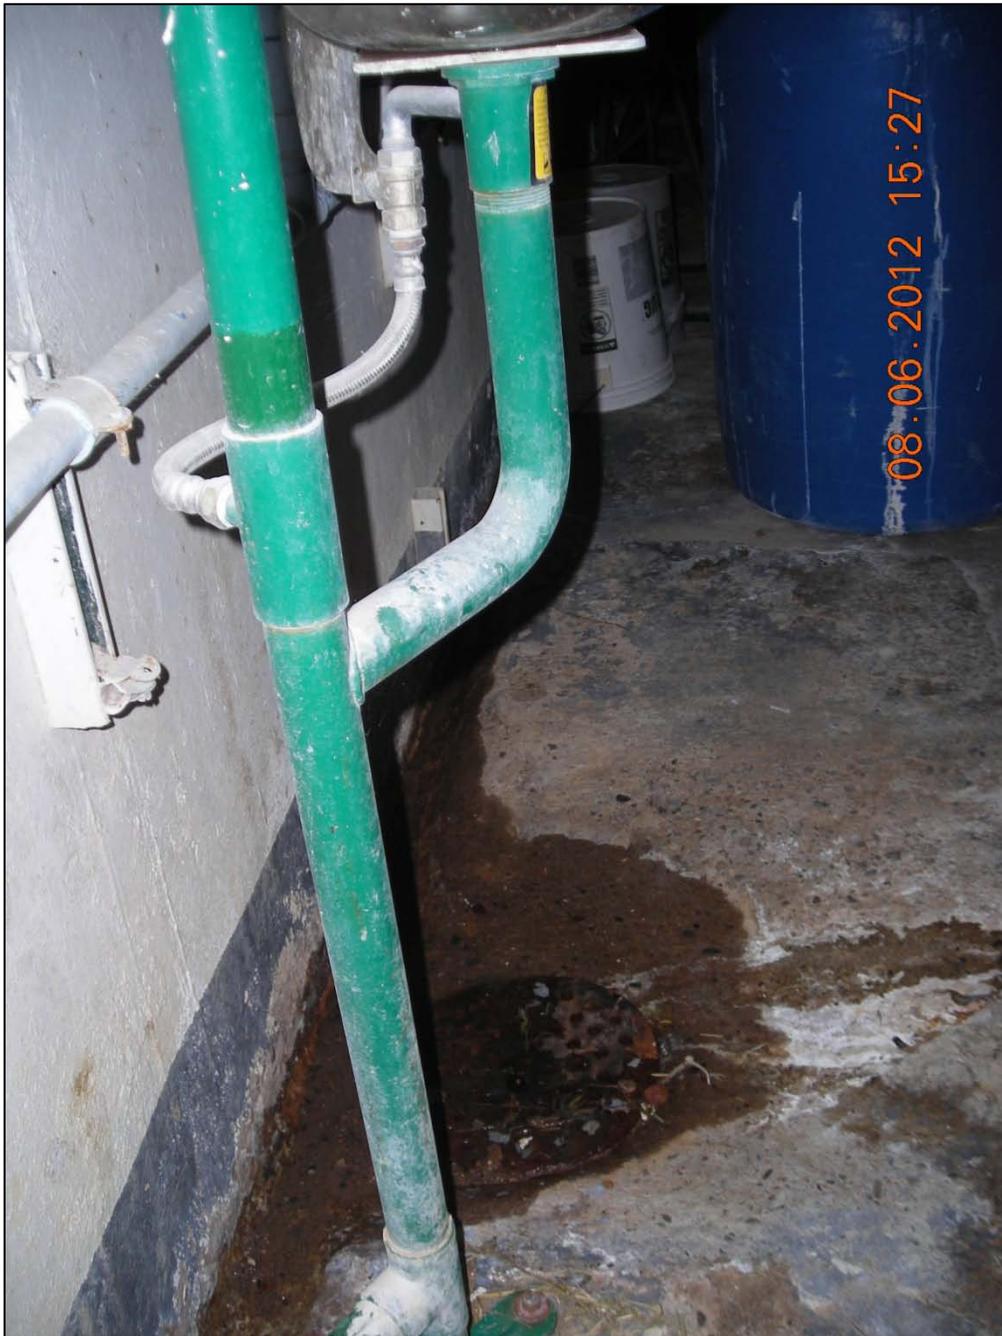
Photo # 1

Photographer: Sarah Holcomb	Date: 8-6-2012	Time: 1527 hours
City/County: Raton/Colfax County		
Location: Raton Water Treatment Plant		
Subject: Trough and drain in basement of the water treatment plant that conducts raw water to the wastewater plant. Located in chemical storage area without secondary containment.

During a tour of the facility, the inspector observed the basement where the water treatment chemicals are kept. The permittee's representative stated that the policy is to avoid keeping more chemicals on site than they absolutely need, however, there were a number of chemicals on hand. On the west side of the room, a small trough contains water from drip lines where the raw water is tested. These drip lines are constantly flowing. This trough directs the water to a drain, which eventually goes to the wastewater treatment plant. However, being that this was also the room where the process chemicals were kept, including chlorine, aluminum chloride, caustic soda and other chemicals, the inspector was concerned to observe that there were no secondary containment measures in place. In the event of a leak, these chemicals would go straight to the wastewater treatment plant and might cause an upset and noncompliance at that facility, or within the collection system on the way to the wastewater plant. The permittee's representative indicated that this was a problem the water treatment plant was well aware of, and that construction upgrades would be occurring at the plant in the fall to remedy this situation. This is a repeat finding from the 2009 inspection.

The facility representative indicated that an engineering report was being drafted in preparation to find funding to complete this project. The facility needs double walled tanks for the alum, the electrical system needs to be upgraded (the facility was built in the 1950s and still has the original electrical system), and they are assessing whether they should build out the basement to accommodate secondary containment measures for the chemicals stored there.

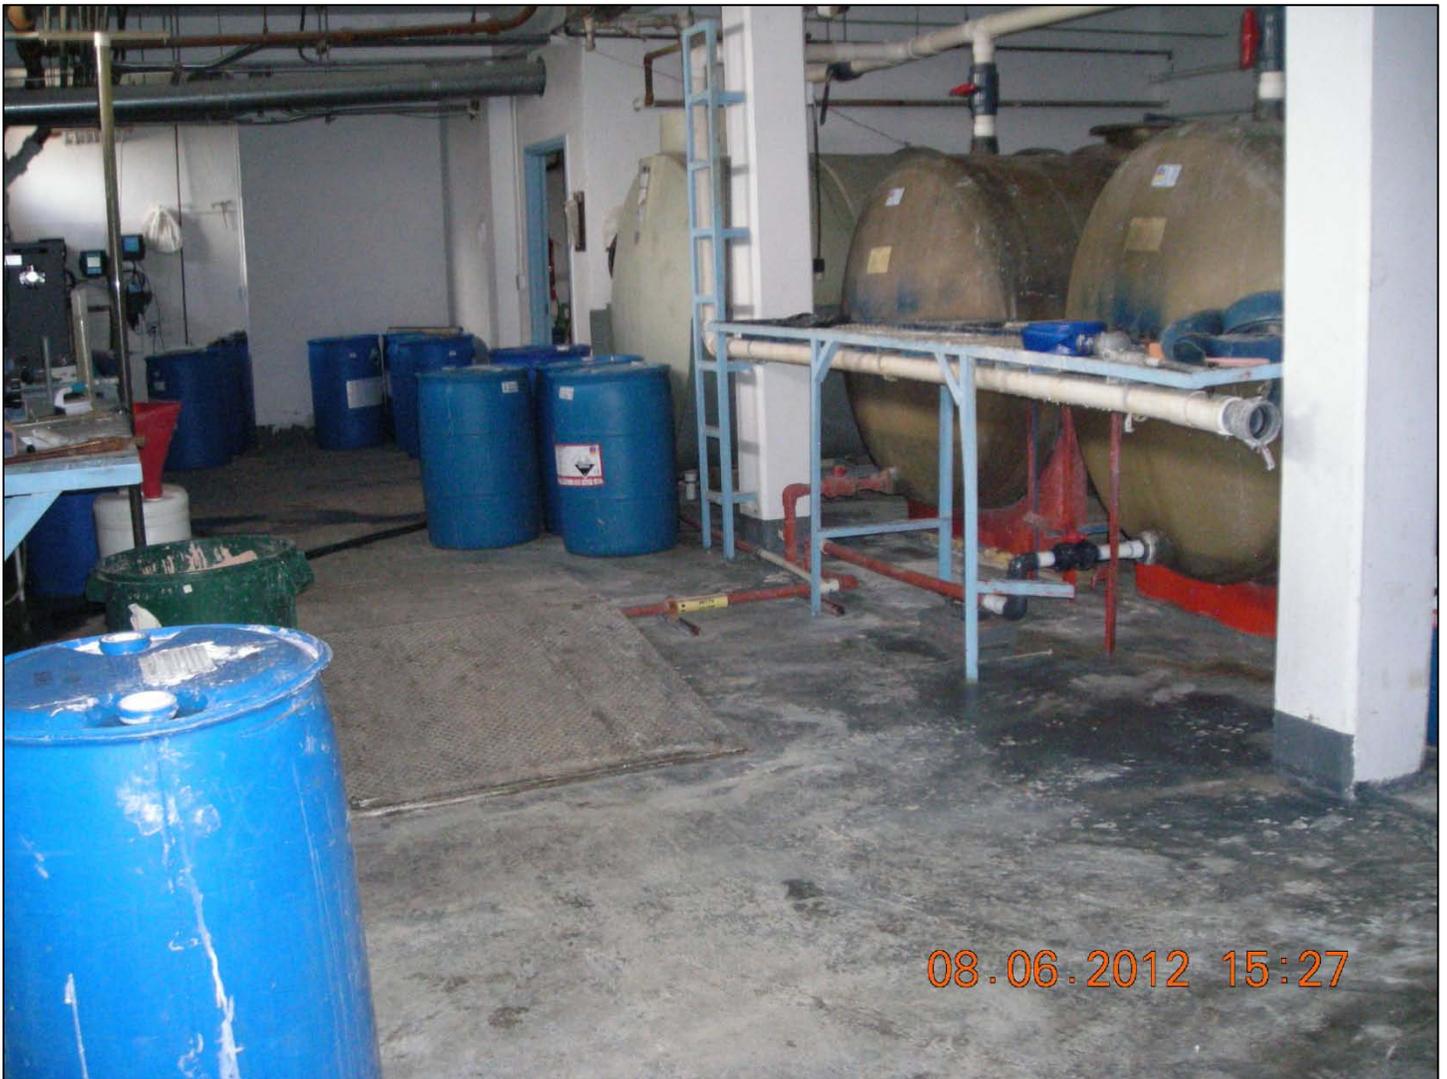
Photo # 2

Photographer: Sarah Holcomb	Date: 8-6-2012	Time: 1527 hours
City/County: Raton/Colfax County		
Location: Raton Water Treatment Plant		
Subject: View of the chemical storage. The tanks on the right are alum storage. Tanks are single walled. There is no secondary containment, and there is another sewer drain located under the middle alum tank. Trough and drain shown in Photo #1 is located to the left in this photo.

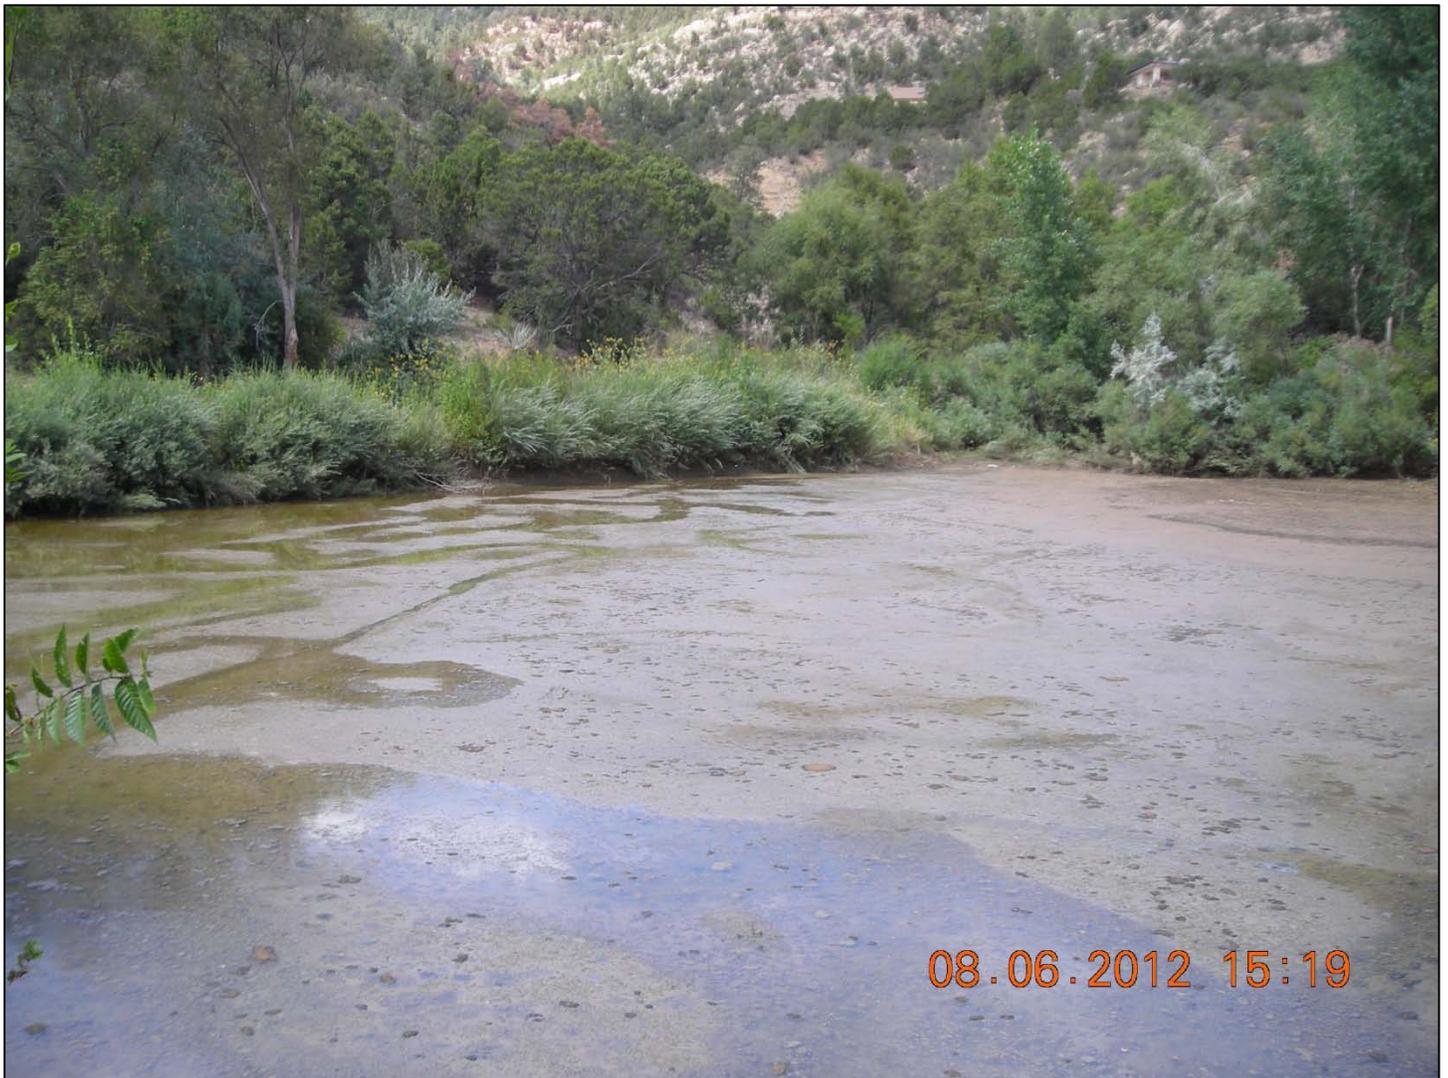
Photo # 3

The pond below the facility (where the filter-to-waste water and filter backwash water are sent) was very full at the time of this inspection. There was perhaps 1-2 feet of freeboard space in the pond. Facility representatives indicated that they are working on a plan to dredge the pond. Their initial goal was to complete this task this summer, however, they anticipate having it done this fall. The facility is still reclaiming as much water as possible from the pond for reuse within the facility, as their practice has historically been. However, if a large rain event were to occur prior to the cleaning of this pond, it might cause a discharge.

Photographer: Sarah Holcomb	Date: 8-6-2012	Time: 1519 hours
City/County: Raton/Colfax County		
Location: Raton Water Treatment Plant		
Subject: Pond below the water treatment plant that holds the filter-to-waste water and filter backwash water. In the event of a discharge, water would overflow the dam that the inspector was standing on to take this photo.

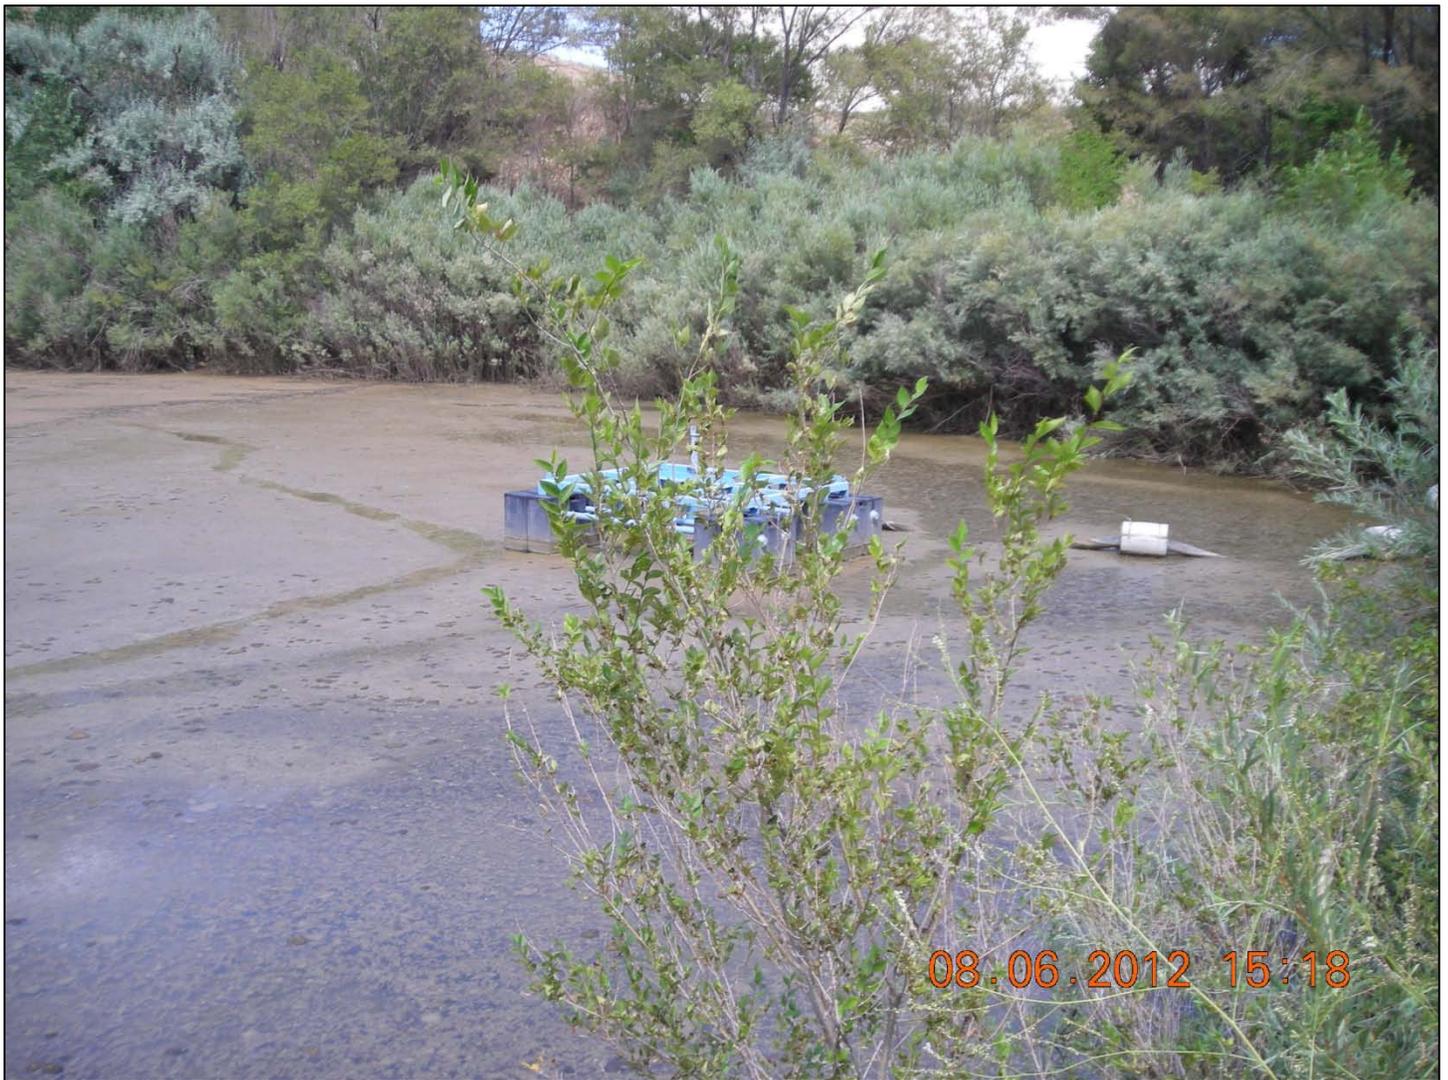
Photo # 4

Photographer: Sarah Holcomb	Date: 8-6-2012	Time: 1518 hours
City/County: Raton/Colfax County		
Location: Raton Water Treatment Plant		
Subject: View of the pump system contained within the pond to facilitate reuse of the water.
