RE: Minor-Non-Municipal, SIC 4911, NPDES Compliance Evaluation, PNM / Person Generating Station,
NM0030384, June 18, 2012

NPDES Compliance Inspection Report

**PNM / Person Generating Station
Compliance Evaluation Inspection
NPDES Permit No. NM0030384
June 18, 2012**

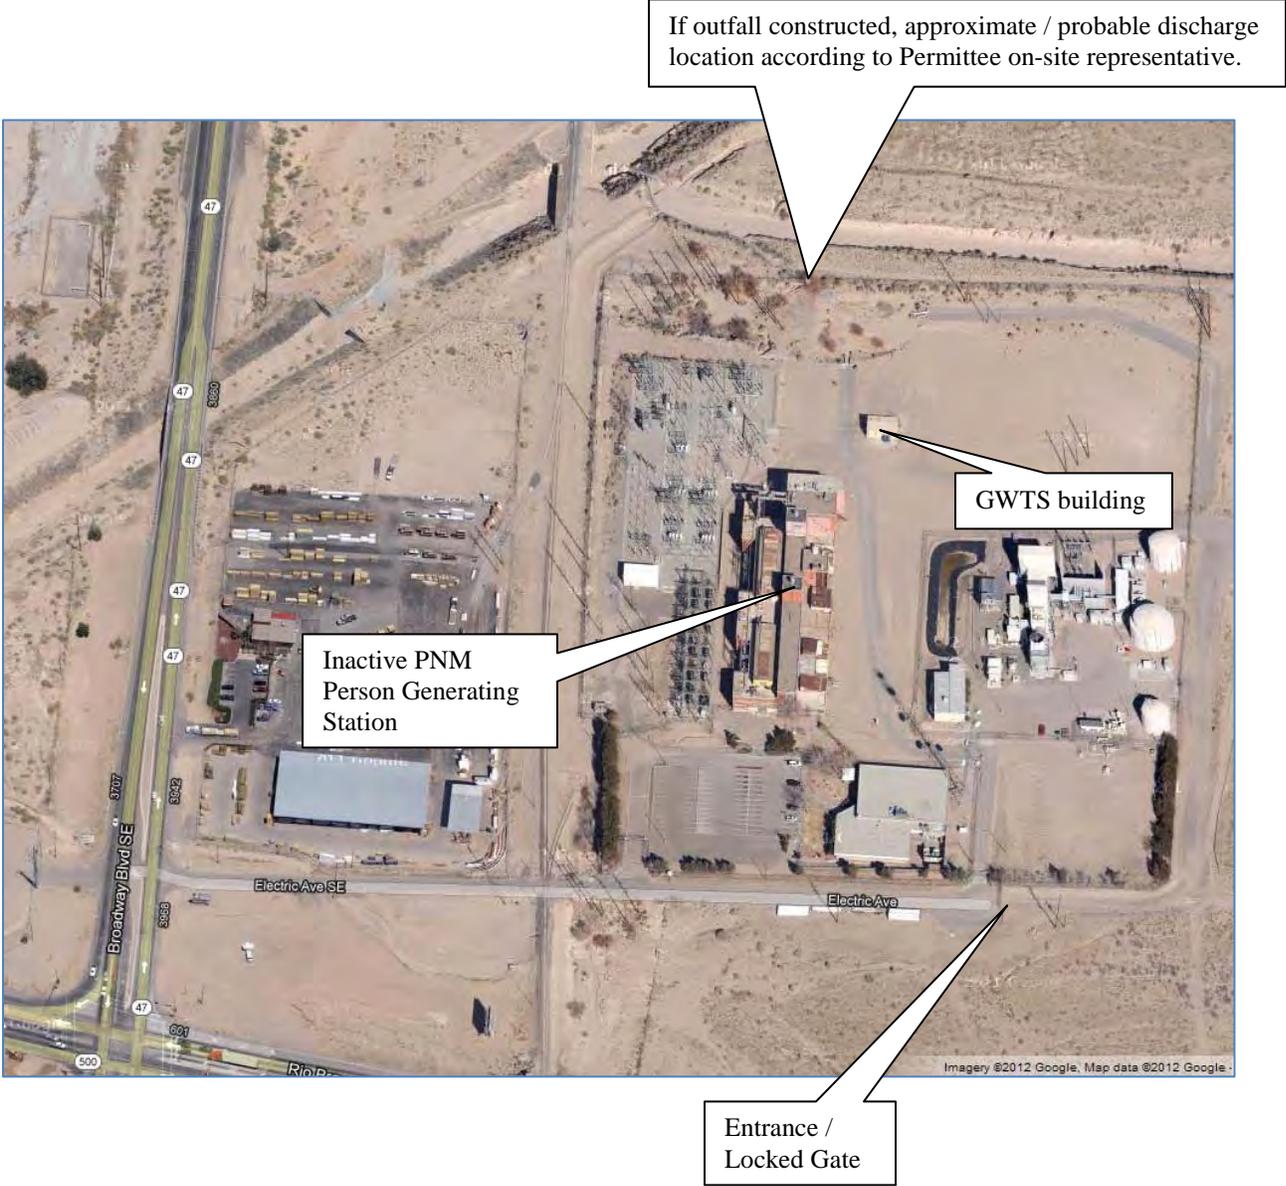
Figure 1: PNM Person Generating Station

The discharge location (if constructed) described by the Permittee on-site representative on the day of this inspection appears consistent with a vicinity map contained in the Permittee application in NMED SWQB files. However, the discharge location (latitude and longitude) on the Permittee application and on the title page of the permit is approximately 400 feet east of the intended location of the outfall based on readily-available on-line mapping tools.

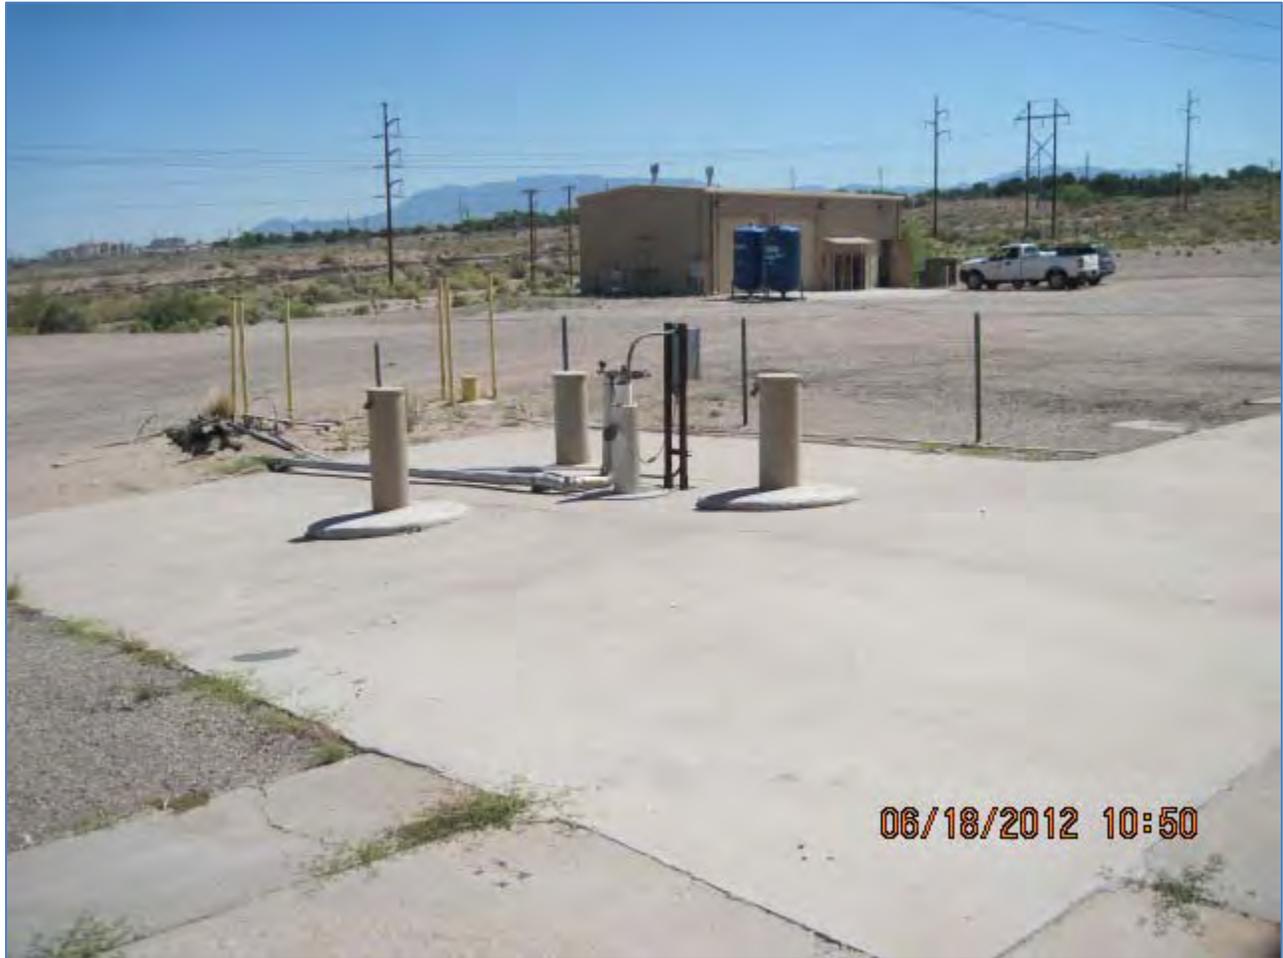
**NMED/SWQB
Official Photograph Log
Photo # 1**

Photographer: Erin S. Trujillo	Date: 06/18/2012	Time: 1050 hours
City/County: Albuquerque / Bernalillo	State: New Mexico	
Location: PNM / Person Generating Station		
Subject: Vapor monitoring and groundwater extraction wells at concrete capped waste oil tank (unlined well). Sheltered (covered and enclosed) groundwater treatment system (GWTS) building is in background of this photo. Enclosed carbon filtration tanks and nitrogen cylinders were stored outside the GWTS building.
