NEW MEXICO
ENVIRONMENT DEPARTMENT

RE: Major-Municipal, SIC 4952, NPDES Compliance Evaluation Inspection, County of Dona Ana, South Central Regional Wastewater Treatment Facility, NM0030490, August 27, 2010

NPDES Compliance Inspection Report

County of Doña Ana, South Central Regional Wastewater Treatment Facility
NPDES Permit No. NM0030490
Compliance Evaluation Inspection
August 27, 2010

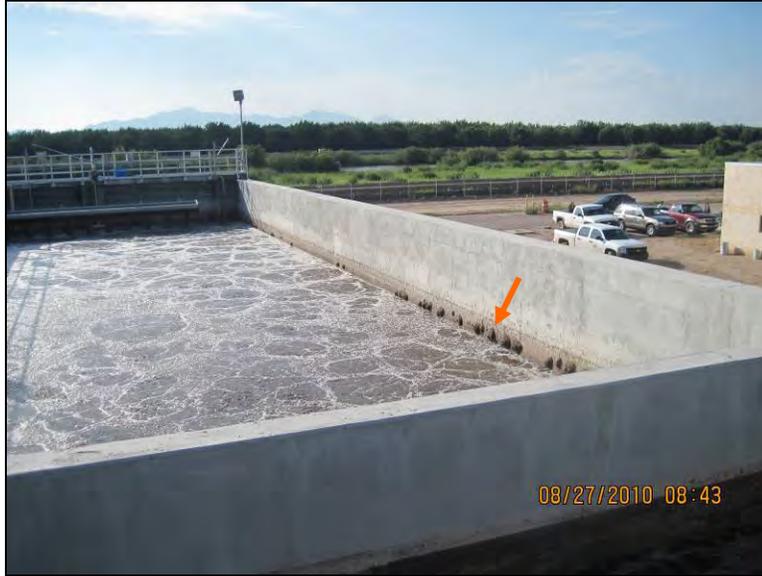
**NMED/SWQB
Official Photograph Log
Photo # 1**

Photographer: Erin S. Trujillo	Date: 08/27/2010	Time: 0843 hours
City/County: Near Vado and La Mesa / Doña Ana	State: New Mexico	
Location: South Central Regional Wastewater Treatment Facility (NPDES Permit No. NM0030490)		
Subject: Arrow points to solid buildup on outer wall of active SBR basin.

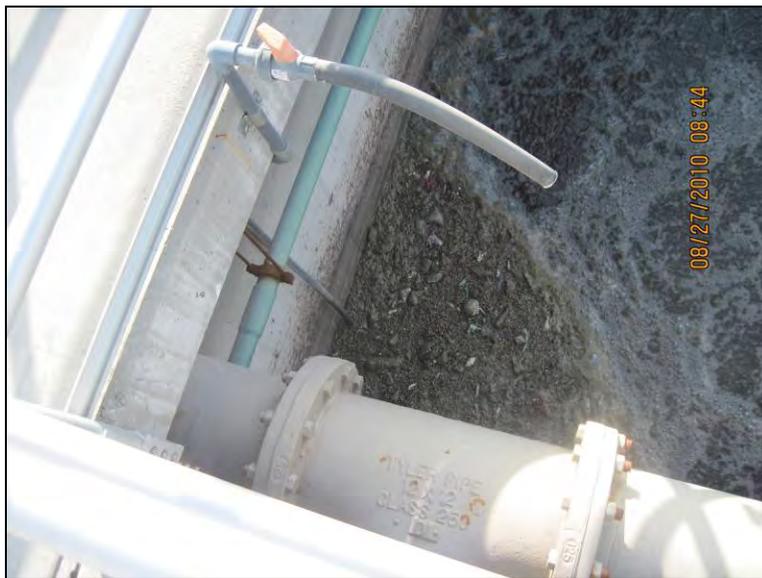
**NMED/SWQB
Official Photograph Log
Photo # 2**

Trash was observed in the pre-react basin on the day of the inspection (see Photo #2) which may indicate that the bar screen openings in the bypass channel are too large especially for continued use while the grinder is down. Problems with the grinder were discussed in the previous inspection report. Solids had collected on the outer wall of the active biological reactor (see Photo #1). This basin does not have an outer walkway making it difficult for operators to access the wall for cleaning or wash down. Solids were also observed in the flume on the day of the inspection (see Photos #3 and #4). Current cleaning practices should be reviewed, supplemented and/or additional wash down done to ensure adequate cleaning of the treatment works and flume to prevent exceedance of the permit's TSS effluent limits. The permit also states, "There shall be no discharge of floating solids...." Cleaning of the flume to ensure proper flow measurement is discussed below.

Photographer: Erin S. Trujillo	Date: 08/27/2010	Time: 0844 hours
City/County: Near Vado and La Mesa / Doña Ana	State: New Mexico	
Location: South Central Regional Wastewater Treatment Facility (NPDES Permit No. NM0030490)		
Subject: Trash accumulation in pre-react basin.

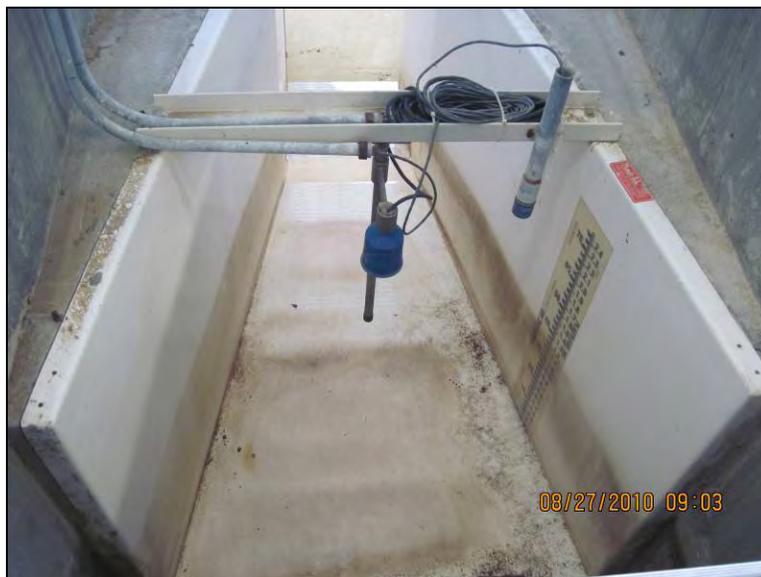
**NMED/SWQB
Official Photograph Log
Photo # 3**

Photographer: Erin S. Trujillo	Date: 08/27/2010	Time: 0903 hours
City/County: Near Vado and La Mesa / Doña Ana	State: New Mexico	
Location: South Central Regional Wastewater Treatment Facility (NPDES Permit No. NM0030490)		
Subject: No discharge in flume. Solid buildup was observed on walls and floor of flume

It is not documented that the facility's flow measurement calibration checks (comparing the staff gage measurement with the depth and flow rate recorded at the meter) is sufficient. Performance checks of the facility's flume secondary instrumentation is conducted and documented once per quarter. Accuracy of flume-based measuring system depends upon a combination of accuracies of the flume and secondary instrumentation. Information that a complete calibration of the primary flume recommended after installation (e.g., using three flow rates, checking levels of the flume for any changes due to settlement) was not available on the day of the inspection. Also, it is not known how much the solid accumulation inside the flume may effect roughness of the flume surface and flow measurement. It is recommended that flume surfaces be wiped down weekly to free them of slimes or other coatings. The transducer was mounted on a pipe that extended below the water surface during discharge on the day of the inspection. This pipe downstream of the transducer did not appear to affect flow at the transducer, but any debris that may collect during discharge may affect accuracy and/or readings. Flume manufacture's recommendations on transducer mounting should be reviewed.

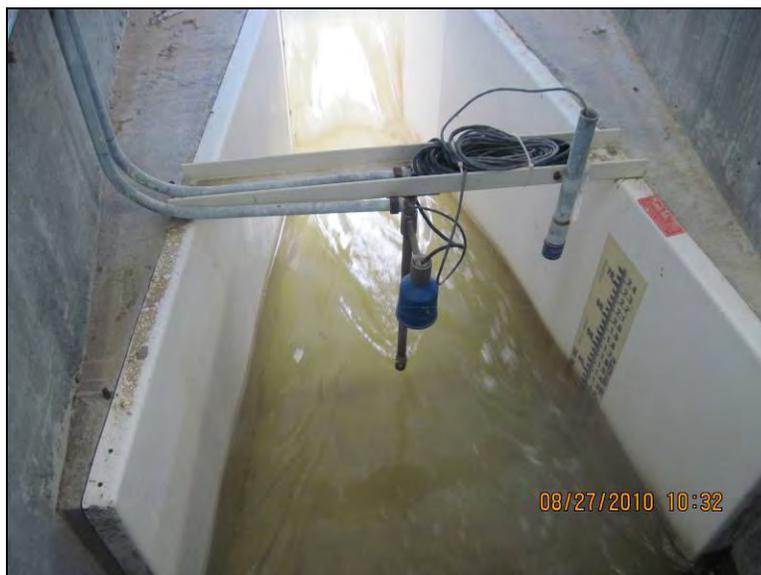
**NMED/SWQB
Official Photograph Log
Photo # 4**

Photographer: Erin S. Trujillo	Date: 08/27/2010	Time: 1032 hours
City/County: Near Vado and La Mesa / Doña Ana	State: New Mexico	
Location: South Central Regional Wastewater Treatment Facility (NPDES Permit No. NM0030490)		
Subject: Effluent discharge in flume. Transducer is mounted on a pipe that extends below the water surface. No debris had collected on this pipe on day of the inspection.
