Re: Major-Municipal, SIC 4952, NPDES Compliance Evaluation Inspection, City of Las Cruces, East Mesa Water Reclamation Facility, NM0030872, Doña Ana County, New Mexico, July 7, 2010

NPDES Compliance Inspection Report

City of Las Cruces - East Mesa Water Reclamation Facility
NPDES Permit No. NM0030872
Compliance Evaluation Inspection
July 7, 2010

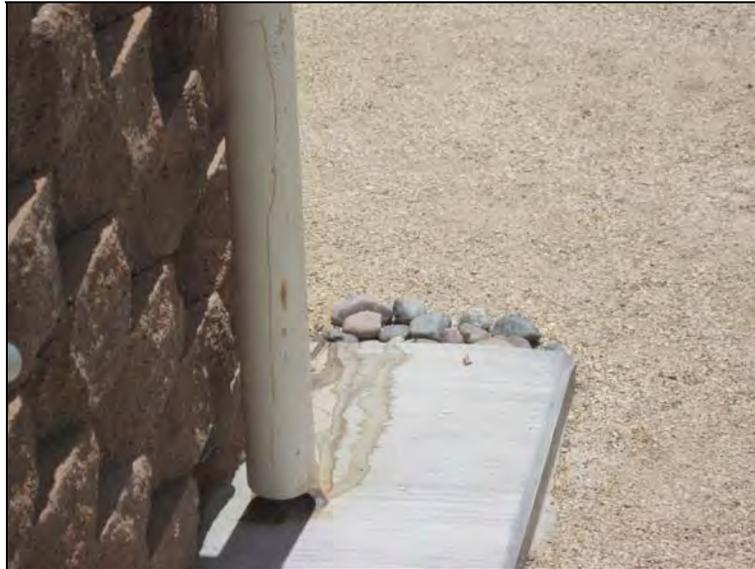
NMED/SWQB
Official Photograph Log
Photo # 1

TREATMENT FACILITY PROPERLY OPERATED AND MAINTAINED. S M U NA (FURTHER EXPLANATION ATTACHED Yes)
 DETAILS: **Untreated wastewater from drum screen cleanout allowed to drain on ground (see Photo #1).**

Staining was observed on the concrete pad below a drain spout from drum screen cleanout. On-site permittee representatives stated that other practices or measures to prevent wastewater from draining to the ground would be investigated.

Photographer: Erin S. Trujillo	Date: 07/07/2010	Time: 1323 hours
City/County: Las Cruces / Doña Ana County		State: New Mexico
Location: East Mesa Water Reclamation Facility		
Subject: Staining from wastewater on concrete pad below drain spout from drum screen cleanout.

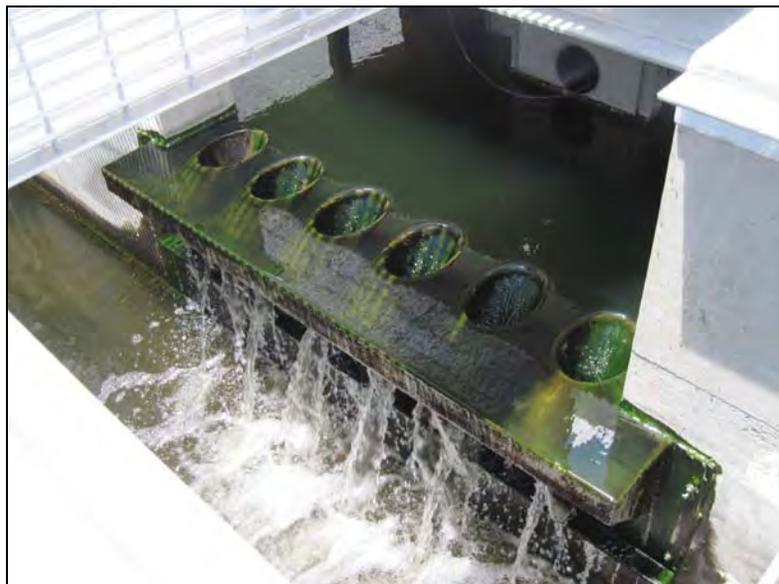
NMED/SWQB
Official Photograph Log
Photo # 2

- 1. TREATMENT UNITS PROPERLY OPERATED. S M U NA
- 2. TREATMENT UNITS PROPERLY MAINTAINED. **Algal growth on weirs before UV system (see Photo #2)** S M U NA
- 3. STANDBY POWER OR OTHER EQUIVALENT PROVIDED. S M U NA
- 4. ADEQUATE ALARM SYSTEM FOR POWER OR EQUIPMENT FAILURES AVAILABLE. S M U NA
- 5. ALL NEEDED TREATMENT UNITS IN SERVICE **1 of 5 blowers down, but only 2 needed for train per on-site rep** S M U NA
- 6. ADEQUATE NUMBER OF QUALIFIED OPERATORS PROVIDED. S M U NA
- 7. SPARE PARTS AND SUPPLIES INVENTORY MAINTAINED. **List compiled, but inventory control not established** S M U NA
- 8. OPERATION AND MAINTENANCE MANUAL AVAILABLE. Y N NA
 STANDARD OPERATING PROCEDURES AND SCHEDULES ESTABLISHED. **Preventative Maintenance Schedule, but no SOP** Y N NA
 PROCEDURES FOR EMERGENCY TREATMENT CONTROL ESTABLISHED. **Also, no updated written spill reporting SOP** Y N NA

The algal growth on weirs below the disc filter system before UV disinfection unit was also observed. Algae was also noted on TSS bench sheets for an effluent composite sample collected on May 3, 2010. Additional maintenance and cleaning (e.g., spray washing, more frequent cleaning) appears needed to prevent future maintenance issues of the UV disinfection unit and/or exceedances of E. coli bacteria or TSS permit effluent limits.

Photographer: Erin S. Trujillo	Date: 07/07/2010	Time: 1355 hours
City/County: Las Cruces / Doña Ana County		State: New Mexico
Location: East Mesa Water Reclamation Facility		
Subject: Algal growth on weirs below filter system before UV disinfection unit.

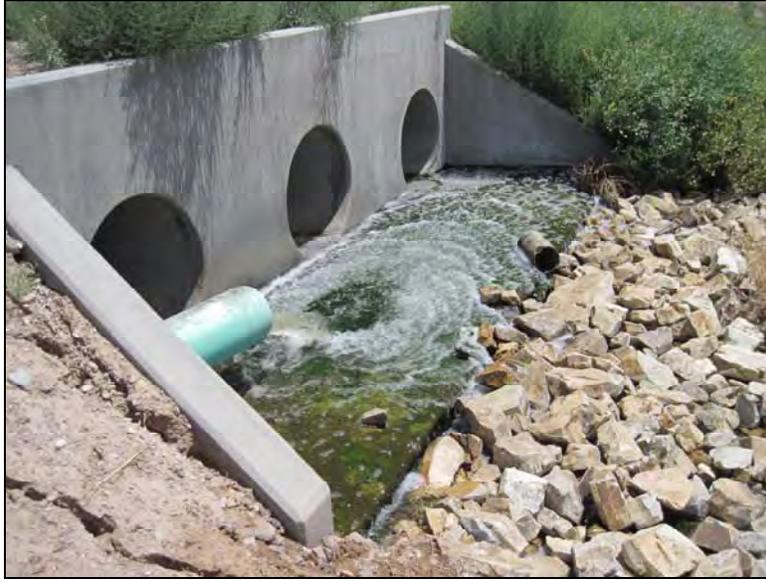
NMED/SWQB
Official Photograph Log
Photo # 3

RECEIVING WATER OBSERVATIONS: **E.coli daily max exceeded in May 2010. Substantial algal growth (often an indicator of nutrients in effluent) observed along water course made effluent appear slightly green from bank, but effluent/receiving water was clear (see Photos #3 and #4).**

Photographer: Erin S. Trujillo	Date: 07/07/2010	Time: 1408 hours
City/County: Las Cruces / Doña Ana County	State: New Mexico	
Location: East Mesa Water Reclamation Facility		
Subject: Discharge from Outfall 001 and algal growth on concrete pad below outfall.

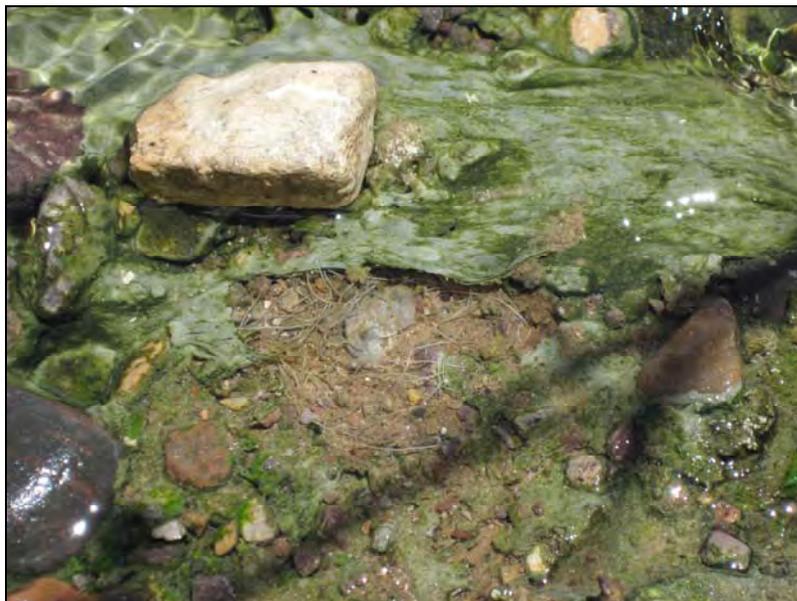
NMED/SWQB
Official Photograph Log
Photo # 4

Photographer: Erin S. Trujillo	Date: 07/07/2010	Time: 1411 hours
City/County: Las Cruces / Doña Ana County	State: New Mexico	
Location: East Mesa Water Reclamation Facility		
Subject: Algal growth mat in receiving stream channel.
