RE: Minor Non-Municipal, SIC 4941, NPDES Compliance Evaluation Inspection, USDOI BOR / Navajo Gallup
Water Supply Pilot Plant Project, NM0031089, May 15, 2013

NPDES Compliance Inspection Report

**U.S. Department of Interior (USDOI) Bureau of Reclamation (BOR)
Navajo Gallup Water Supply Pilot Plant Project
NPDES Permit No. NM0031089
Compliance Evaluation Inspection
May 15, 2013**

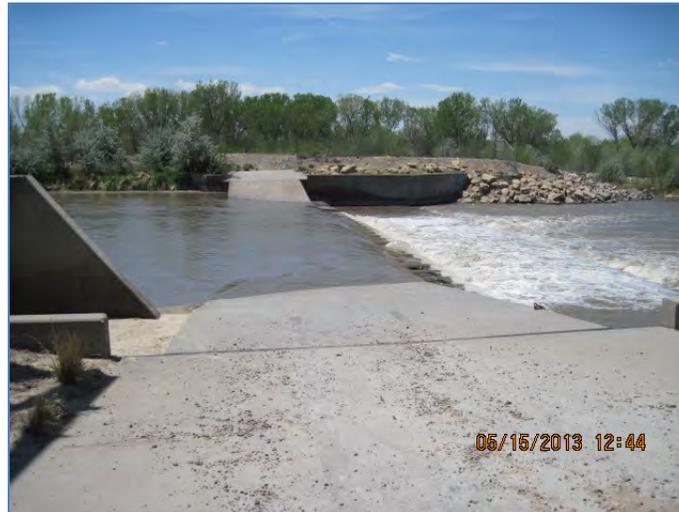
**MED/SWQB
Official Photograph Log
Photo # 1**

Photographer: Erin S. Trujillo	Date: 05/15/2013	Time: 1244 hours
City/County: Navajo Dam / San Juan County	State: New Mexico	
Location: Previous location of Navajo Gallup Water Supply Pilot Plant Project - NM0031089		
Subject: Location of previous outfall at San Juan River according to permittee representative. Treatment system and outfall removed.

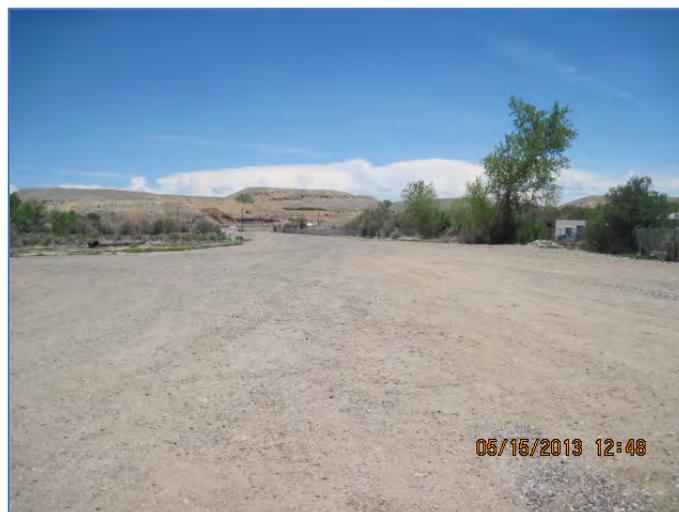
**NMED/SWQB
Official Photograph Log
Photo # 2**

Photographer: Erin S. Trujillo	Date: 05/15/2013	Time: 1248 hours
City/County: Fruitland / San Juan County	State: New Mexico	
Location: Previous location of Navajo Gallup Water Supply Pilot Plant Project - NM0031089		
Subject: Location of previous pilot plant according to permittee representative. Treatment system equipment removed.
