NEW MEXICO
ENVIRONMENT DEPARTMENT
Surface Water Quality Bureau

RE: Industrial Storm Water, SIC 1442, NPDES Compliance Evaluation Inspection, Sky Ute Sand & Gravel, LLC /
Link Pit, NMR05GC40, June 29, 2011

NPDES Industrial Storm Water Checklist (MSGP)

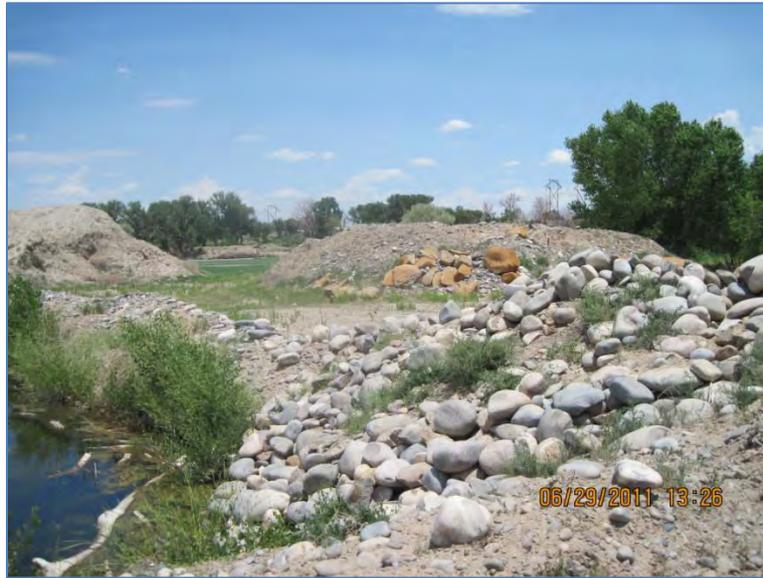
**NMED/SWQB
Official Photograph Log
Photo # 1**

Photographer: Erin S. Trujillo	Date: 06/29/2011	Time: 1326 hours
City/County: Near Waterflow / San Juan County		State: New Mexico
Location: Sky Ute Sand & Gravel, LLC, Link Pit, NMR05GC40		
Subject: Two stockpiles (background of photo) located outside berm. Based on information from operator's on-site representative, stockpile (left side of photo) is topsoil shown on map inside berm. Stockpile not stabilized.

SWPPP Implementation	
Spill Prevention and Response	<p><i>(e.g., minimizing the potential for leaks, spills and other releases that may be exposed to storm water and develop plans for effective response to such spills if or when they occur)</i></p> <p>Fuel storage tank was labeled and had secondary containment. Overpack drum and spill kit near fuel tank.</p> <p>It was noted that responsibilities and control measures (e.g., training, spill response) during equipment and sand and gravel removal was not described in SWPPP. For example, no leaks or spills observed; but, need for drip pan or absorbent around mobile fuel tank should be considered.</p>
Erosion and Sediment Controls	<p><i>(e.g., stabilize exposed areas and contain runoff using structural and/or non-structural control measures to minimize onsite erosion and sedimentation, flow velocity dissipation devices at discharge locations and within outfall channels)</i></p> <p>Section 4.1.1 of SWPPP states “any reclamation topsoil will be removed and stockpiled for reclamation activities.” No erosion rills or gullies observed, but some topsoil stockpiles were not stabilized (see Photos 1 and 4).</p>

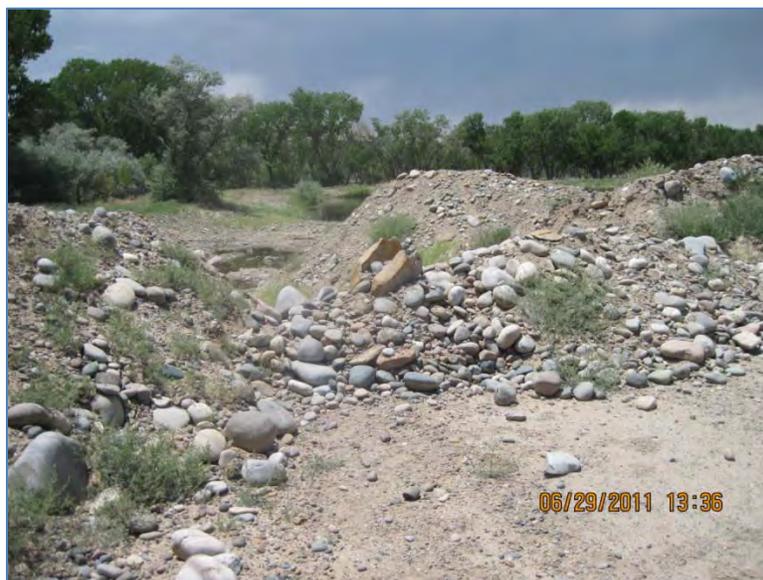
**NMED/SWQB
Official Photograph Log
Photo # 2**

Photographer: Erin S. Trujillo	Date: 06/29/2011	Time: 1336 hours
City/County: Near Waterflow / San Juan County		State: New Mexico
Location: Sky Ute Sand & Gravel, LLC, Link Pit, NMR05GC40		
Subject: Portion of berm shown on current site map had not been constructed or maintained as described in SWPPP.

SWPPP Implementation	
<p>Measures to minimize the exposure of manufacturing, processing, and material storage areas (including loading and unloading, storage, disposal, cleaning, maintenance, and fueling operations) to rain, snow, snowmelt, and runoff</p>	<p><i>(e.g., use grading, berming, or curbing to prevent runoff of contaminated flows and divert run-on away; locate materials, equipment, and activities so that leaks are contained in existing containment and diversion systems; clean up spills and leaks promptly using dry methods (e.g., absorbents) to prevent the discharge of pollutants; use drip pans and absorbents under or around leaky vehicles and equipment or store indoors where feasible; use spill/overflow protection equipment; drain fluids from equipment and vehicles prior to on-site storage or disposal; perform all cleaning operations indoors, under cover, or in bermed areas that prevent runoff and run-on and also that capture any overspray; and ensure that all washwater drains to a proper collection system)</i></p> <p>Site uses berm and pits, except for portion of top soil stockpile in eastern portion of site (see Photo 1). Revisions to site map, additional control measure and/or relocation of topsoil stockpile in accordance with site map appears needed.</p> <p>Diagrams and Section 5 of SWPPP show earthen berm to be at least three feet tall. Portions of the earthen berm needed maintenance or repair to meet specifications in SWPPP (see Photos 2 and 3).</p> <p>Drum stored in covered shelter. Two covered drum storage units on site.</p>

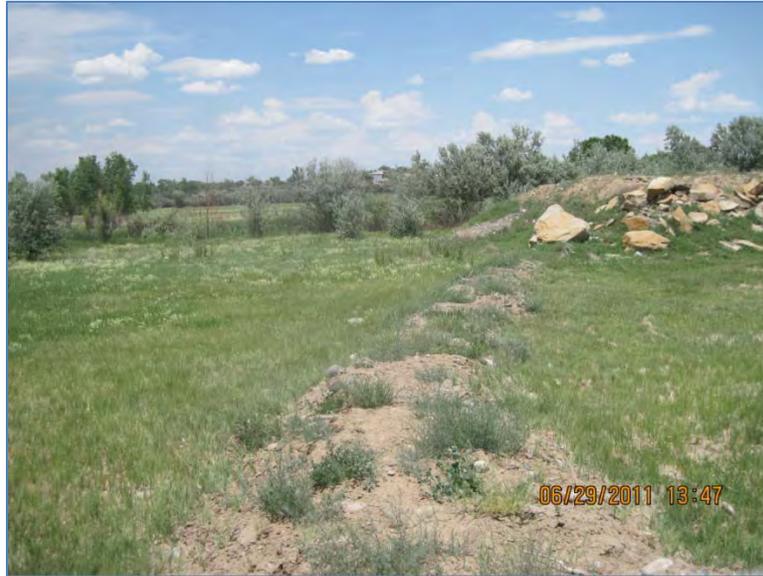
**NMED/SWQB
Official Photograph Log
Photo # 3**

Photographer: Erin S. Trujillo	Date: 06/29/2011	Time: 1347 hours
City/County: Near Waterflow / San Juan County		State: New Mexico
Location: Sky Ute Sand & Gravel, LLC, Link Pit, NMR05GC40		
Subject: Portion of berm shown on current site map was not three feet high as described in SWPPP.

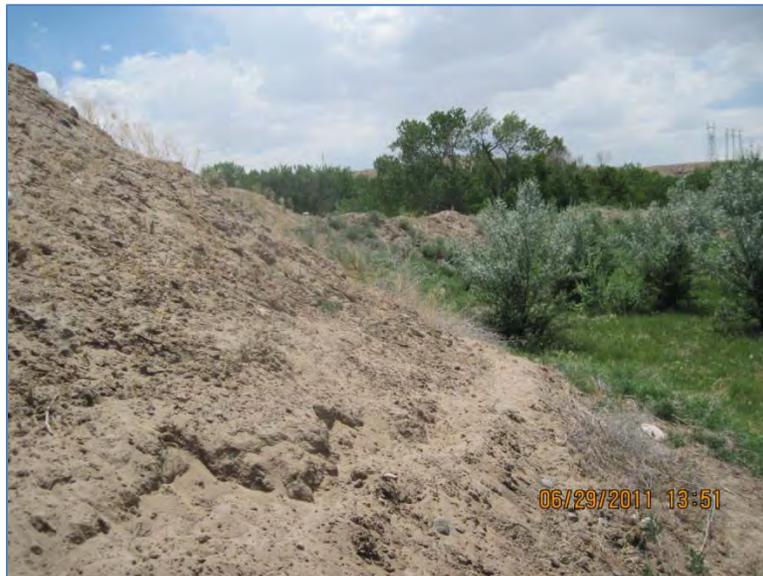
**NMED/SWQB
Official Photograph Log
Photo # 4**

Photographer: Erin S. Trujillo	Date: 06/29/2011	Time: 1351 hours
City/County: Near Waterflow / San Juan County		State: New Mexico
Location: Sky Ute Sand & Gravel, LLC, Link Pit, NMR05GC40		
Subject: Topsoil stockpile was not stabilized.
