NEW MEXICO
ENVIRONMENT DEPARTMENT

Surface Water Quality Bureau

RE: Construction Stormwater; SIC 1611; NPDES Compliance Evaluation; Star Paving; Agua Fria Phase III Utilities; NMR10H876; February 10, 2011

NPDES Compliance Inspection Report

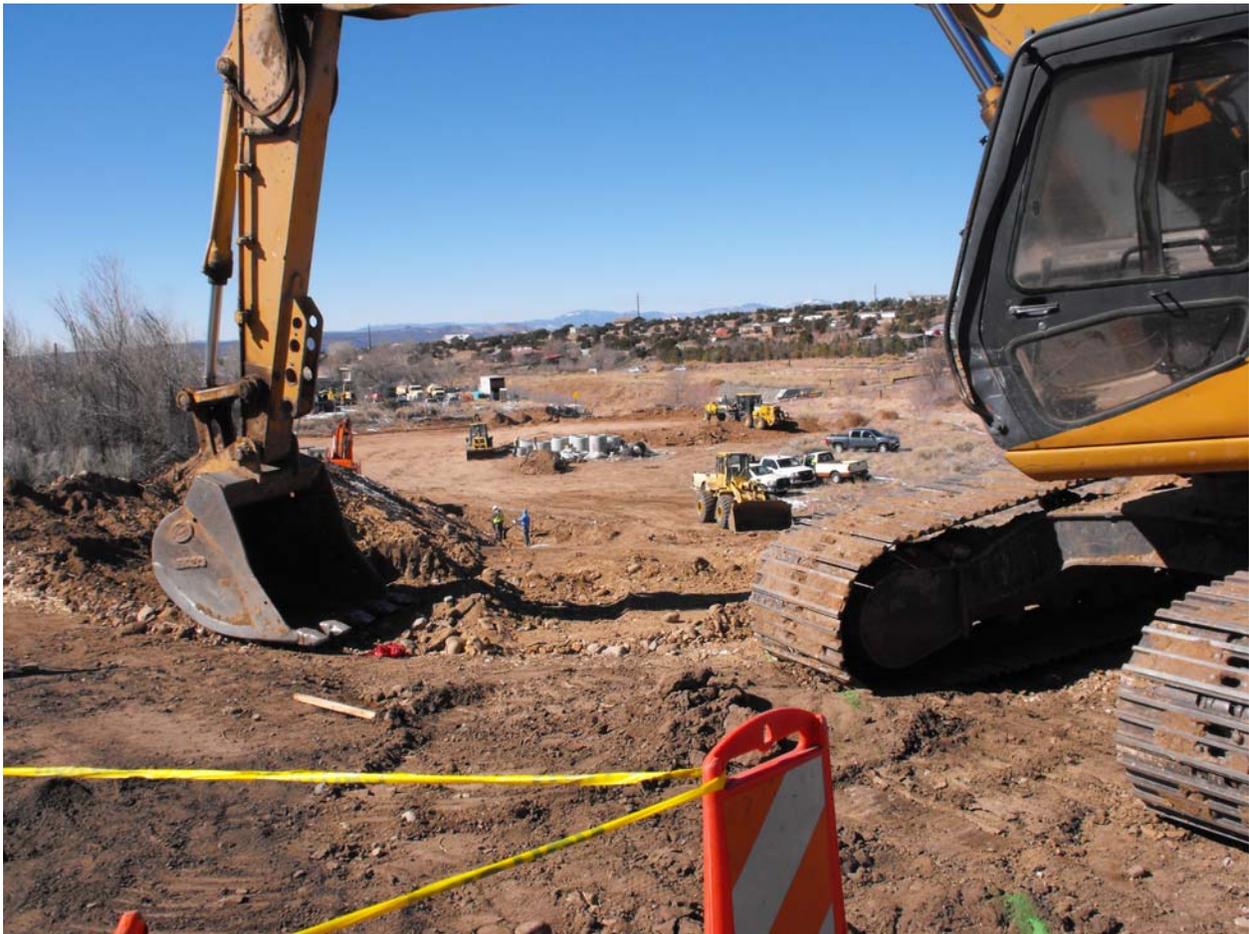
Photo # 1

Photographer: Daniel Valenta	Date: 02/10/2011	Time: 1302 Hours
City/County: Santa Fe /Santa Fe		
Location: Agua Fria Phase III Utilities Project		
Subject: Site overview of project

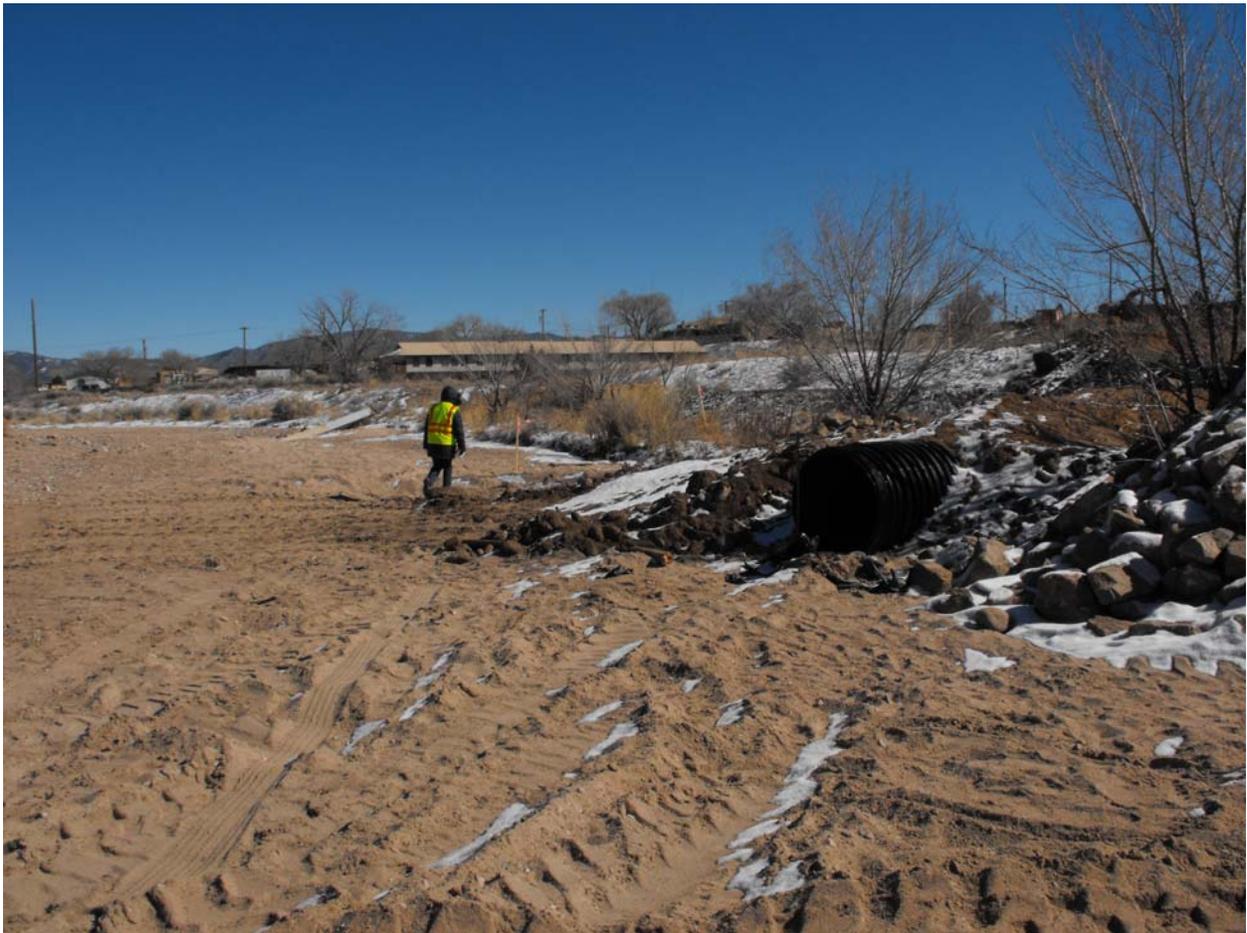
Photo # 2

Does SWPPP describe measures to prevent discharge of dredge/fill materials to waters of the U.S.? Does site have 404 permit? <i>ESO Element 17</i>	Y	<input type="checkbox"/> N	During the site inspection work was being completed on a culvert entering the Santa Fe River. This project is inside the flood plain of the river. No discussion of 404 requirements was discussed in the SWPPP.
Does SWPPP describe measures to minimize off-site vehicle tracking and generation of dust? <i>ESO Element 18</i>	<input checked="" type="checkbox"/> Y	N	SWPPP states off-site tracking will be eliminated/minimized by street cleaning with a broom/scraping. Dust generation will be controlled with reusable uncontaminated or potable dischargeable water.
Does SWPPP describe controls for pollutants from storage of construction or waste materials? <i>ESO Element 19</i>	Y	<input type="checkbox"/> N	
Does the SWPPP describe controls for pollutants from non-construction activities? <i>ESO Element 20</i>	Y	N

Photographer: Daniel Valenta	Date: 02/10/2011	Time: 1250 hours
City/County: Santa Fe /Santa Fe		
Location: Agua Fria Phase III Utilities Project		
Subject: View of stormwater culvert entering Santa Fe River on northwest corner of project

No inspections have been performed. However, because this site includes construction of a culvert entering the Santa Fe River, additional BMPs may be warranted in this area.

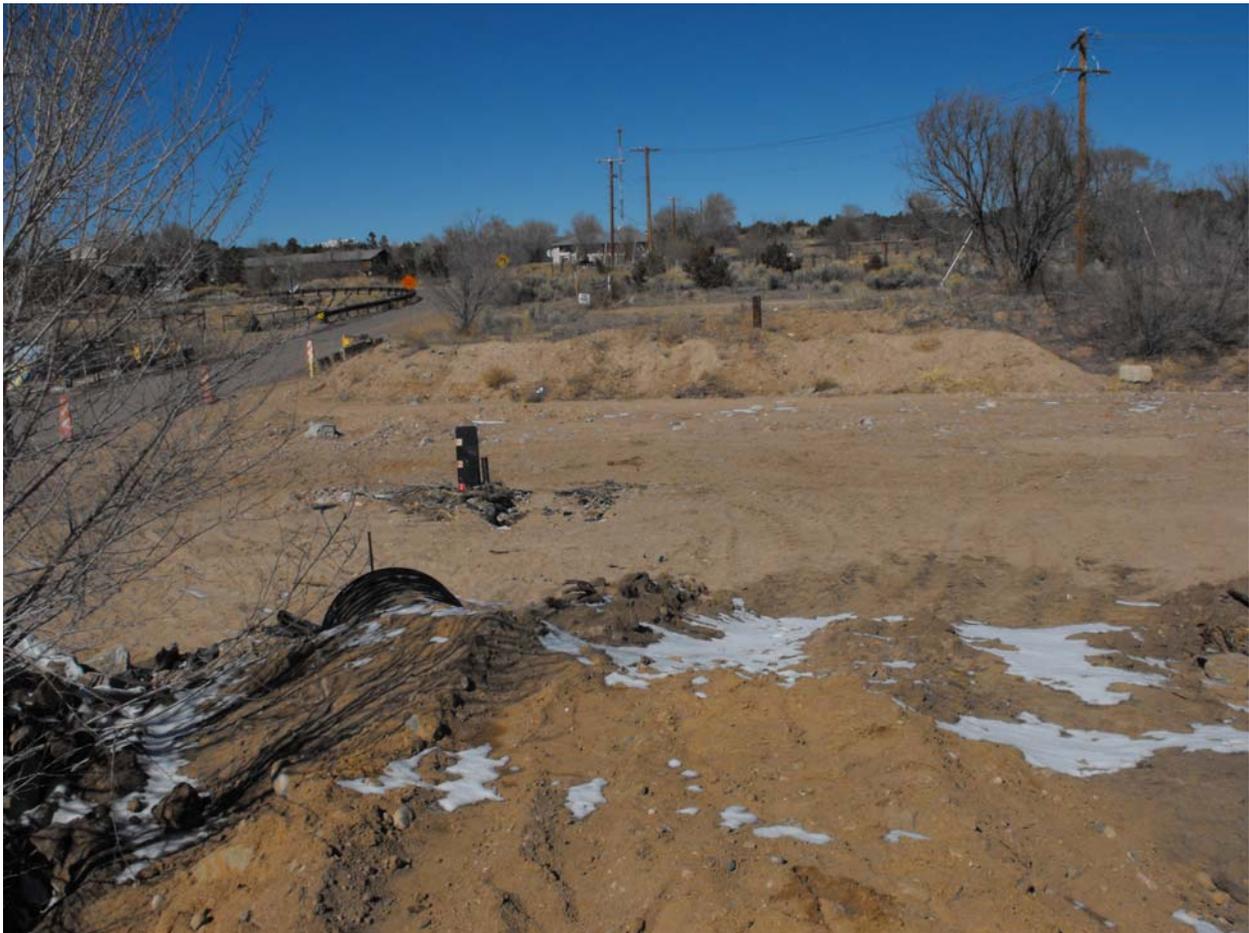
Photo # 3

Photographer: Daniel Valenta	Date: 02/10/2011	Time: 1251 Hours
City/County: Santa Fe /Santa Fe		
Location: Agua Fria Phase III Utilities Project		
Subject: Picture taken above the stormwater culvert
