RE: Construction Storm Water, SIC 1623, NPDES Compliance Evaluation Inspection, San Juan County, San Juan County and Valley Water, NMU001679, September 13, 2010

This project concerns the installation of sewer line along Hwy 64 in Kirtland, NM, in order to tie in to Farmington's sewer system.

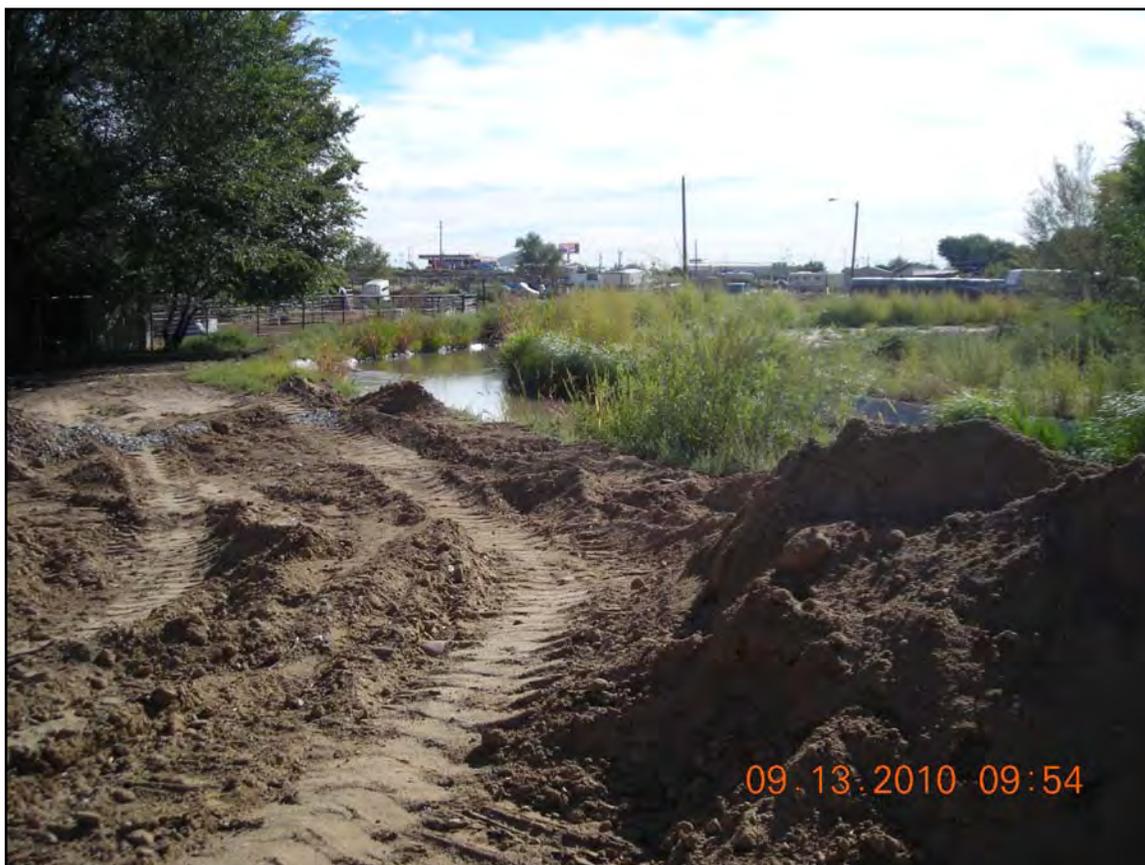
NMED/SWQB
Official Photograph Log
Photo # 1

Photographer: Sarah Holcomb	Date: 9-13-2010	Time: 0954 hours
City/County: Kirtland/San Juan		
Location: Lift station #1 installation site off of County Road 6500.		
Subject: Berm along irrigation canal had been compromised. Needed to be re-installed.

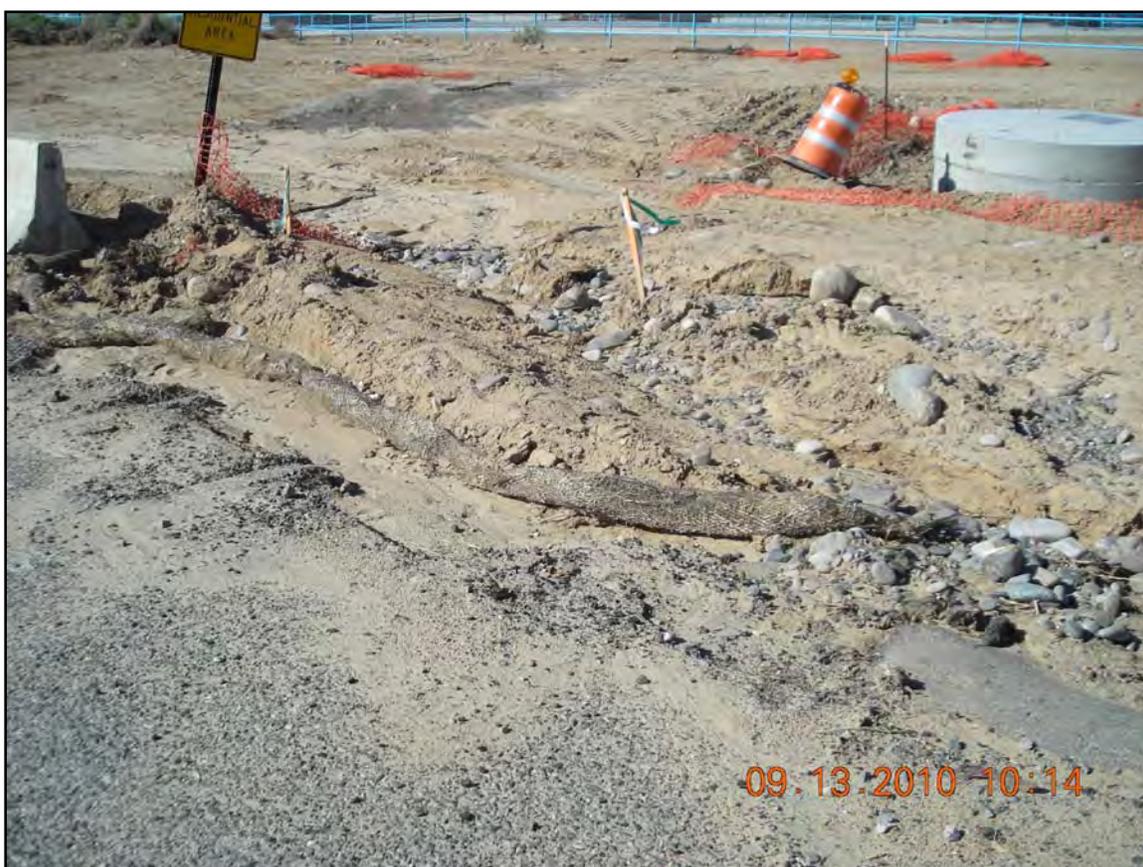
NMED/SWQB
Official Photograph Log
Photo # 2

Photographer: Sarah Holcomb	Date: 9-13-2010	Time: 1014 hours
City/County: Kirtland/San Juan		
Location: Lift station #2 near Hwy 64 and CR 6299		
Subject: Erosion socks at this location were in dire need of repair and reinstallation.

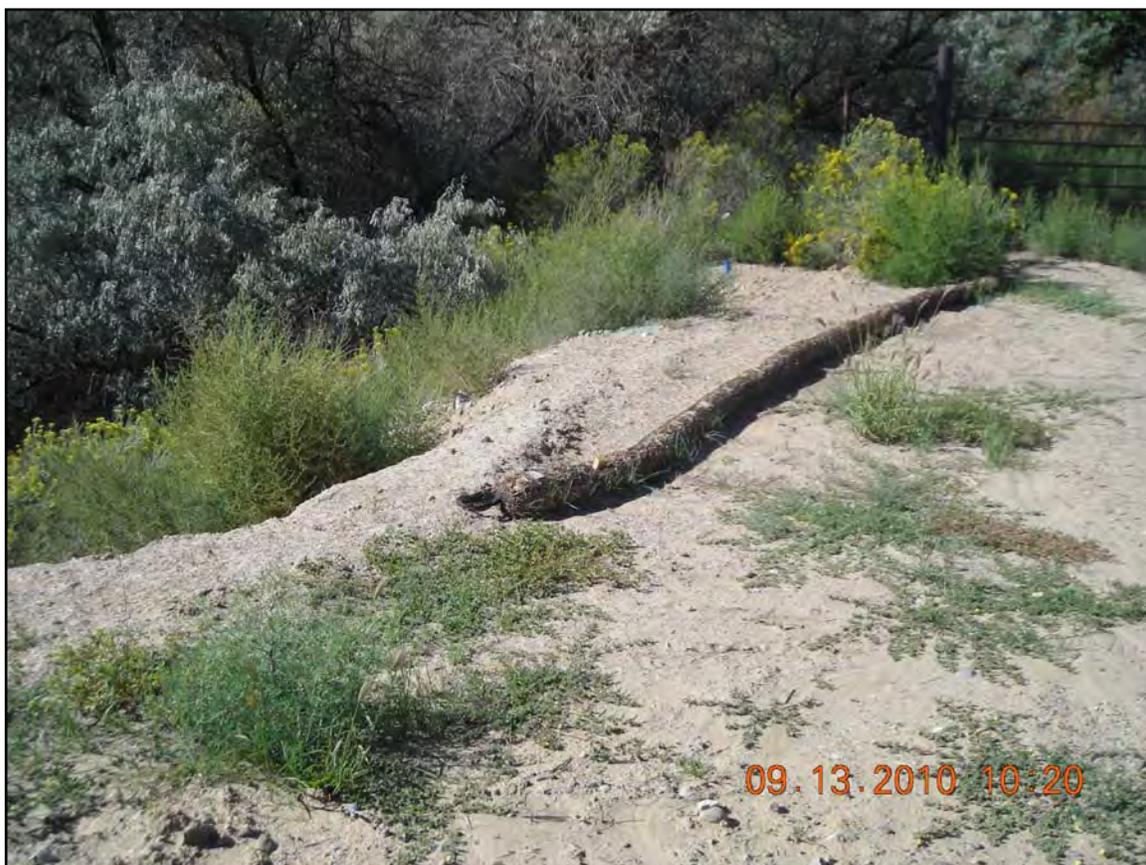
NMED/SWQB
Official Photograph Log
Photo # 3

Photographer: Sarah Holcomb	Date: 9-13-2010	Time: 1020 hours
City/County: Kirtland/San Juan		
Location: Coolidge Arroyo at east end of project site.		
Subject: Inadequate BMPs/protection for arroyo from all of the upstream activity.
