NEW MEXICO
ENVIRONMENT DEPARTMENT

Surface Water Quality Bureau

RE: Construction Storm Water; SIC 1611; NPDES Compliance Evaluation Inspection; Town of Taos Waste Water Treatment Plant; NMU001711; February 17, 2011

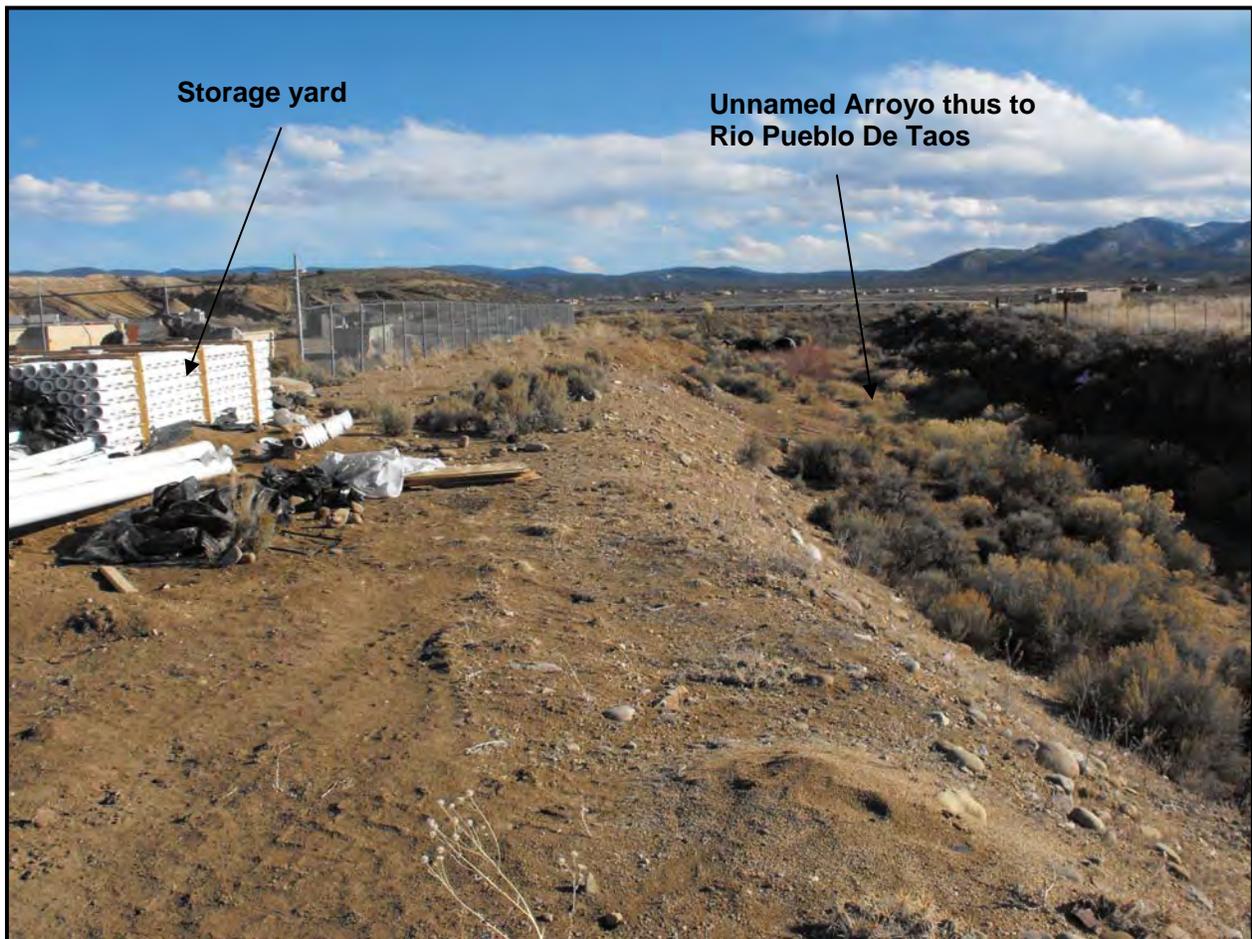
Photo # 1

5. A staging yard has been set up on the south side of the construction site to hold equipment and construction material, (see photo 1). This area faces the unnamed arroyo running along the south side of the facility. It is not included in the SWPPP or contained with any BMP's.

Photographer: Daniel Valenta	Date: 2/17/2011	Time: 1539 hours
City/County: Town of Taos/Taos County		
Location: 182 Los Cordovas Road, Taos, New Mexico 87557 South side of construction site facing south.		
Subject: Storage/staging area not included in the SWPP.

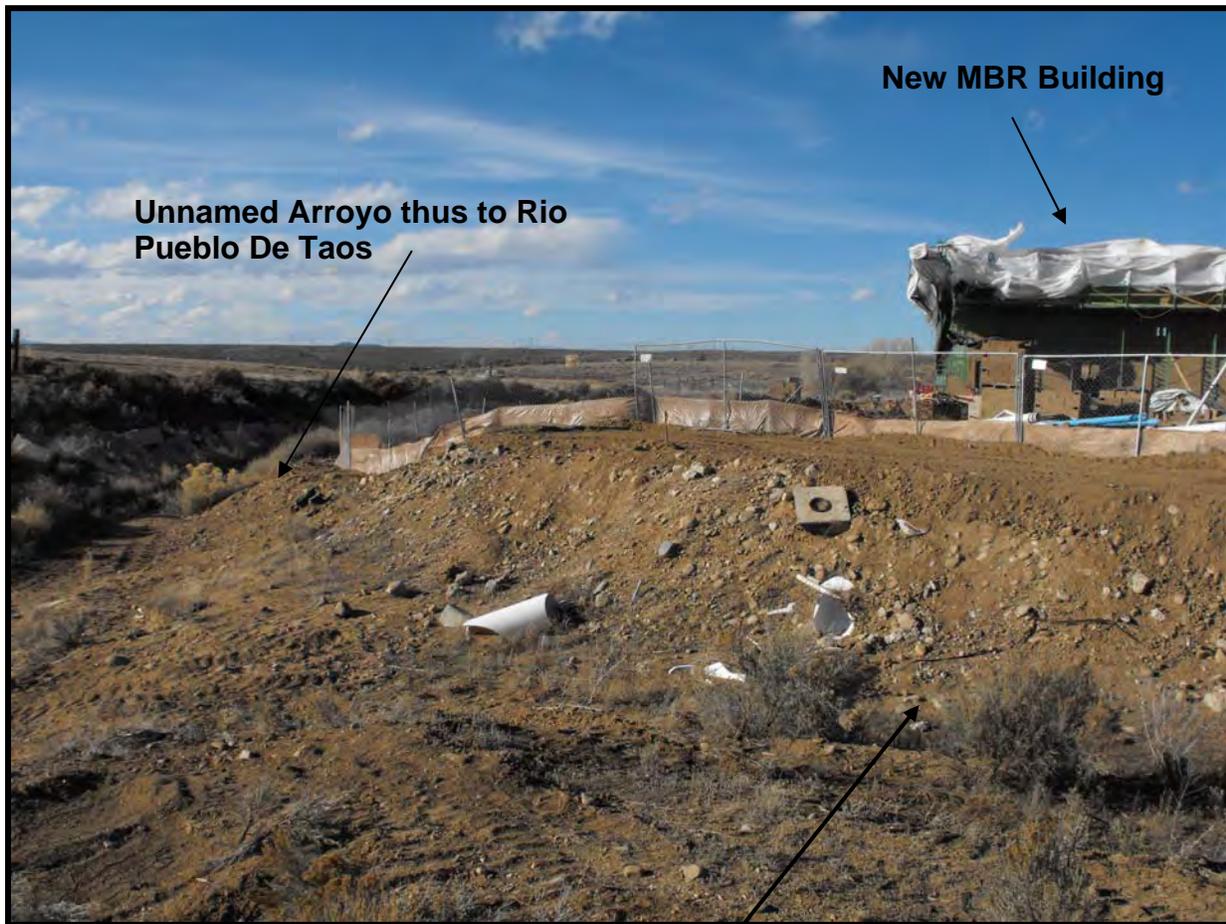
Photo # 2

(e.g., significant turbidity observed in a receiving water body) Yes
Yes, see photo 2.

Photographer: Daniel Valenta	Date: 02/17/2011	Time: 1537 hours
City/County: Town of Taos/Taos County		
Location: 182 Los Cordovas Road, Taos, New Mexico 87557 South side of construction site facing north.		
Subject: South side of construction site, unnamed arroyos run along the south and west side of construction site.

Unnamed Arroyo thus to Rio Pueblo De Taos

New MBR Building

Silt fence in place across bottom of arroyo.
