**RE: Industrial Storm Water, SIC 3273, NPDES Compliance Evaluation Inspection, Clovis Concrete Co., Inc., NMU001724, March 2, 2011**

### NPDES Compliance Inspection Report

**Clovis Concrete Co., Inc.**  
**Compliance Evaluation Inspection – Industrial Stormwater**  
**NPDES Tracking No. NMU001724**  
**March 2, 2011**

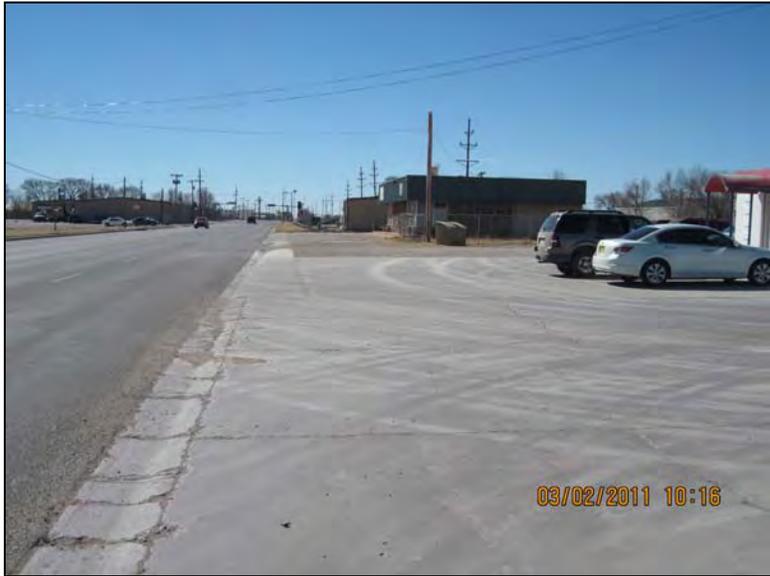
<b>NMED/SWQB Official Photograph Log Photo # 1</b>		
Photographer: Erin S. Trujillo	Date: 03/02/2011	Time: 1016 hours
City/County: Clovis / Curry County		State: New Mexico
Location: Clovis Concrete Co., Inc., 100 North Norris Clovis, NM		
Subject: Accumulated sediments from vehicle tracking at main entrance on North Norris Street. City of Clovis stormwater drain inlets on North Norris Street are located south of the facility's main entrance.

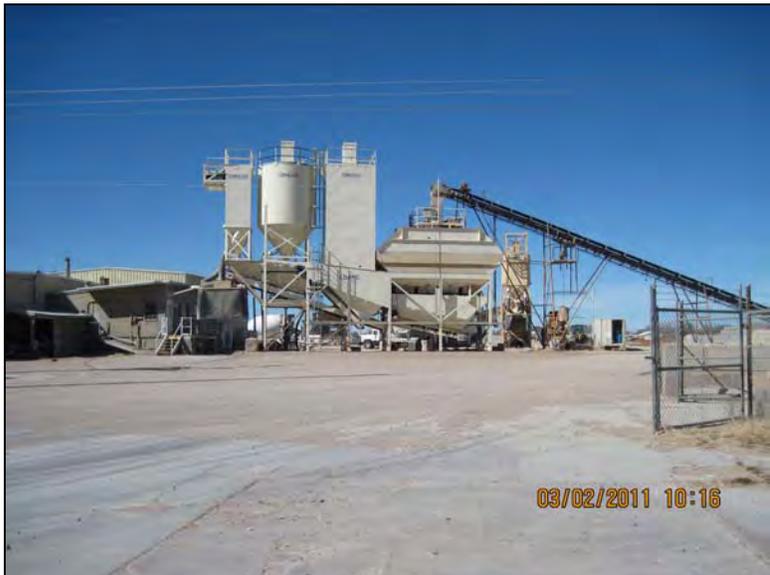
<b>NMED/SWQB Official Photograph Log Photo # 2</b>		
Photographer: Erin S. Trujillo	Date: 03/02/2011	Time: 1016 hours
City/County: Clovis / Curry County		State: New Mexico
Location: Clovis Concrete Co., Inc., 100 North Norris Clovis, NM		
Subject: Concrete manufacturing facility at main entrance shown in previous photo (east facility boundary)

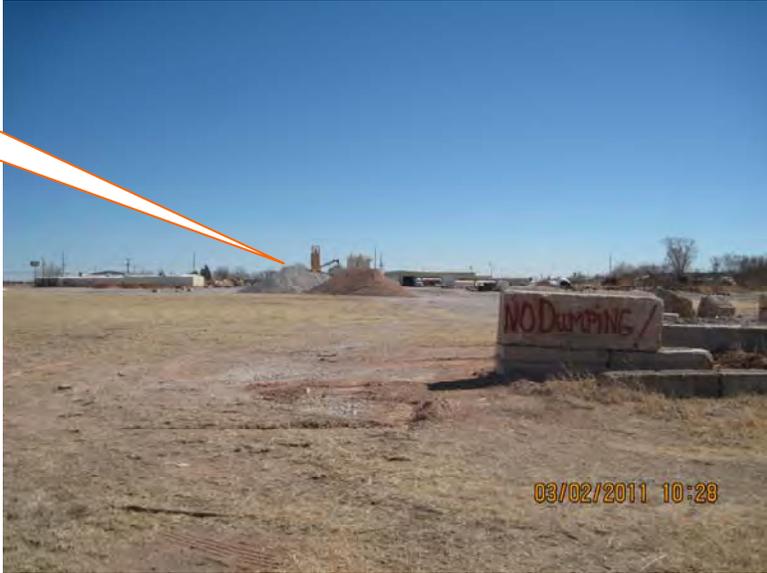
Example of material piles

NMED/SWQB Official Photograph Log Photo # 3		
Photographer: Erin S. Trujillo	Date: 03/02/2011	Time: 1028 hours
City/County: Clovis / Curry County		State: New Mexico
Location: Clovis Concrete Co., Inc., 100 North Norris Clovis, NM		
Subject: Example of aggregate material piles at various locations on site. This photo was taken at the western boundary of the site.

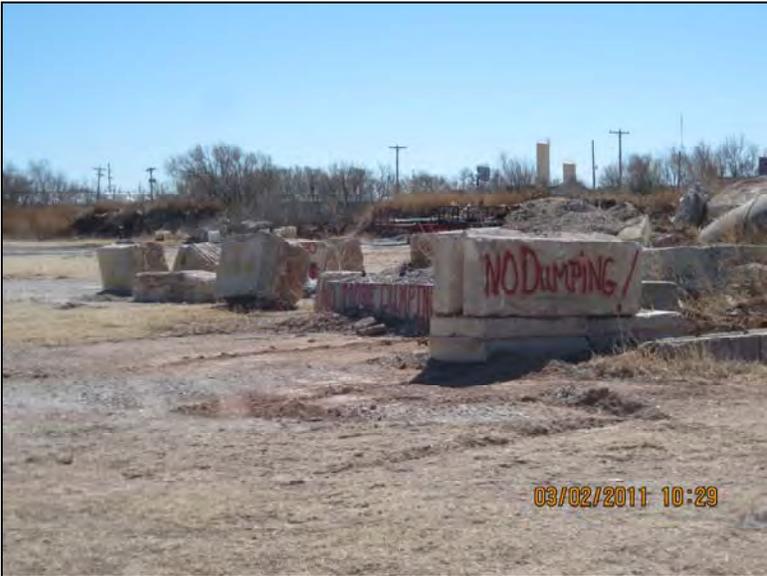
NMED/SWQB Official Photograph Log Photo # 4		
Photographer: Erin S. Trujillo	Date: 03/02/2011	Time: 1029 hours
City/County: Clovis / Curry County		State: New Mexico
Location: Clovis Concrete Co., Inc., 100 North Norris Clovis, NM		
Subject: On-site concrete washout and concrete at western boundary of site (Johnson Street/East 1 <sup>st</sup> Street). Spray paint on blocks states, "No More Dumping" and "No Dumping!"
