**RE: Construction Stormwater, SIC 1521, NPDES Compliance Evaluation Inspection, Joe Miller Property
11 Avenida Amistad, Santa Fe, New Mexico, NPDES Permit No. NMU001742**

**Joe Miller Property – 11 Avenida Amistad
NPDES Compliance Evaluation Inspection
NPDES Permit #NMR001742
July 8, 2011**

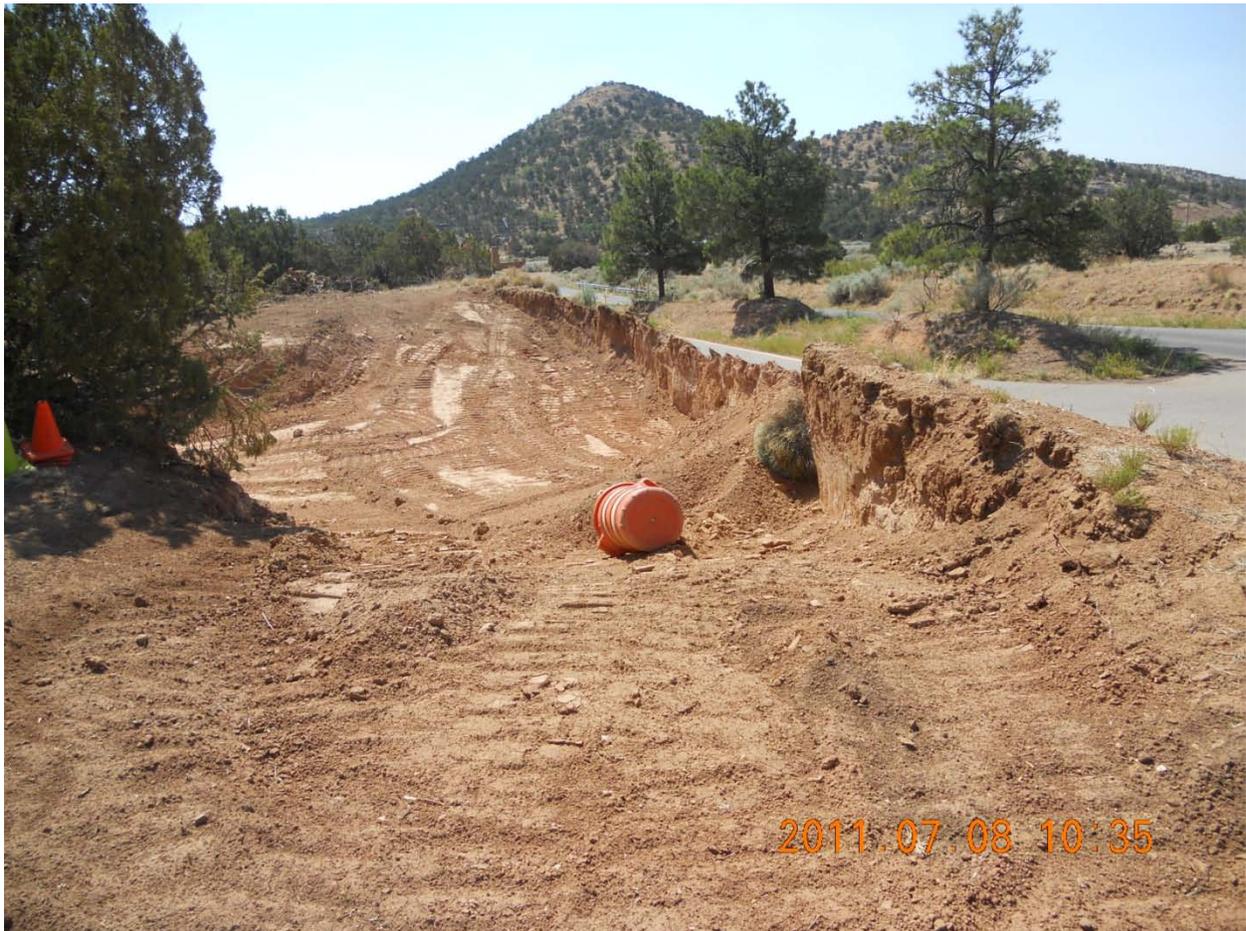
NMED/SWQB
Official Photograph Log
Photo # 1

Photographer: Sandra Gabaldón	Date: July 8, 2011	Time: 1035
City/County: Eldorado / Santa Fe		State: New Mexico
Location: 11 Avenida Amistad		
Subject: Looking East at property entrance

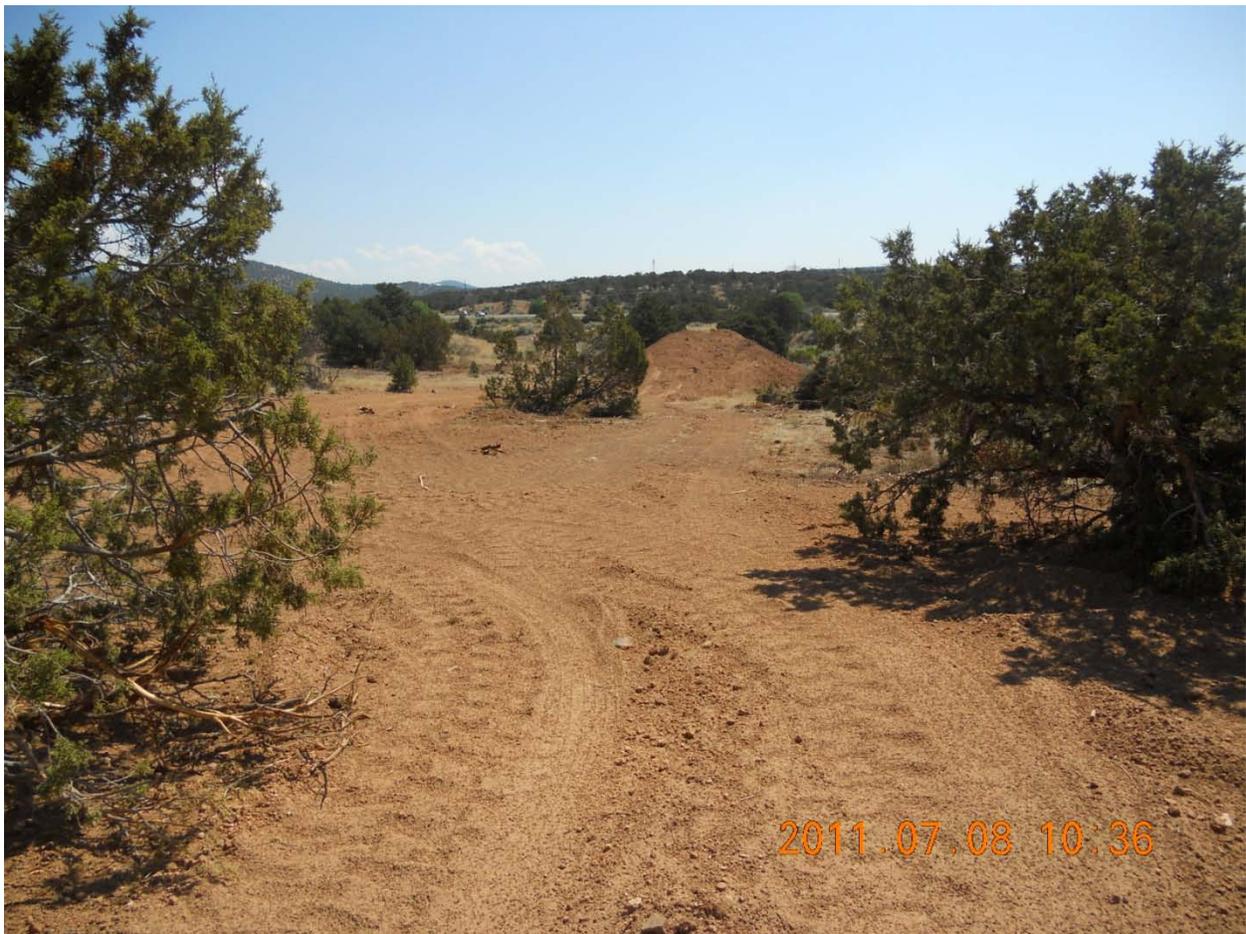
NMED/SWQB
Official Photograph Log
Photo # 2

Photographer: Sandra Gabaldón	Date: July 8, 2011	Time: 1036
City/County: Eldorado / Santa Fe		State: New Mexico
Location: 11 Avenida Amistad		
Subject: Northeast area of property. Graded area along with stockpiled dirt. (Dirt pile approximately 20 feet high)

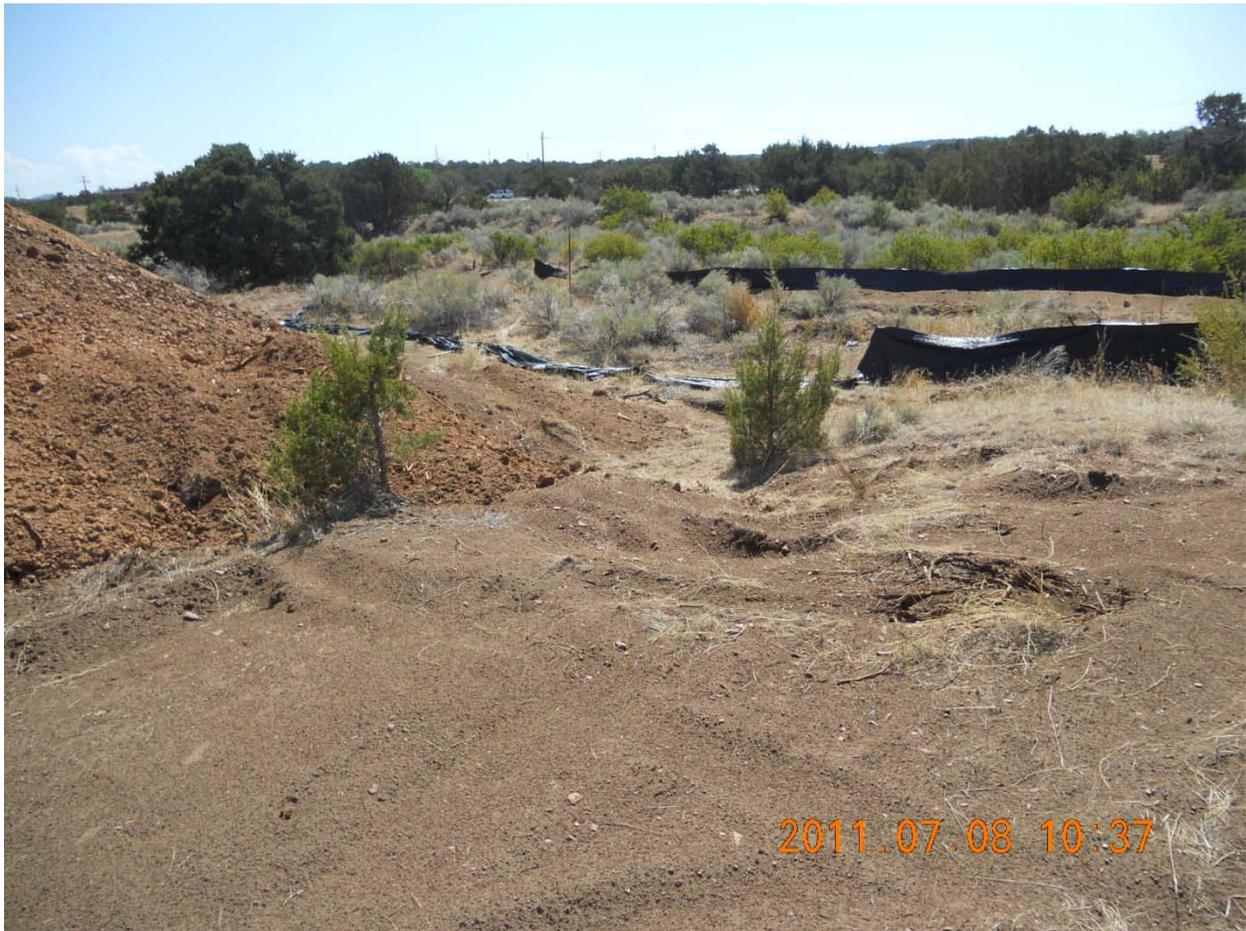
NMED/SWQB
Official Photograph Log
Photo # 3

Photographer: Sandra Gabaldón	Date: July 8, 2011	Time: 1037
City/County: Eldorado / Santa Fe		State: New Mexico
Location: 11 Avenida Amistad		
Subject: East side of property. Two silt fences, one completely down and the other 50% filled.

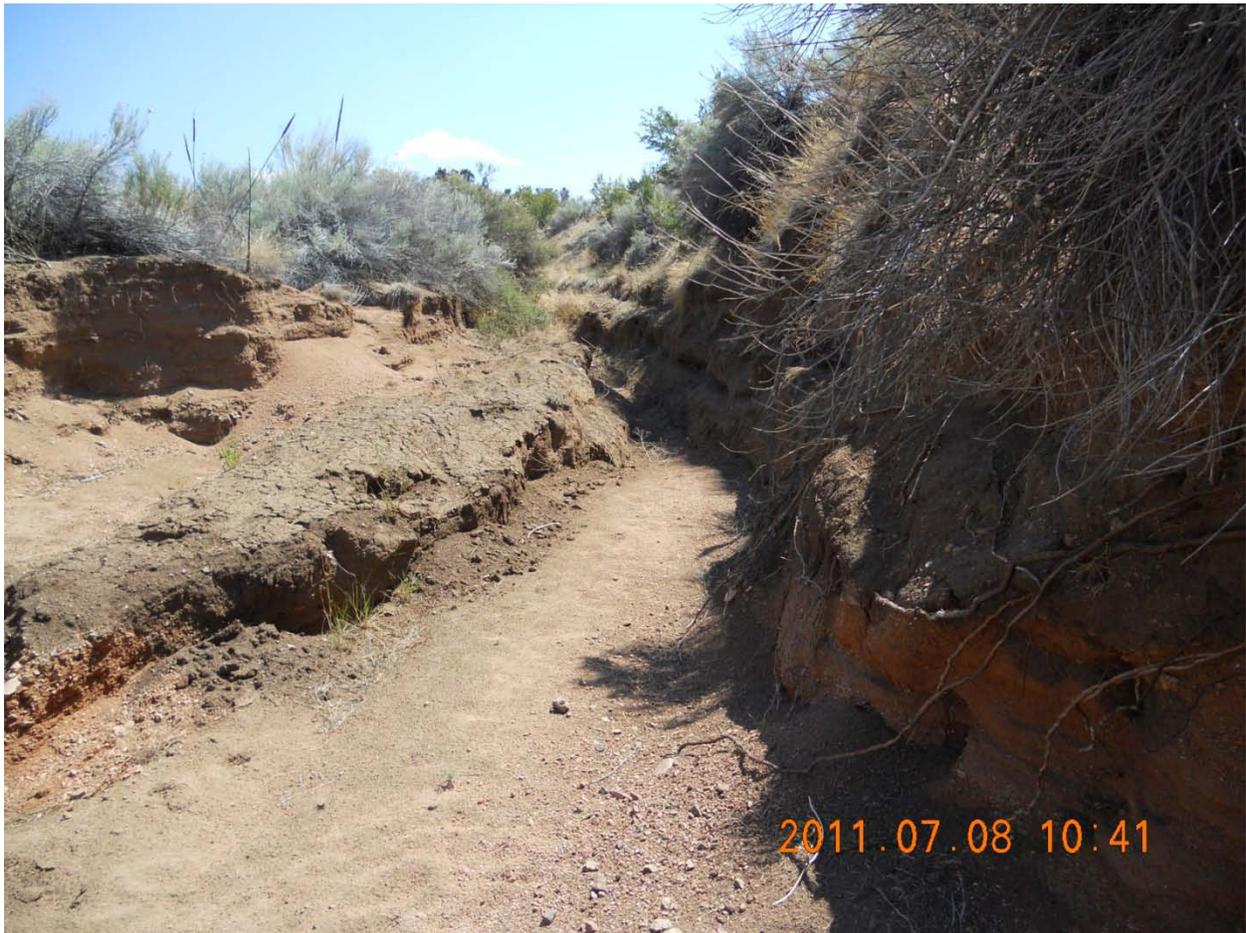
NMED/SWQB
Official Photograph Log
Photo # 3

Photographer: Sandra Gabaldón	Date: July 8, 2011	Time: 1041
City/County: Eldorado / Santa Fe		State: New Mexico
Location: 11 Avenida Amistad		
Subject: Facing North – Canada de Los Alamos Arroyo adjacent to grading activities
