**RE: Industrial Storm Water; SIC 2023; NPDES Compliance Evaluation Inspection; DairiConcepts, L.P.
Portales, NM; NMU001791; April 26, 2012**

NPDES Compliance Inspection Report

**Compliance Evaluation Inspection
DairiConcepts L.P.
April 26, 2012
NMU001791**

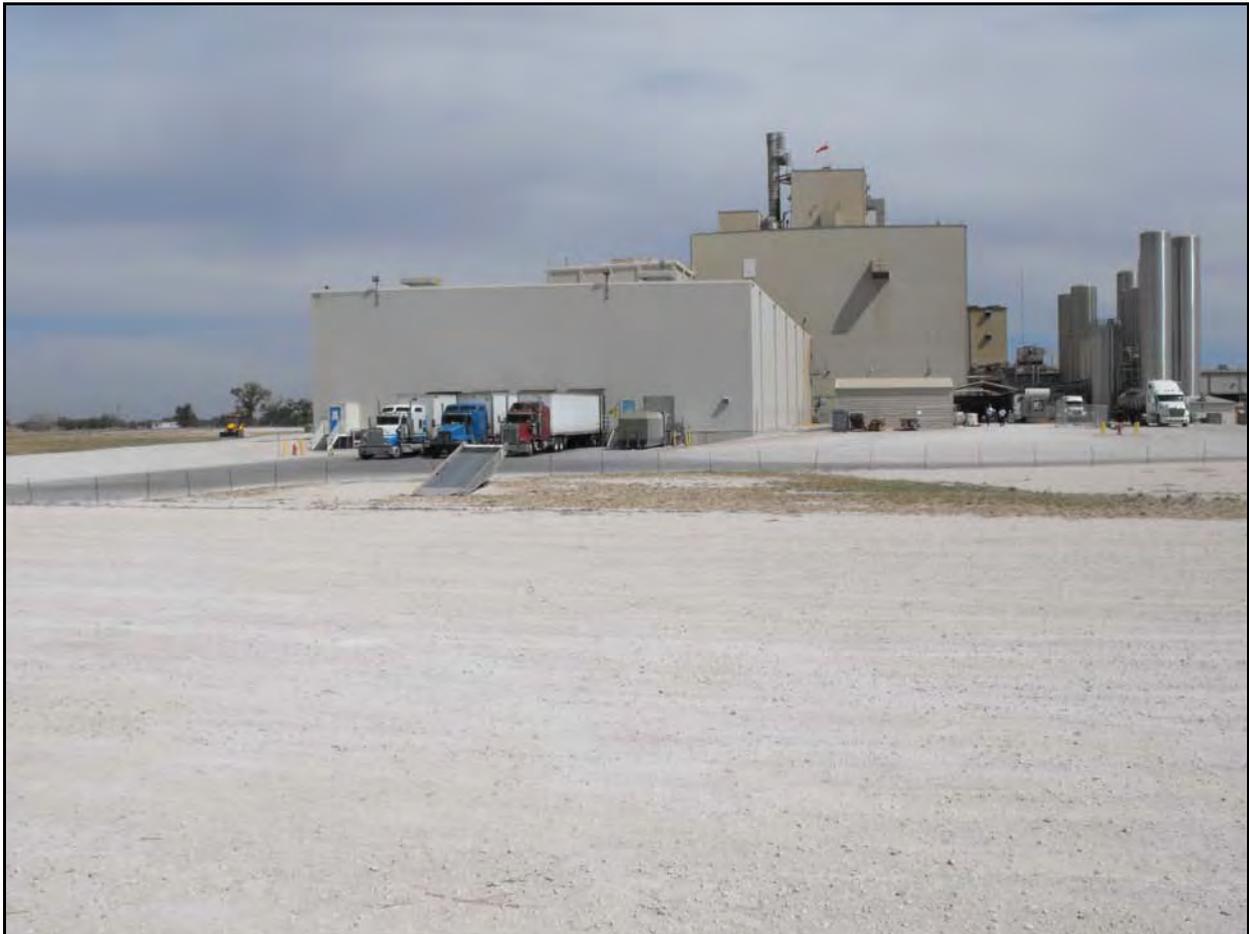
Photo # 1

At loading and unloading bays a white material was found on the ground and thus exposed to rainwater. See instructions below on how to quantify for a No Exposure Certification. The site appeared well maintained and managed, trash containers had covers. Cement covered the area around the facility and had channels to funnel stormwater to a large stormwater storage area. However it is unknown if the impoundments do capture all stormwater discharges. The facility discharges its process waste to its lined treatment lagoons off site. The facility has a scrap area on the south side of the plant where old parts, process equipment, and broken items are stored. This area is exposed to the elements.

Photographer: Daniel Valenta	Date: 4/26/2012	Time: 1033 hours
City/County: Portales/Roosevelt County		
Location: 1820 S. Industrial Drive, Portales, New Mexico, facing north.		
Subject: Picture taken from the scrap yard, south side of facility.

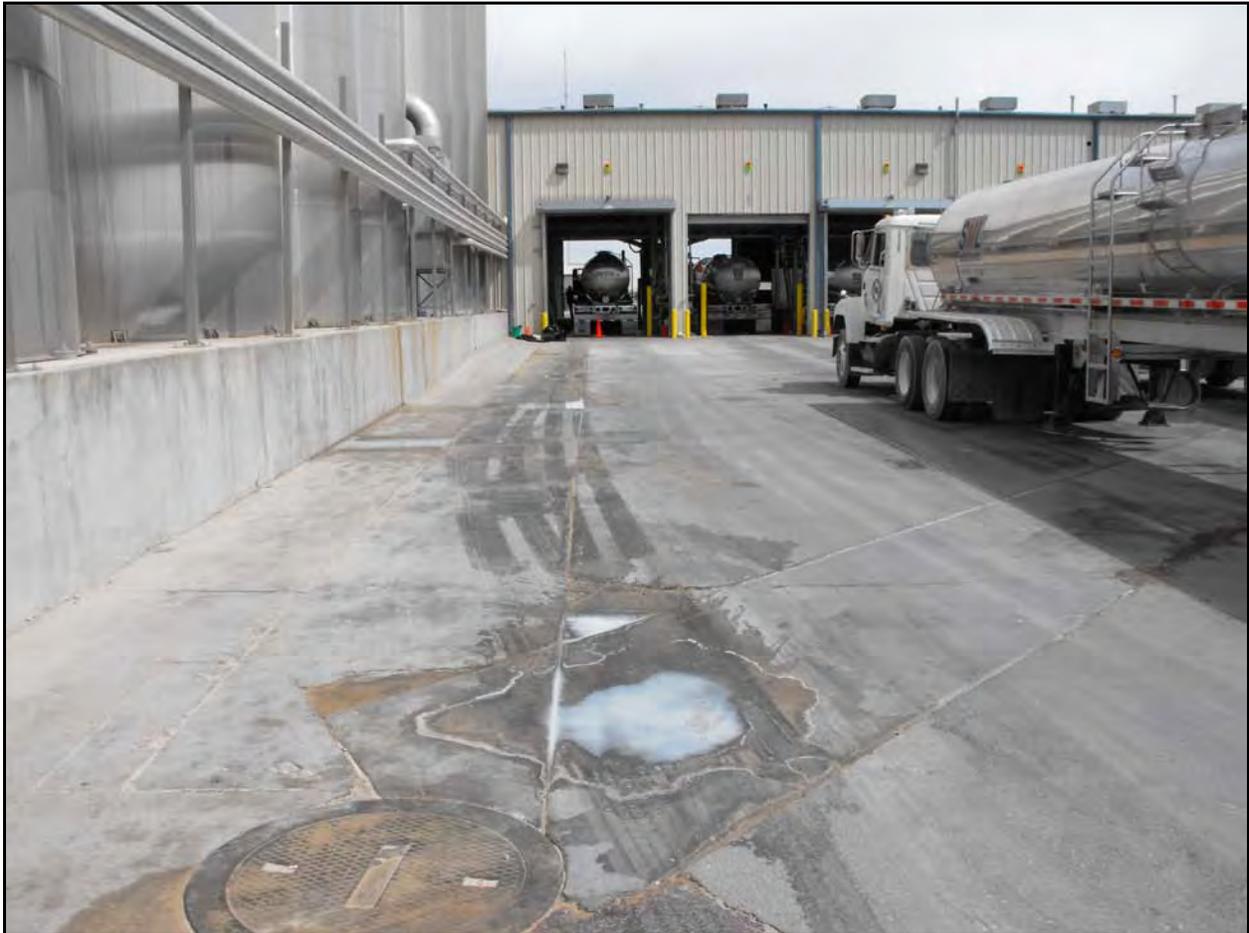
Photo # 2

Photographer: Daniel Valenta	Date: 4/26/2012	Time: 1043 hours
City/County: Portales/Roosevelt County		
Location: 1820 S. Industrial Drive, Portales, New Mexico, facing north.		
Subject: Unloading bays for the delivery of milk.
