RE: Construction Storm Water; SIC 1611; NPDES Compliance Evaluation Inspection; ENMR-Plateau Telecommunications Round II Broadband Project; NMU001794; May 14, 2012

NPDES Compliance Inspection Report

NPDES Construction Storm Water Compliance Evaluation Inspection
ENMR Telephone Cooperative, Inc. dba ENMR-Plateau
May 14, 2012

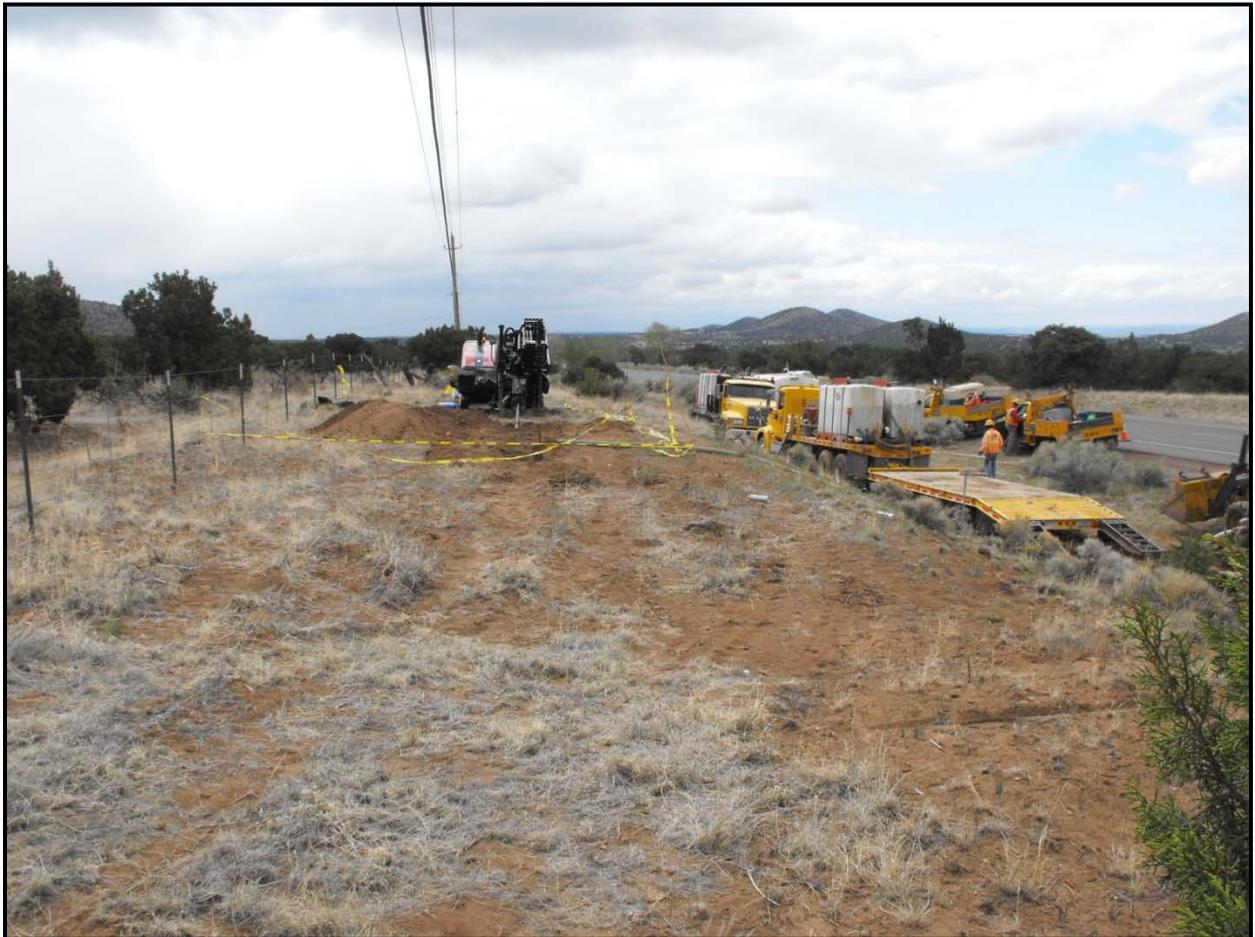
Photo # 1

Photographer: Daniel Valenta	Date: 5/14/2012	10:45 hours
City/County: East of Santa Fe on Old Vegas Hwy, west of Glorieta, NM/ Santa Fe County.		
Location: Near the intersection of Hwy 285/Bobcat Road/Old Vegas Hwy, facing east.		
Subject: Directional bore used at this site, surface trenching used when the ground is rocky.

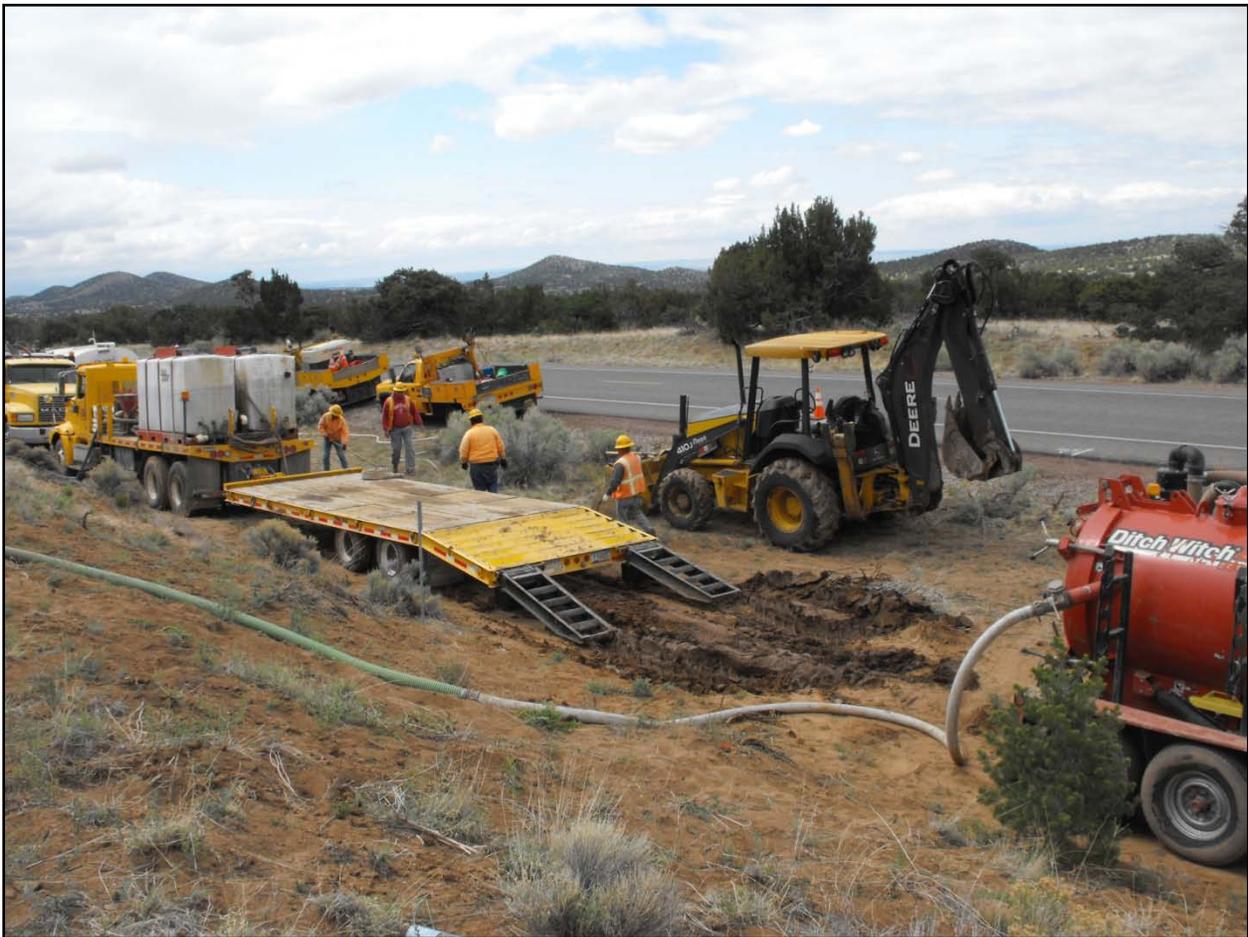
Photo # 2

Photographer: Daniel Valenta	Date: 5/14/2012	10:45 hours
City/County: East of Santa Fe on Old Vegas Hwy, west of Glorieta, NM/ Santa Fe County		
Location: Near the intersection of Hwy 285/Bobcat Road/Old Vegas Hwy, facing southeast.		
Subject: Disturbance footprint at this site.

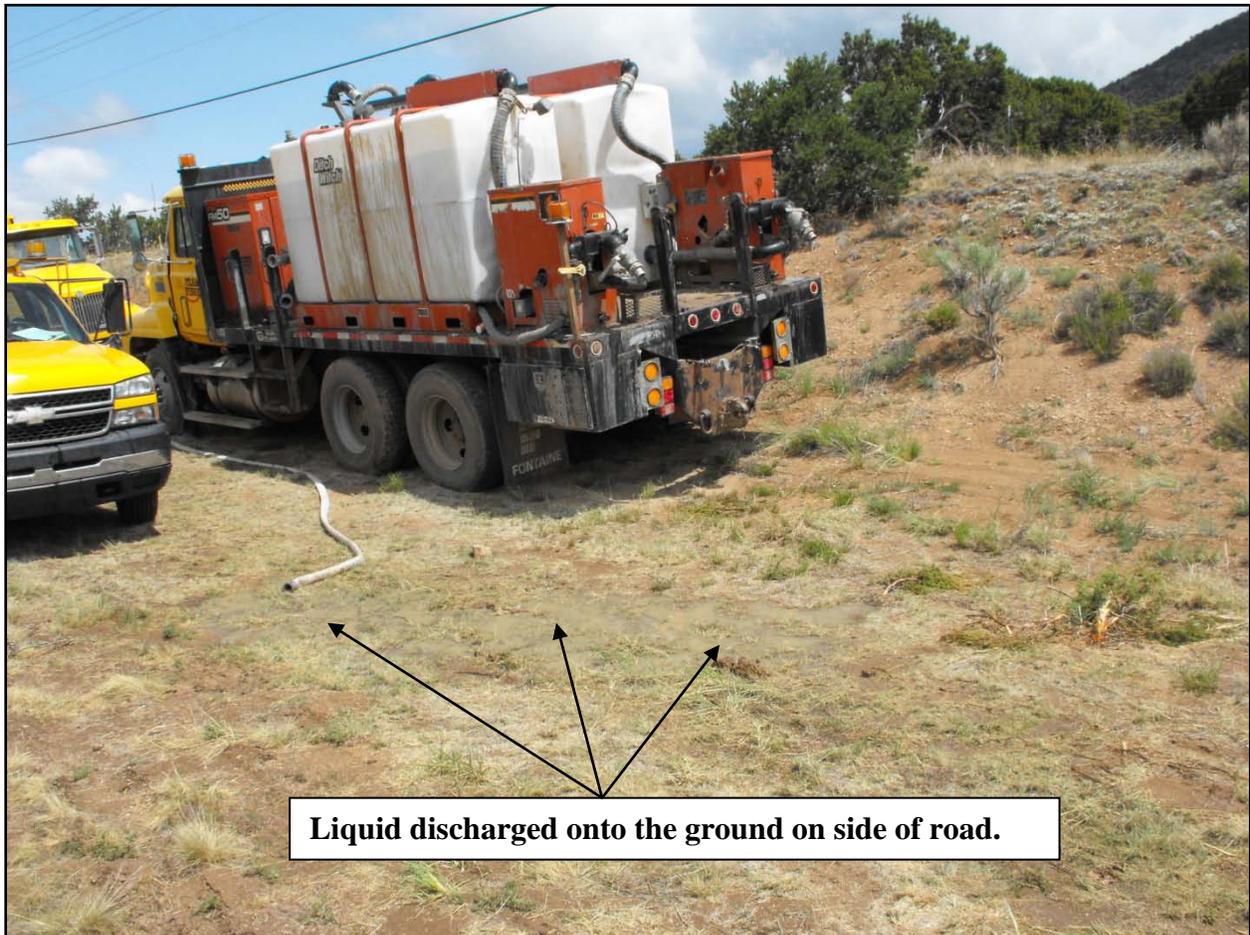
Photo # 3

Photographer: Daniel Valenta	Date: 5/14/2012	11:48 hours
City/County: East of Santa Fe on Old Vegas Hwy, west of Glorieta, NM/ Santa Fe County		
Location: Near the intersection of Hwy 285/Bobcat Road/Old Vegas Hwy, facing northwest.		
Subject: Unknown liquid discharge.
