**NEW MEXICO
ENVIRONMENT DEPARTMENT**

RE: Industrial Storm Water; SIC 2448; NPDES Compliance Evaluation Inspection; Riteway Pallet MFG Company; NPDES Permit NMU001806; October 3, 2012

NPDES Compliance Inspection Report

Riteway Pallet MFG Company
Compliance Evaluation Inspection – Industrial Stormwater
NPDES Permit NMU001806
October 3, 2012

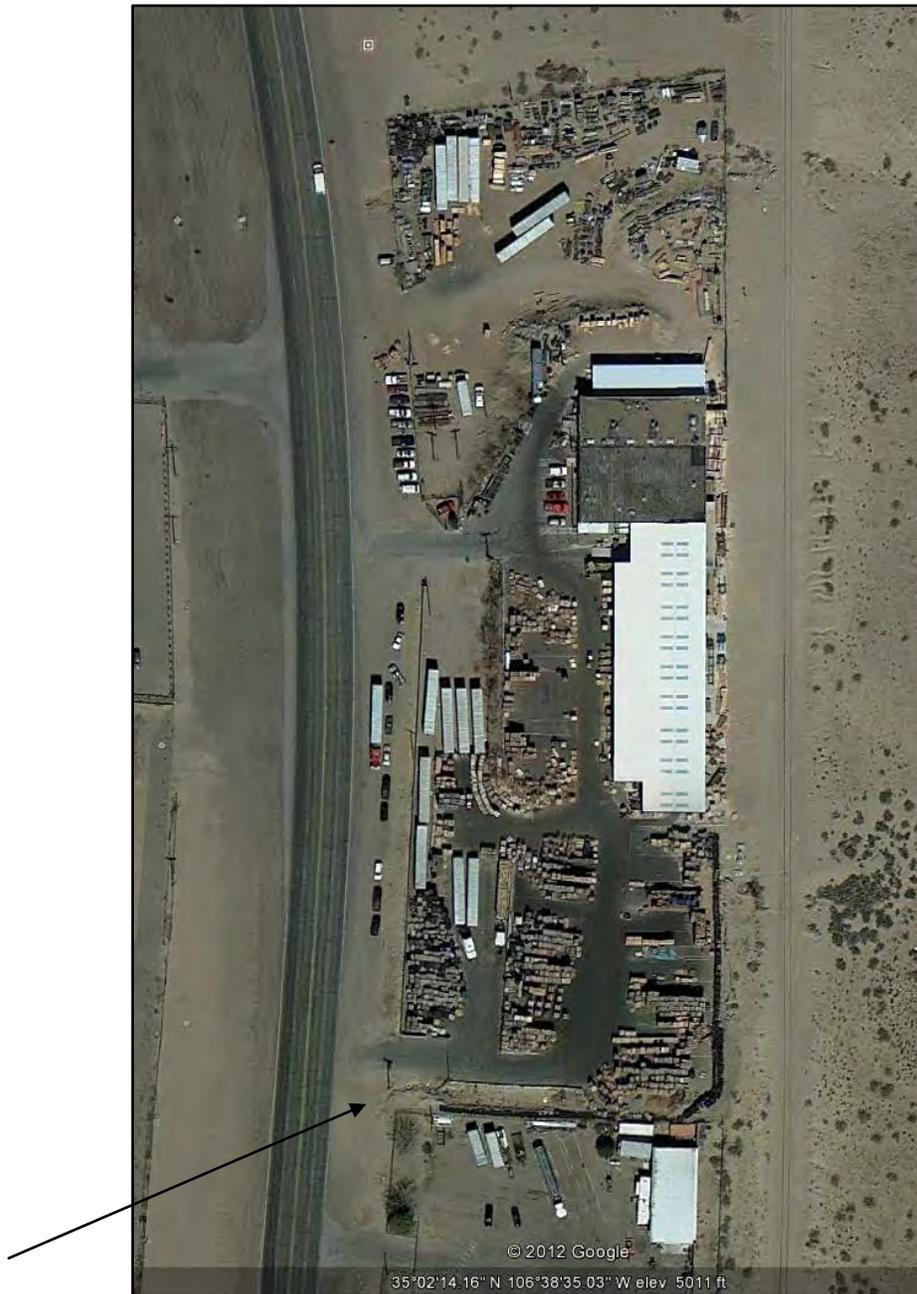
NMED/SWQB
Site Overview

City/County:	Albuquerque/Bernalillo	
Location:	3524 Broadway S. E., Albuquerque, New Mexico 87105.	
Subject:	Overview of Riteway Pallets MFG, Co. Inc. Discharge point in photos below.

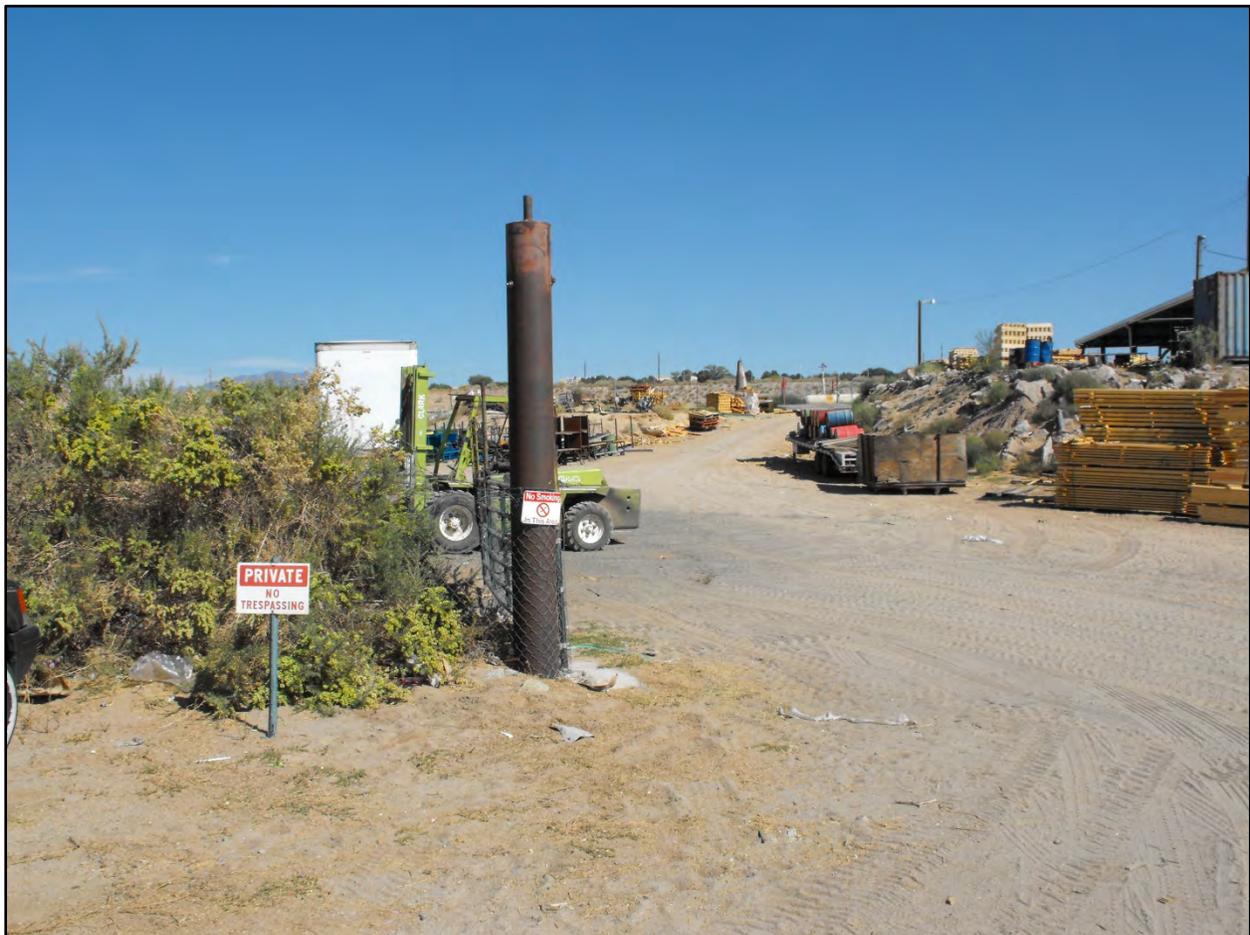
Photo # 1

Photographer: Daniel Valenta	Date: 10/3/2012	Time: 1421 hours
City/County: Albuquerque/Bernalillo		
Location: 3524 Broadway S. E., Albuquerque, New Mexico 87105, facing east.		
Subject: Raw lumber being brought in, oil containers, broken or salvage equipment.

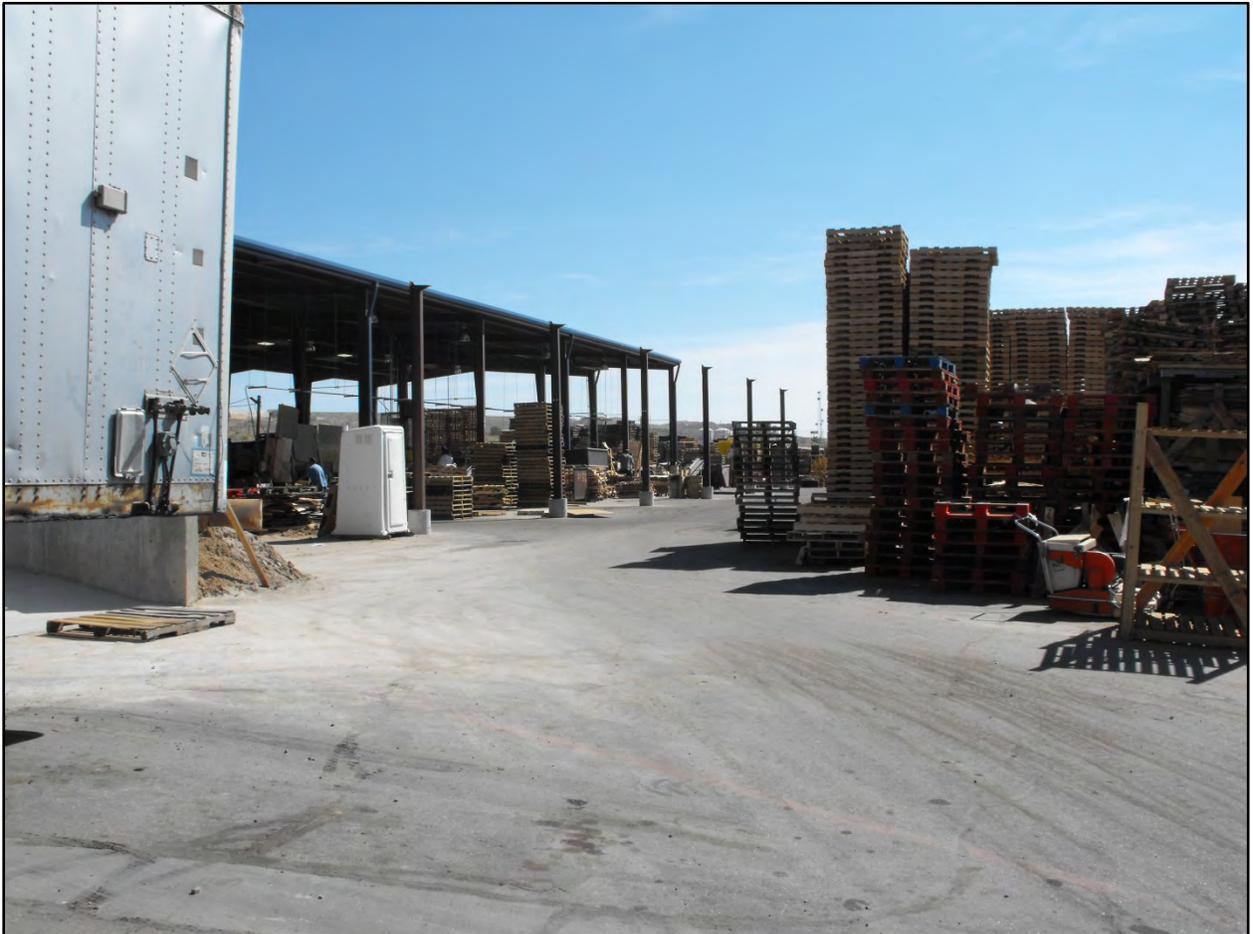
Photo # 2

Much of the facility's assembly process is outdoors, under a roof but exposed on the sides. Finished products and used pallets are stored outdoors (see photo 2-4). The site slopes from east to west, towards Broadway Blvd. On the west side is a raised railroad bed which acts as a barrier to stormwater flowing onto the property. Stormwater falling on the property flows to the east or southeast to discharge along Broadway Blvd, (see photo 3-5).

Photographer: Daniel Valenta	Date: 10/3/2012	Time: 1418 hours
City/County: Albuquerque/Bernalillo		
Location: 3524 Broadway S. E., Albuquerque, New Mexico 87105, facing south.		
Subject: Assemble line and storage of new/rebuilt pallets.

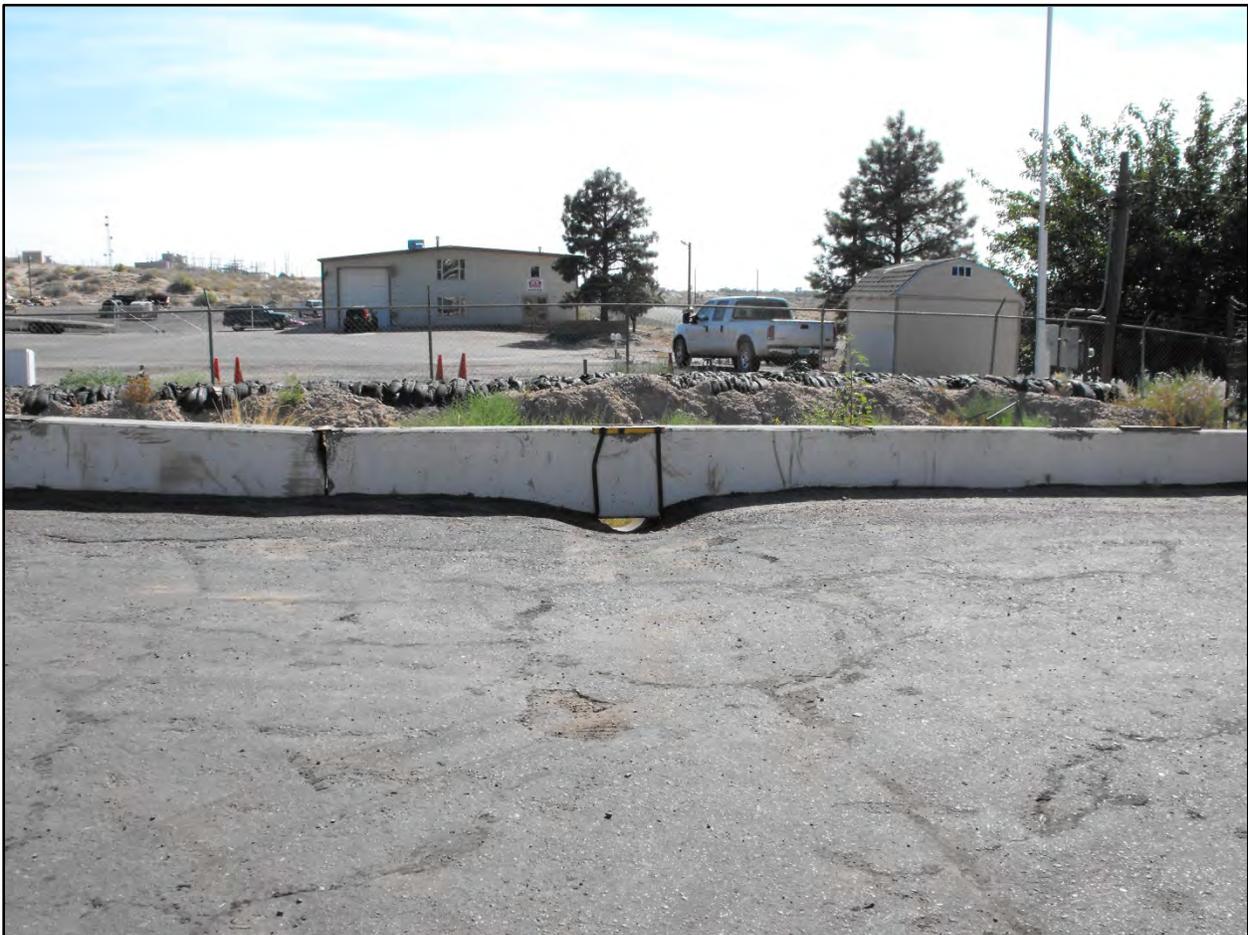
Photo # 3

Photographer: Daniel Valenta	Date: 10/3/2012	Time: 1434 hours
City/County: Albuquerque/Bernalillo		
Location :	3524 Broadway S. E., Albuquerque, New Mexico 87105, facing south.	
Subject:	South side of facility drains to this point to discharge to Broadway Blvd.

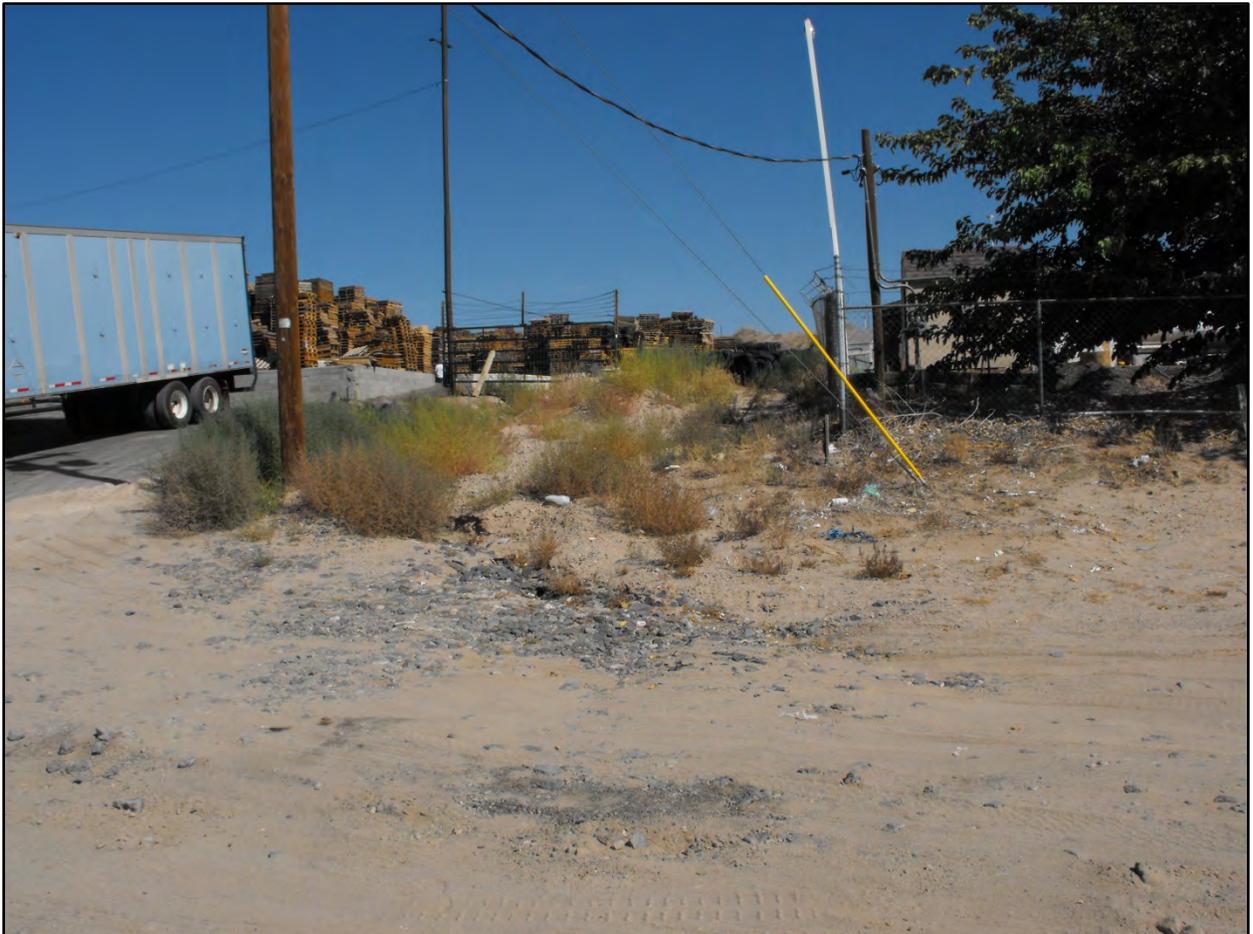
Photo # 4

Photographer: Daniel Valenta	Date: 10/3/2012	Time: 1437 hours
City/County: Albuquerque/Bernalillo		
Location: 3524 Broadway S. E., Albuquerque, New Mexico 87105, facing east.		
Subject: One discharge point onto Broadway Blvd from the site.

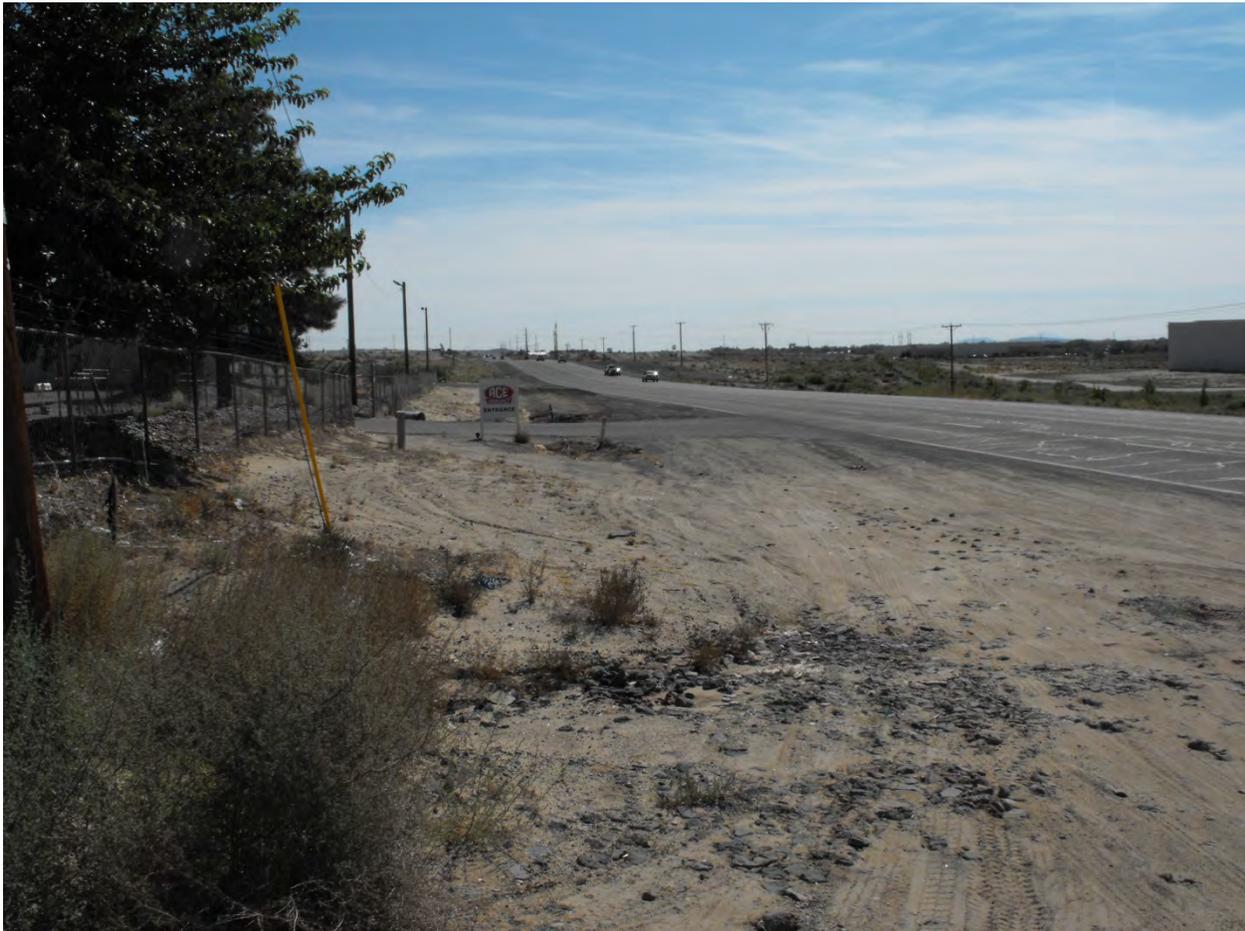
Photo # 5

Photographer: Daniel Valenta	Date: 10/3/2012	Time: 1122 hours
City/County: Albuquerque/Bernalillo		
Location:	4201 Williams SE, Albuquerque, New Mexico, facing northwest corner of property, facing south.	
Subject:	One discharge point onto Broadway Blvd from the site.
