**RE: Industrial Stormwater Inspection; SIC 3721; NPDES Compliance Evaluation Inspection; Southwest Block; NPDES Permit NMU001809 ; October 17, 2012**

**Southwest Block**  
**NPDES Compliance Evaluation Inspection**  
**NPDES Permit NMU001809**  
**Inspection Date: October 17, 2012**

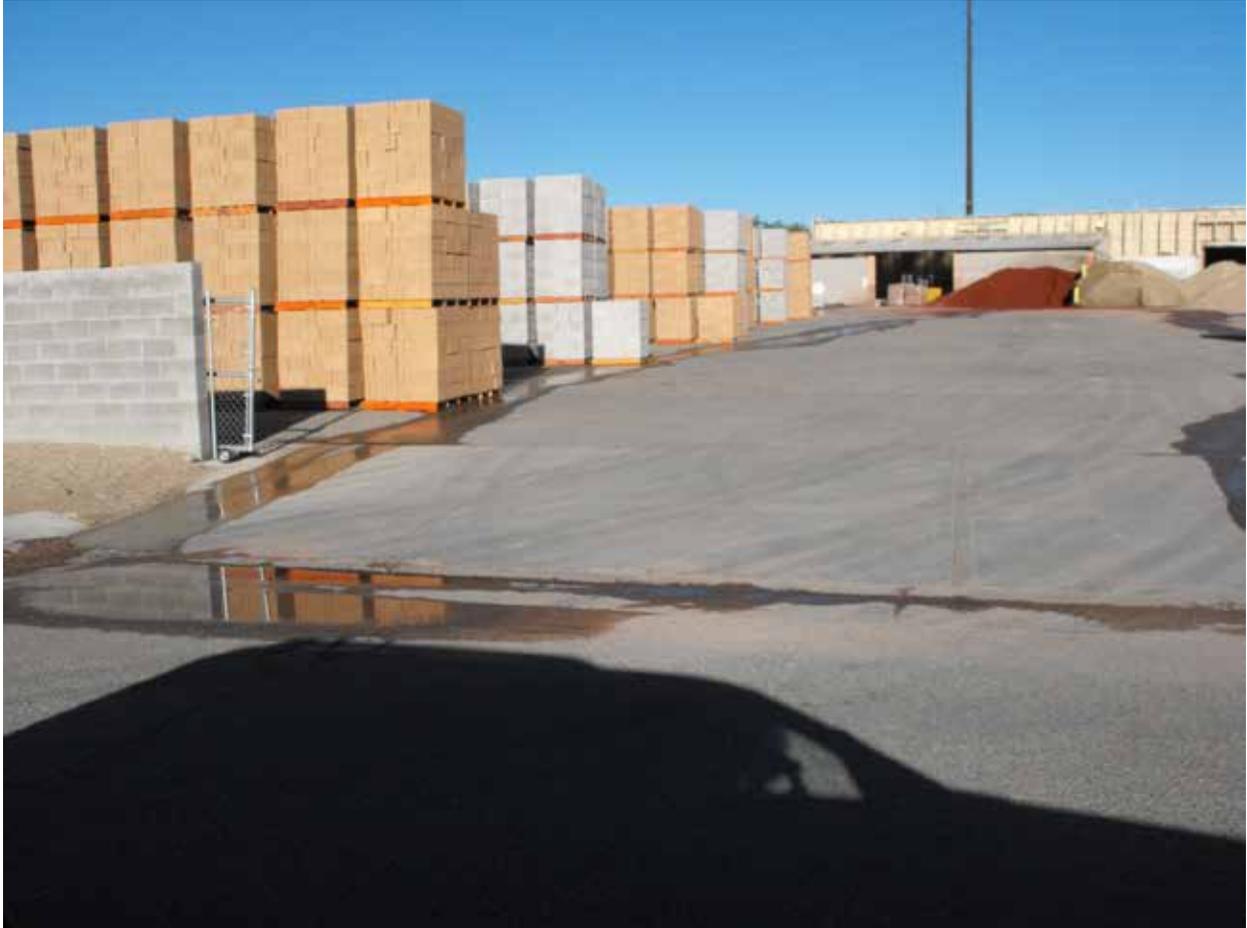
NMED/SWQB  
Official Photograph Log  
Photo #1

Photographer: Daniel Valenta	Date: October 17, 2012	Time: 0905 Hours
City/County: Albuquerque / Sandoval		
Location: Southwest Block, 136 Rio Rancho Blvd., Rio Rancho, NM		
Subject: East side of Southwest Block. Photograph taken from public access road prior to entrance interview.

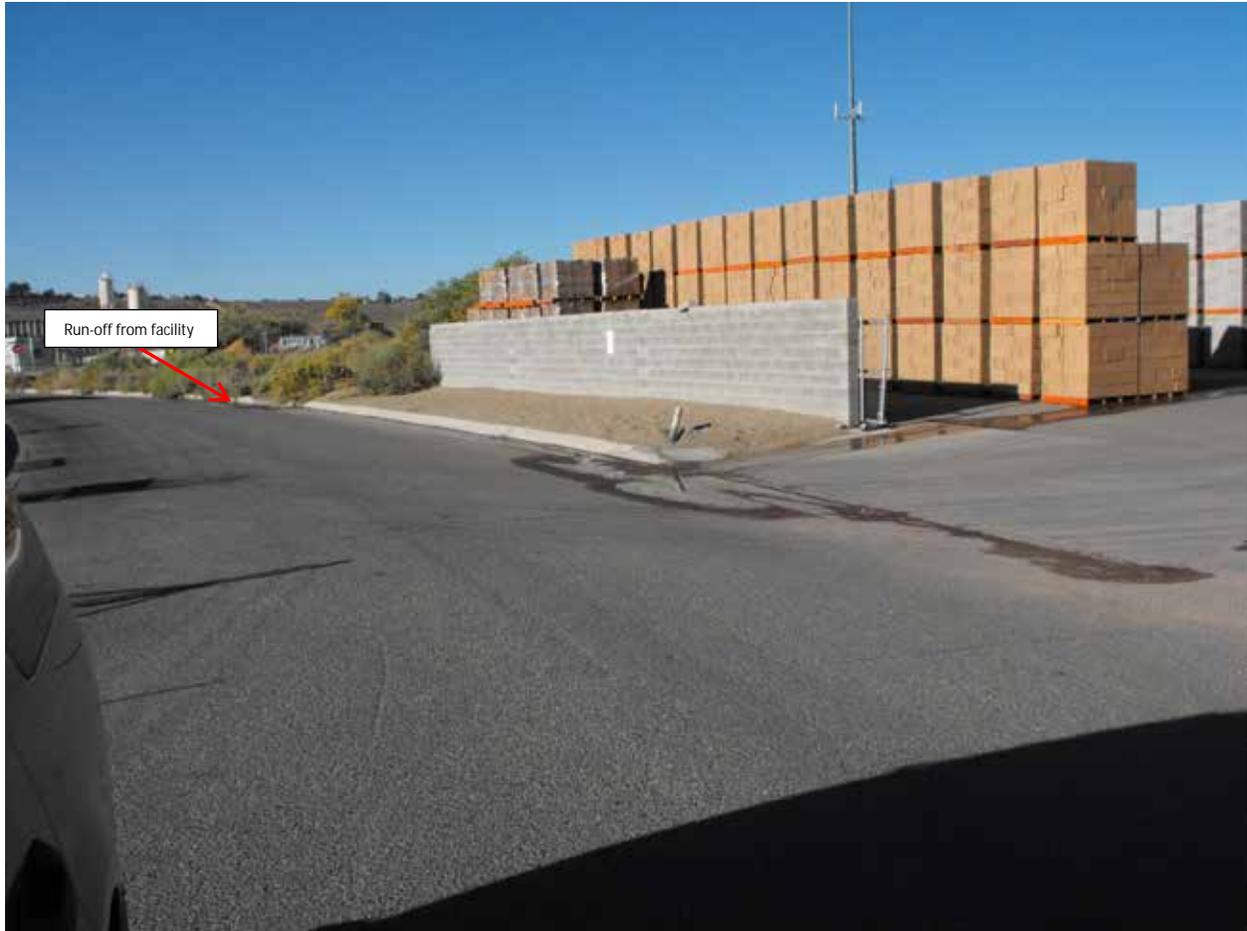
NMED/SWQB  
Official Photograph Log  
Photo #2

Photographer: Daniel Valenta	Date: October 17, 2012	Time: 0906 Hours
City/County: Albuquerque / Sandoval		
Location: Utility Block, 136 Rio Rancho Blvd., Rio Rancho, NM		
Subject: East side of facility. Photograph taken prior to entrance interview from public access road.

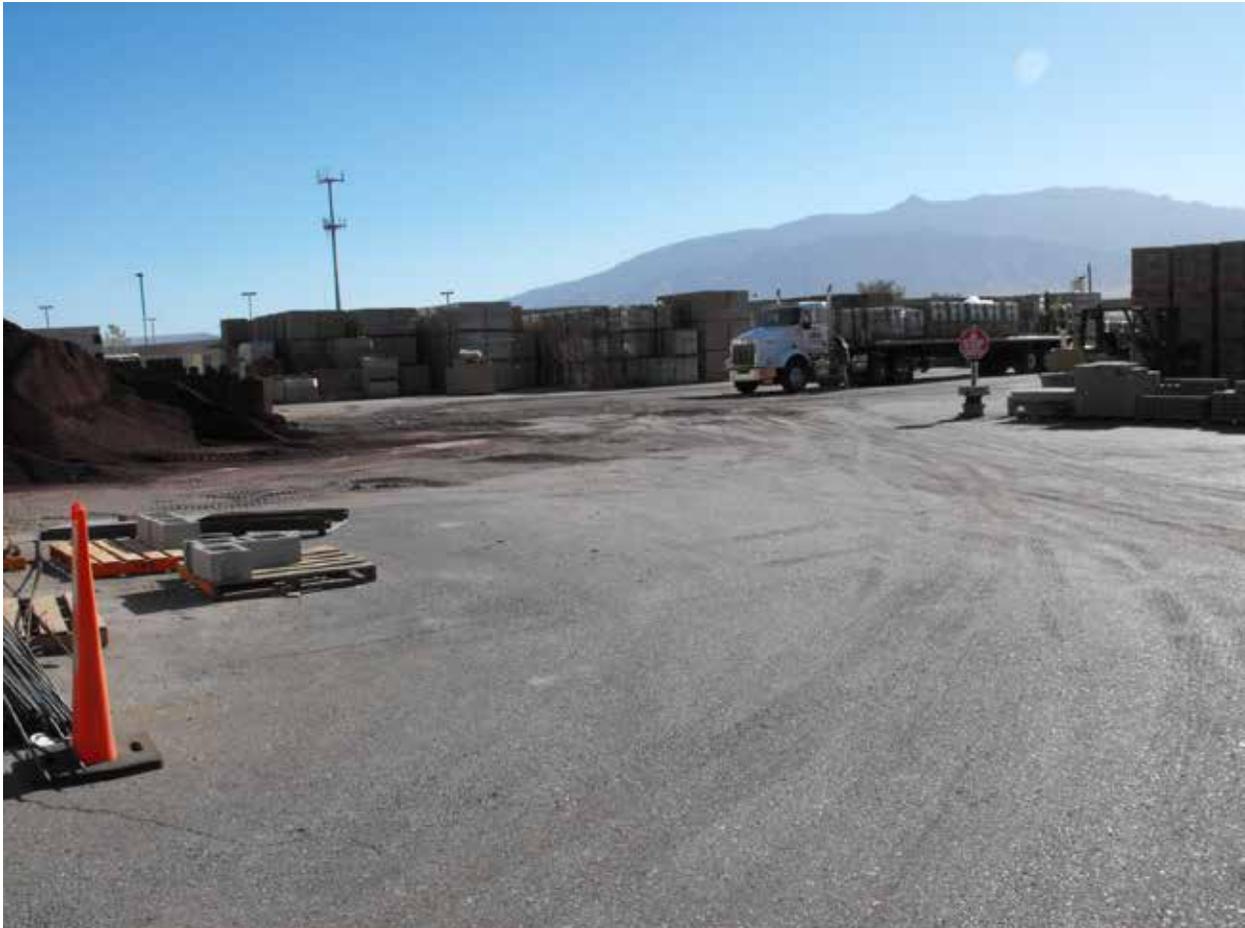
NMED/SWQB  
Official Photograph Log  
Photo #3

Photographer: Daniel Valenta	Date: October 17, 2012	Time: 0945 Hours
City/County: Rio Rancho / Sandoval		
Location: Southwest Block		
Subject: Overview of site, facing north

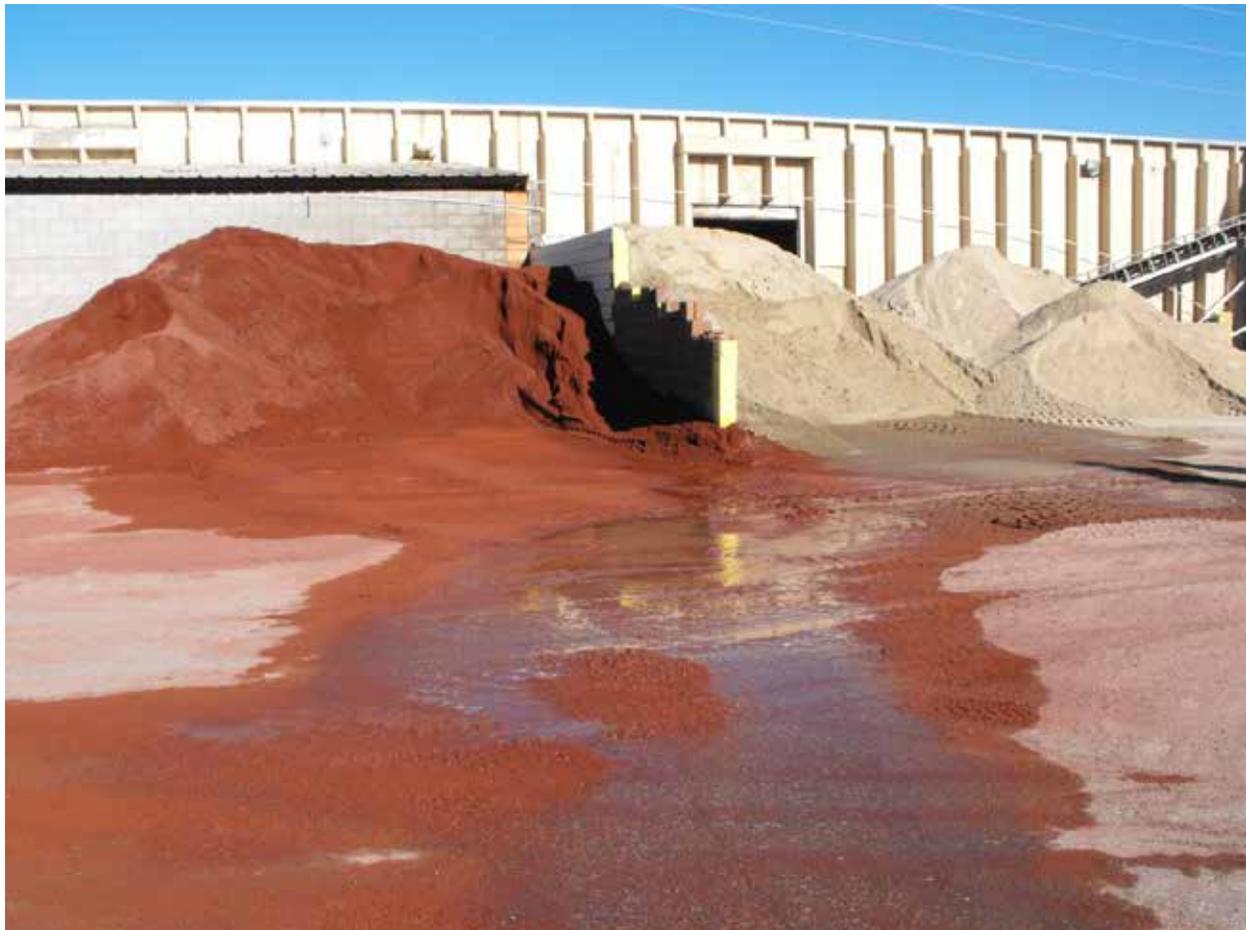
NMED/SWQB  
Official Photograph Log  
Photo #4

Photographer: Daniel Valenta	Date: October 17, 2012	Time: 0946 Hours
City/County: Rio Rancho / Sandoval		
Location: Southwest Block		
Subject: Stockpiles of raw materials. One source of runoff.
