**RE: Industrial Stormwater Inspection; SIC 3441; NPDES Compliance Evaluation
Inspection; Santa Fe Steel; NPDES Permit NMU001823 ; November 21, 2012**

NPDES Compliance Inspection Report

Santa Fe Steel
NPDES Compliance Evaluation Inspection
NPDES Permit No. NMU001823
Inspection Date: November 21, 2012

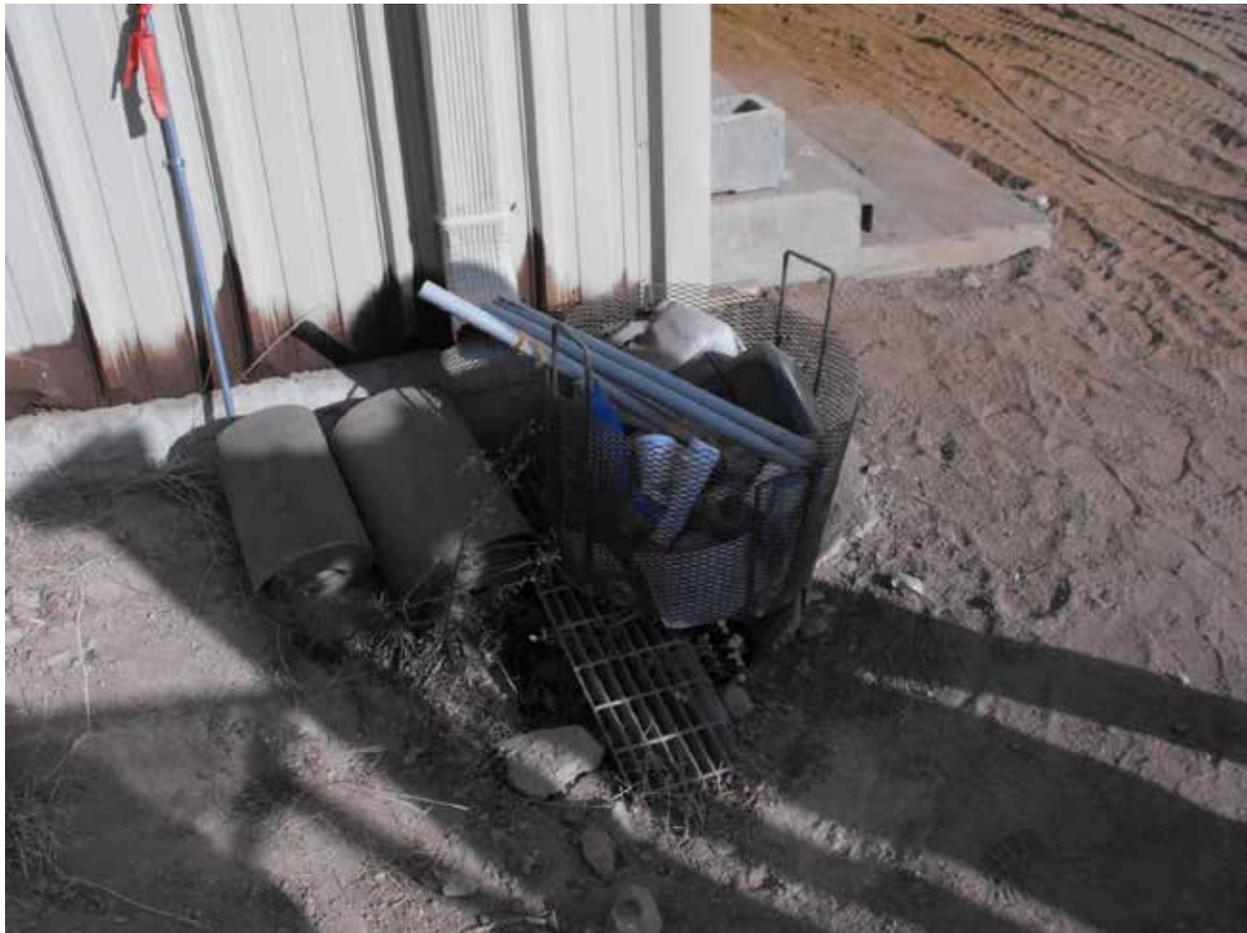
New Mexico Environment Department/Surface Water Quality Bureau
Official Photo Log
Photo #1

Photographer: Daniel Valenta	Date: November 21, 2012	Time: 1032 Hours
City/County: Santa Fe/Santa Fe		
Location: Santa Fe Steel		
Subject: Oil containers and debris piled up on stormwater collection inlet (pipe crosses underneath road to unknown discharge point outside of property – unable to locate outlet due to overgrowth of brush)

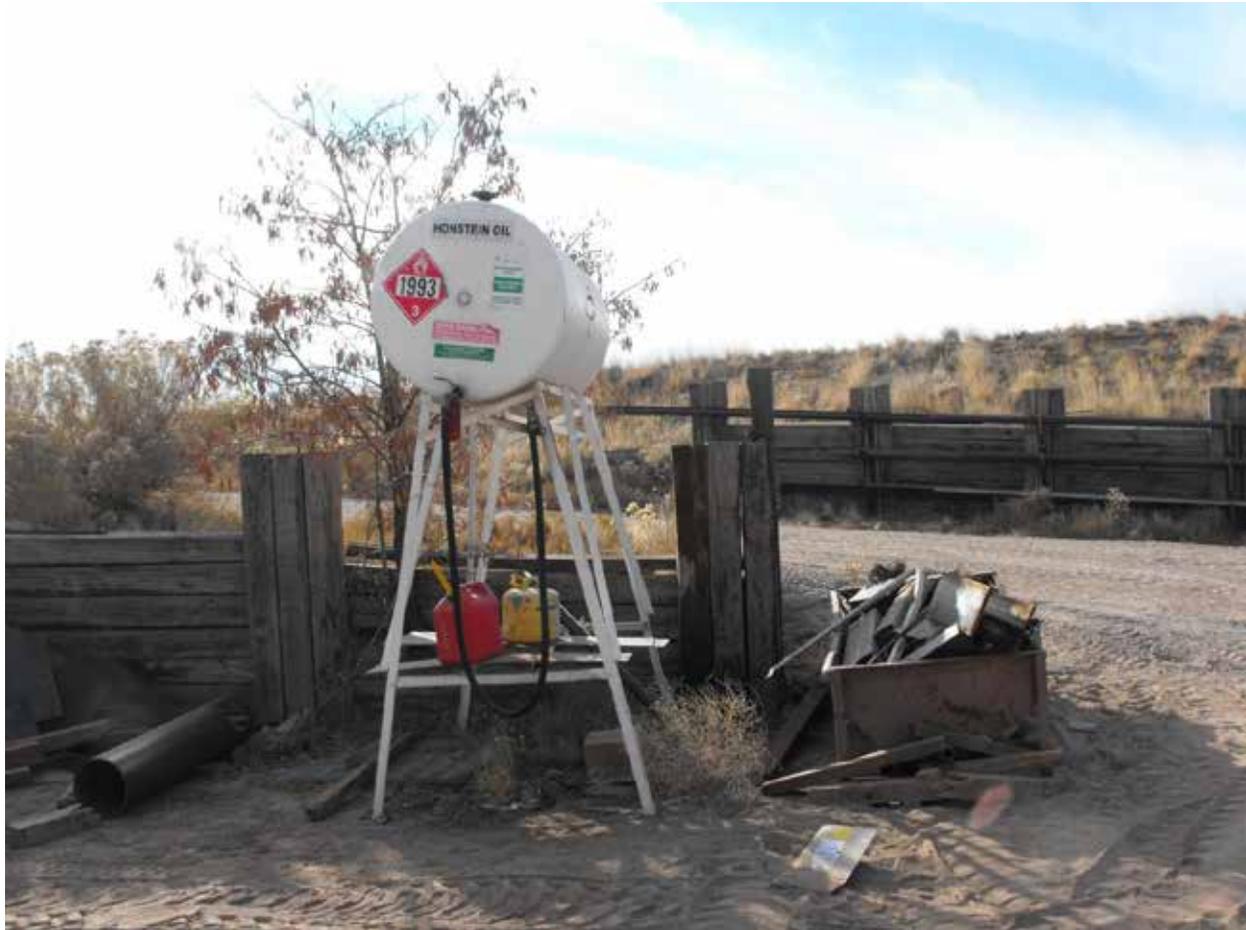
New Mexico Environment Department/Surface Water Quality Bureau
Official Photo Log
Photo #2

Photographer: Daniel Valenta	Date: November 21, 2012	Time: 1036 Hours
City/County: Santa Fe/Santa Fe		
Location: Santa Fe Steel		
Subject: Diesel Fuel Tank with no secondary containment

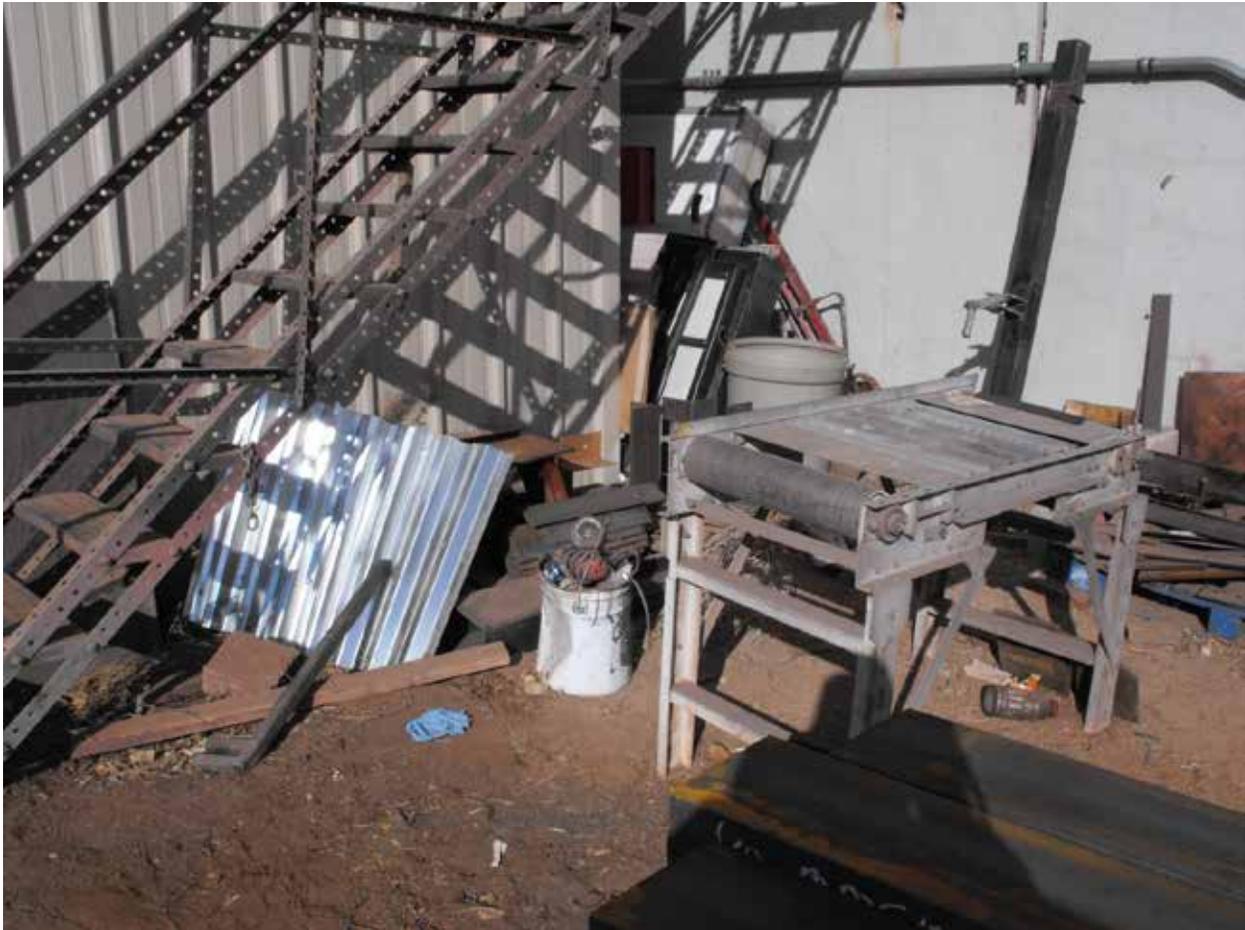
New Mexico Environment Department/Surface Water Quality Bureau
Official Photo Log
Photo #3

Photographer: Daniel Valenta	Date: November 21, 2012	Time: 1034Hours
City/County: Santa Fe/Santa Fe		
Location: Santa Fe Steel		
Subject: Miscellaneous scrap metal stored outside of workshop.

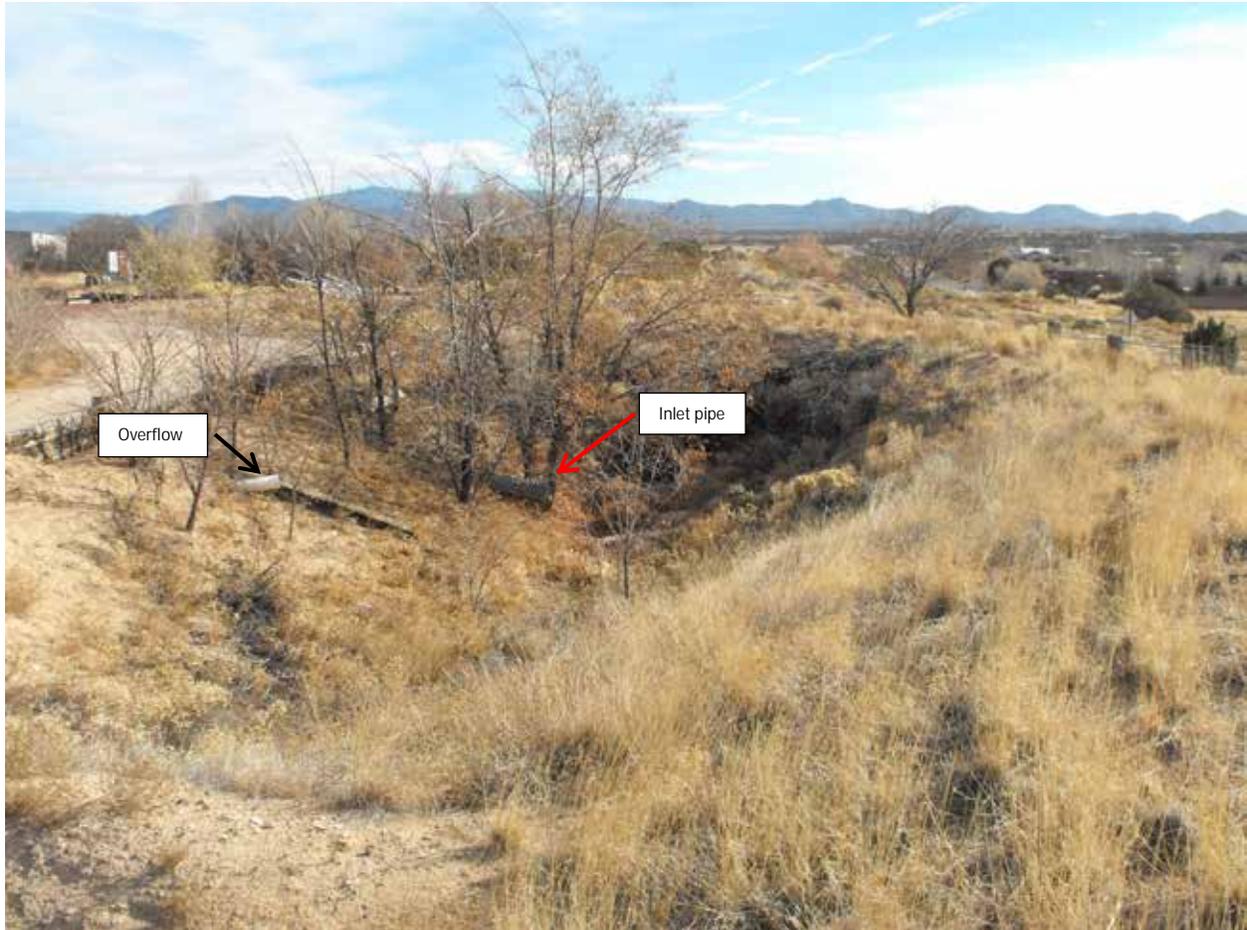
New Mexico Environment Department/Surface Water Quality Bureau
Official Photo Log
Photo #4

Photographer: Daniel Valenta	Date: November 21, 2012	Time: 1047 Hours
City/County: Santa Fe/Santa Fe		
Location: Santa Fe Steel		
Subject: Retention pond (18" inlet, 12" overflow, which enters stormwater collection inlet in Photo #1; 12,500 cu.ft. capacity)

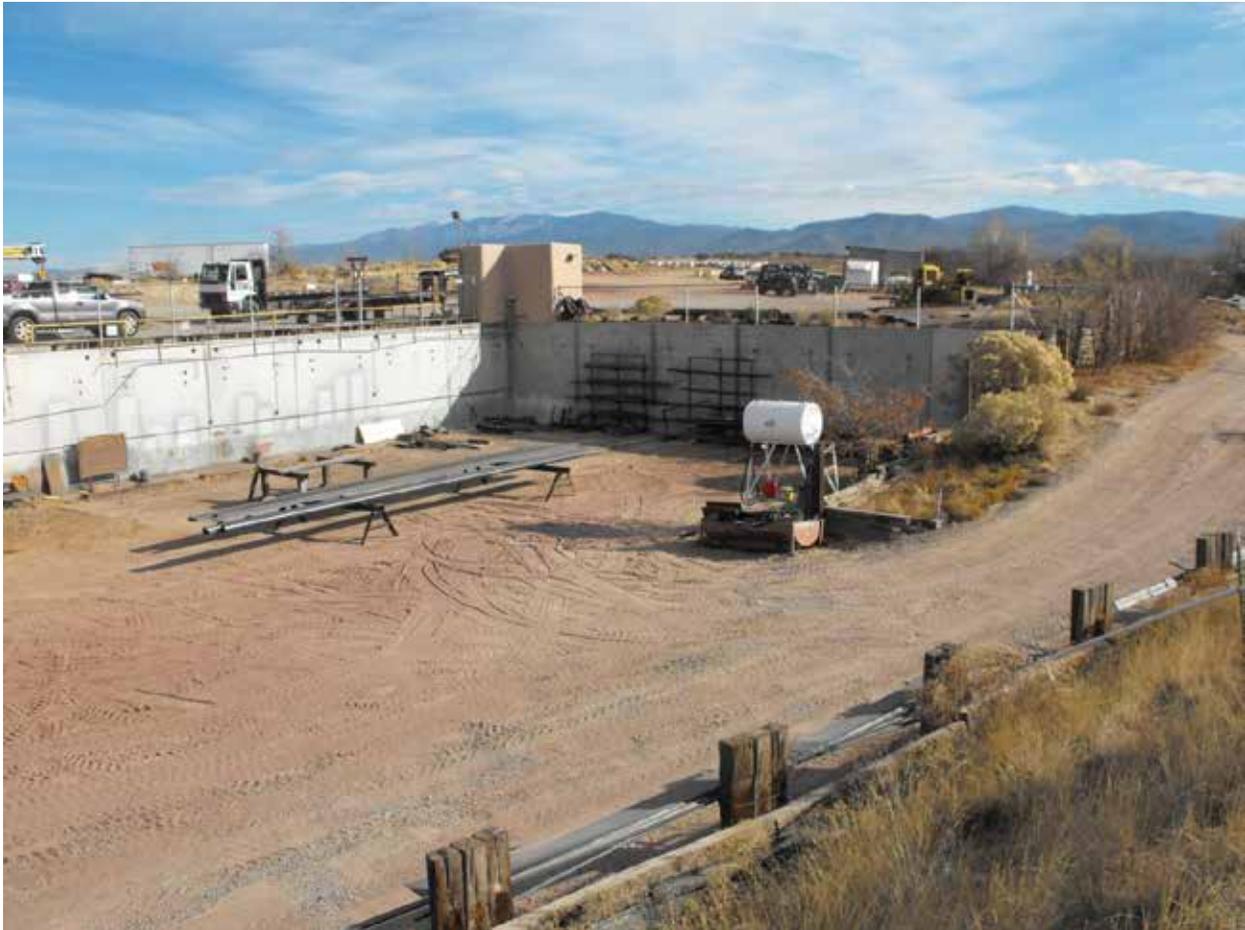
New Mexico Environment Department/Surface Water Quality Bureau
Official Photo Log
Photo #5

Photographer: Daniel Valenta	Date: November 21, 2012	Time: 1046 Hours
City/County: Santa Fe/Santa Fe		
Location: Santa Fe Steel		
Subject: Overview of site
