NEW MEXICO
ENVIRONMENT DEPARTMENT

RE: Industrial Stormwater Inspection; SIC 2099; NPDES Compliance Evaluation Inspection; Santa Fe Tortilla Company, LLC; NPDES Permit NMU001826; November 29, 2012

NPDES Compliance Inspection Report

Santa Fe Tortilla Company
NPDES Compliance Evaluation Inspection
NPDES Permit NMU001826
Inspection Date: November 29, 2012

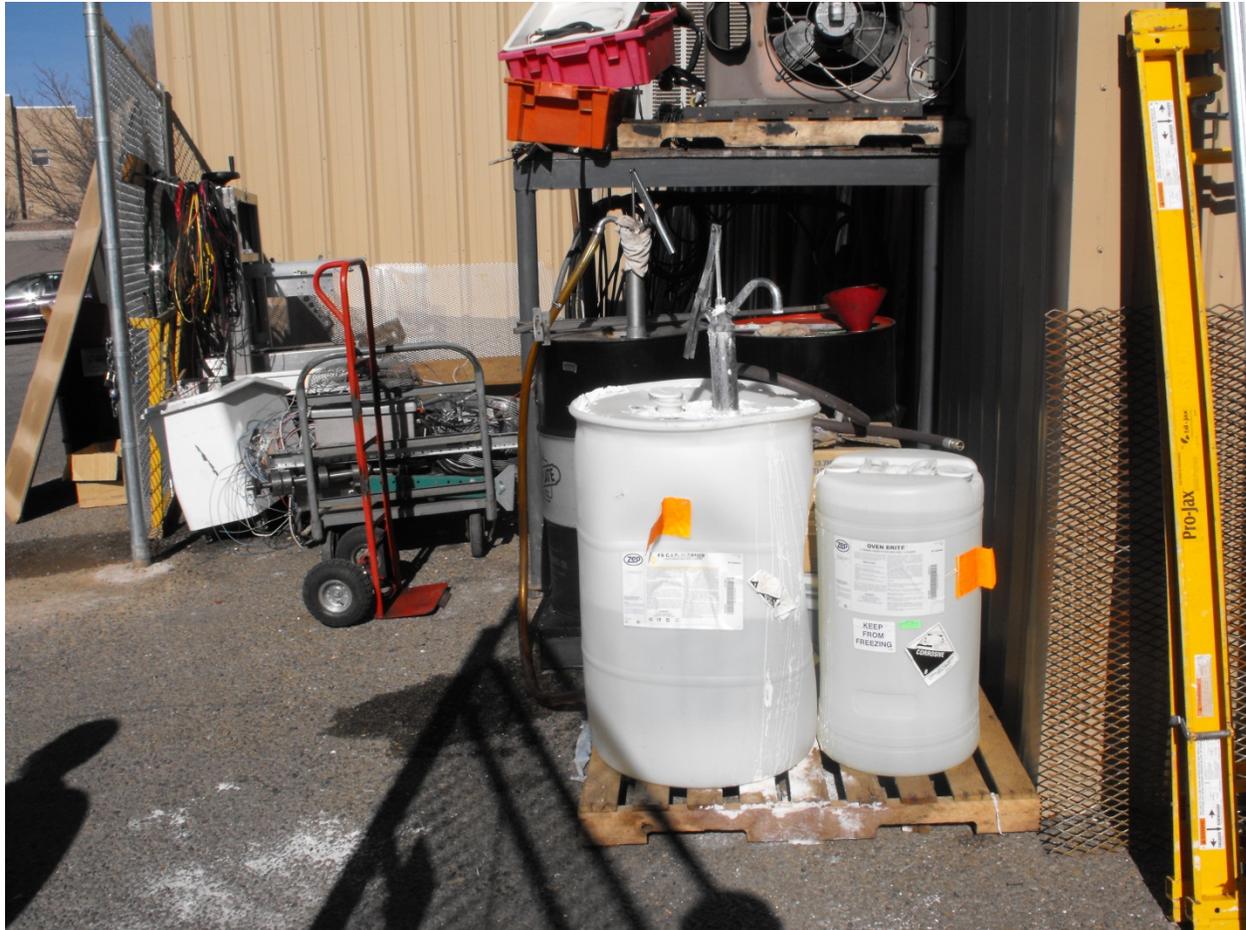
New Mexico Environment Department/Surface Water Quality Bureau
Official Photo Log
Photo #1

Photographer: Daniel Valenta	Date: November 29, 2012	Time: 1137 Hours
City/County: Santa Fe/Santa Fe		
Location: Santa Fe Tortilla Company		
Subject: Oven Cleaner, ZEP CIP Cleaner and Lubriplate containers stored outdoors. Please note the staining from both the lubriplate as well as the ZEP CIP cleaner.

Your facility does not have permit coverage for the industrial activities associated with the food preparation industry. You are encouraged to review the permit, complete your SWPPP and apply for coverage under the eNOI system.

ZEP CIP Cleaner is classified as a hazardous waste and contains sodium hydroxide and potassium hydroxide. Each of these is caustic with a pH of 13-14. Its aquatic ecotoxicity is known to be acute LC50 25 ppm for trout with an exposure time of 24 hours and for other fish it is acute LC50 179 mg/L with an exposure time of 96 hours. Disposal of such waste must be in accordance with federal, state, and local environmental regulations.

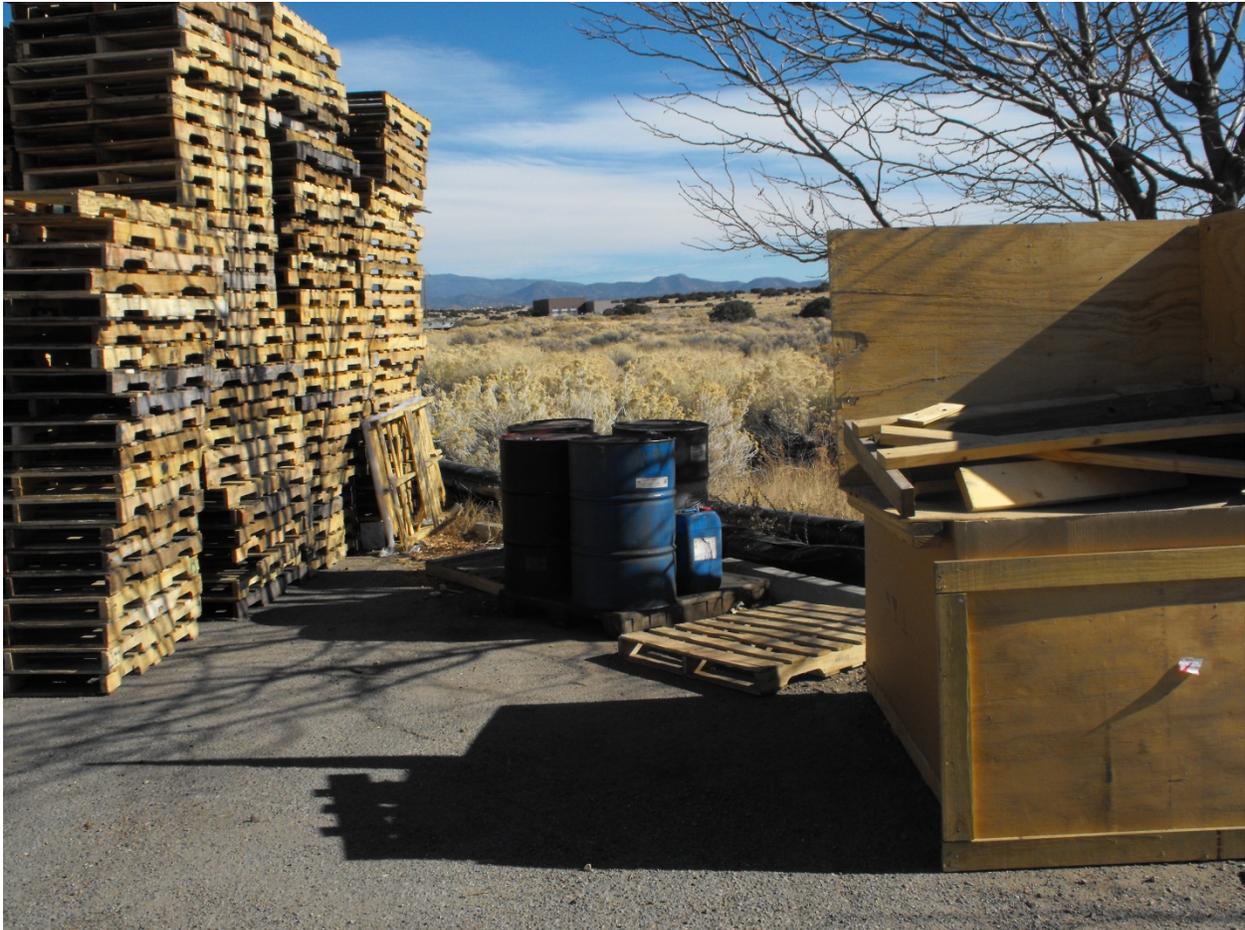
New Mexico Environment Department/Surface Water Quality Bureau
Official Photo Log
Photo #2

Photographer: Daniel Valenta	Date: November 29, 2012	Time: 1139 Hours
City/County: Santa Fe/Santa Fe		
Location: Santa Fe Tortilla Company		
Subject: Hydraulic lubricants stored outdoors.

Mr. Kalfin communicated to the inspectors during the introductions that there were no pollutants stored outdoors or exposed to precipitation. During the facility tour, it was noted that there were numerous 55-gallon barrels of what appeared to be used hydraulic fluid (empty containers with residue and no caps) as well as oven cleaner and ZEP CIP cleaner exposed to precipitation.

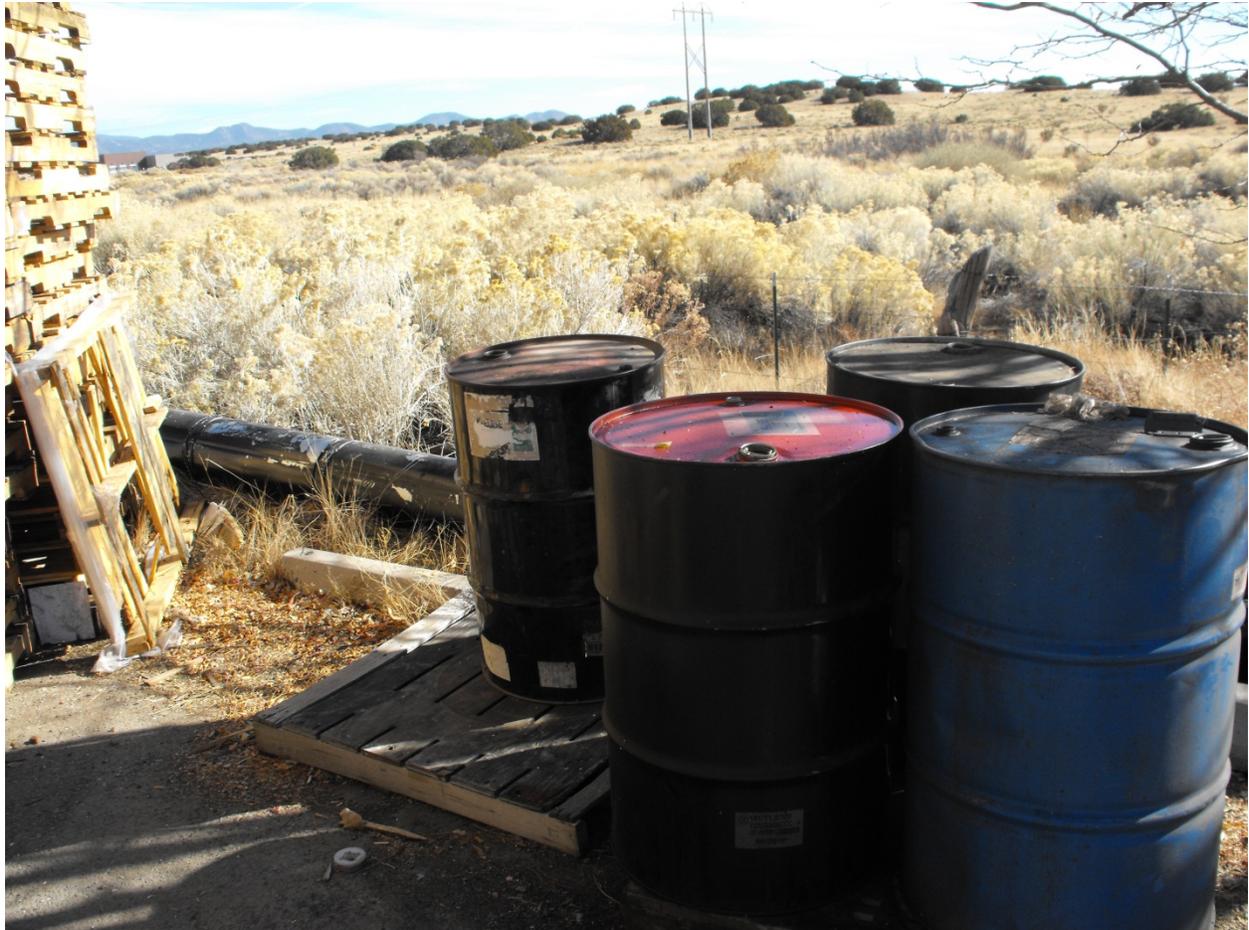
New Mexico Environment Department/Surface Water Quality Bureau
Official Photo Log
Photo #3

Photographer: Daniel Valenta	Date: November 29, 2012	Time: 1140 Hours
City/County: Santa Fe/Santa Fe		
Location: Santa Fe Tortilla Company		
Subject: Close up view of hydraulic lubricants stored outdoors with no caps.

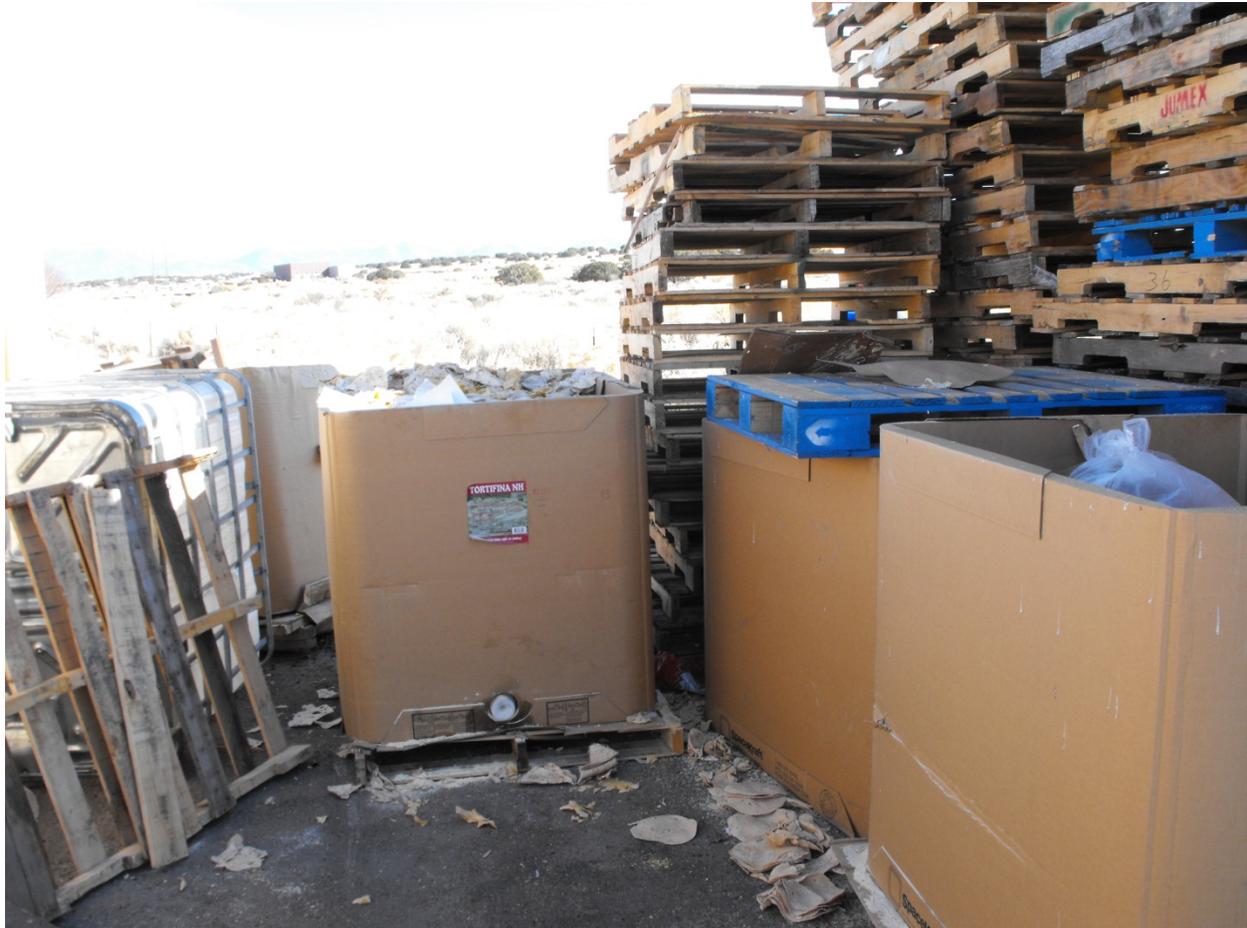
New Mexico Environment Department/Surface Water Quality Bureau
Official Photo Log
Photo #4

Photographer: Daniel Valenta	Date: November 29, 2012	Time: 1140 Hours
City/County: Santa Fe/Santa Fe		
Location: Santa Fe Tortilla Company		
Subject: Open bins of tortillas. Please note tortillas on the pavement.

There were also bins of flour tortillas as well as tortilla chips seen, uncovered. Mr. Terrones stated that these were removed daily and placed into covered dumpsters. There were also tortillas and tortilla chips seen on the ground, which did not appear to be placed into dumpsters.

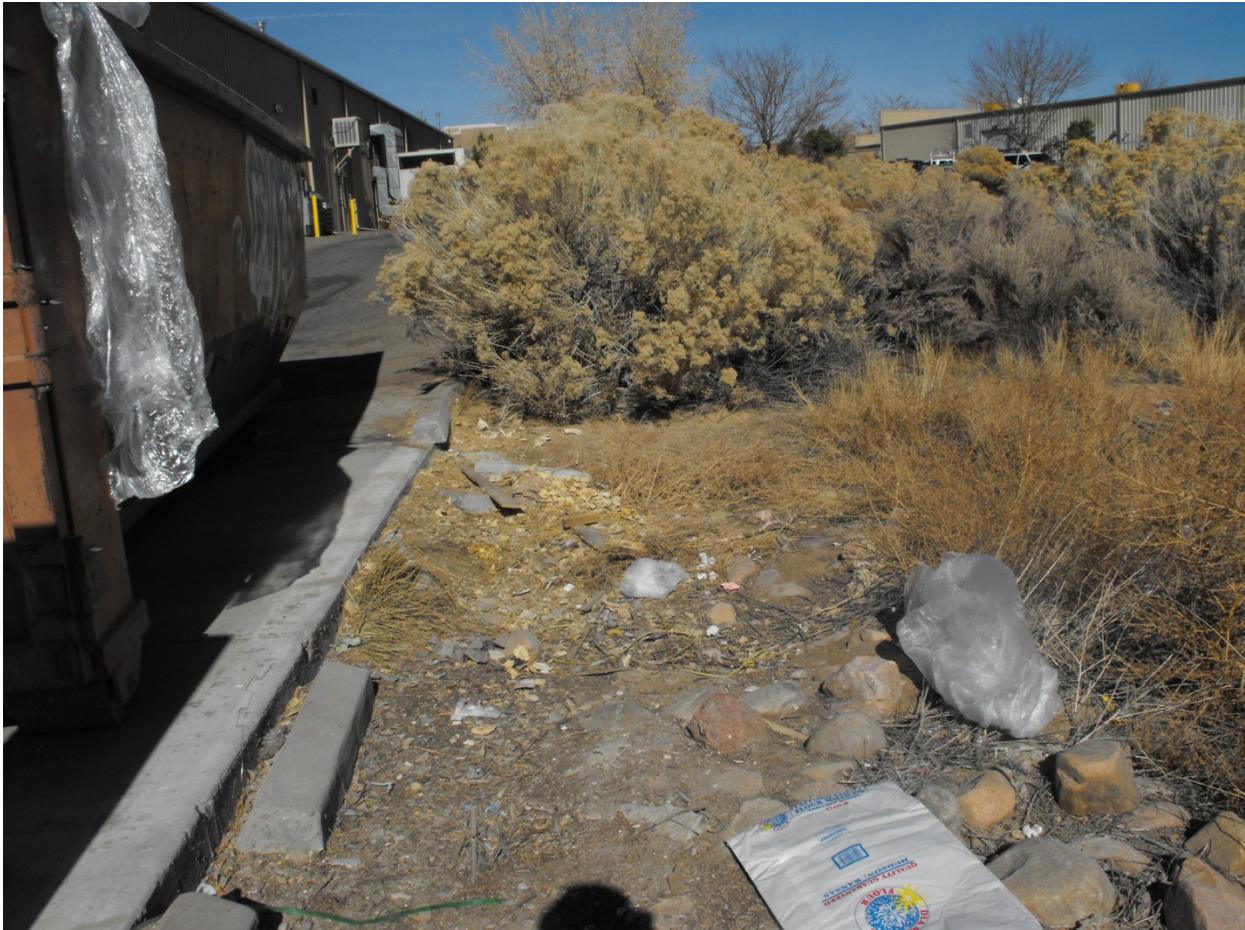
New Mexico Environment Department/Surface Water Quality Bureau
Official Photo Log
Photo #5

Photographer: Daniel Valenta	Date: November 29, 2012	Time: Hours
City/County: Santa Fe/Santa Fe		
Location: Santa Fe Tortilla Company		
Subject: Corn tortilla chips on the ground.

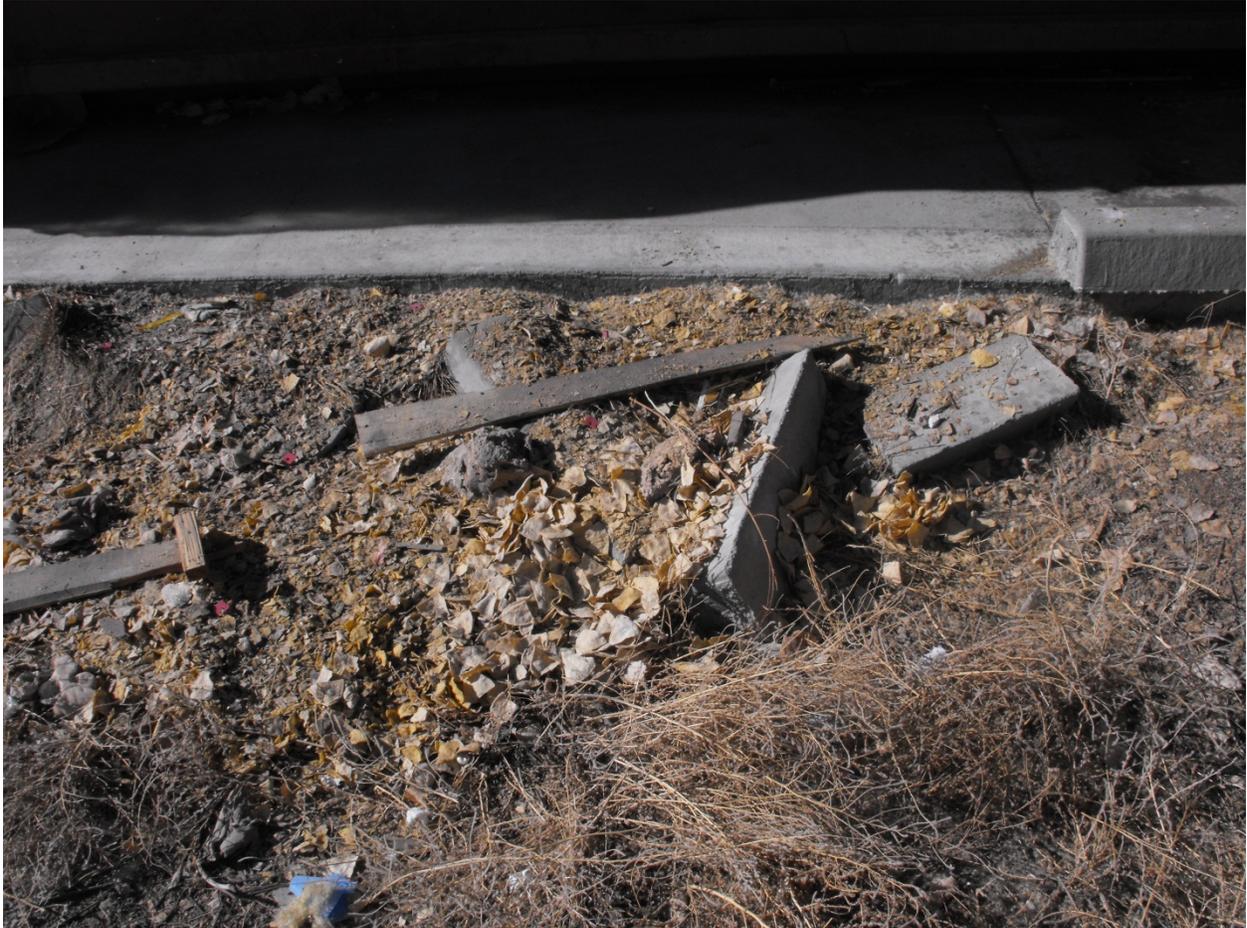
New Mexico Environment Department/Surface Water Quality Bureau
Official Photo Log
Photo #6

Photographer: Daniel Valenta	Date: November 29, 2012	Time: Hours
City/County: Santa Fe/Santa Fe		
Location: Santa Fe Tortilla Company		
Subject: Close up of corn tortilla chips.
