**RE: Industrial Storm Water; SIC 3441; NPDES Compliance Evaluation Inspection; Phat Steel Inc.;  
NPDES Permit NMU001836; January 9, 2013**

### NPDES Compliance Inspection Report

**Phat Steel Inc.**  
**NPDES Compliance Evaluation**  
**Inspection NMU001836**  
**January 9, 2013**

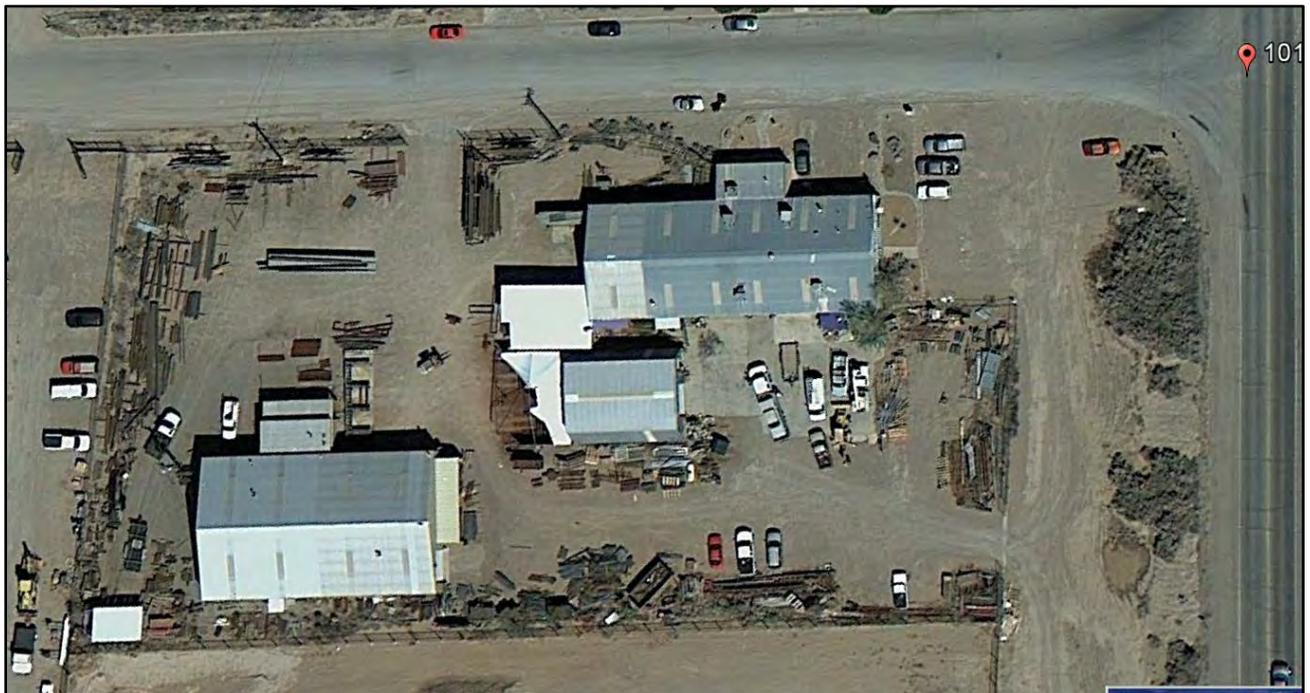
**NMED/SWQB  
Site Overview**

City/County: Bernalillo/Sandoval County		
Location: 101 Calle Industrial, Bernalillo, New Mexico		
Subject: Phat Steel facility

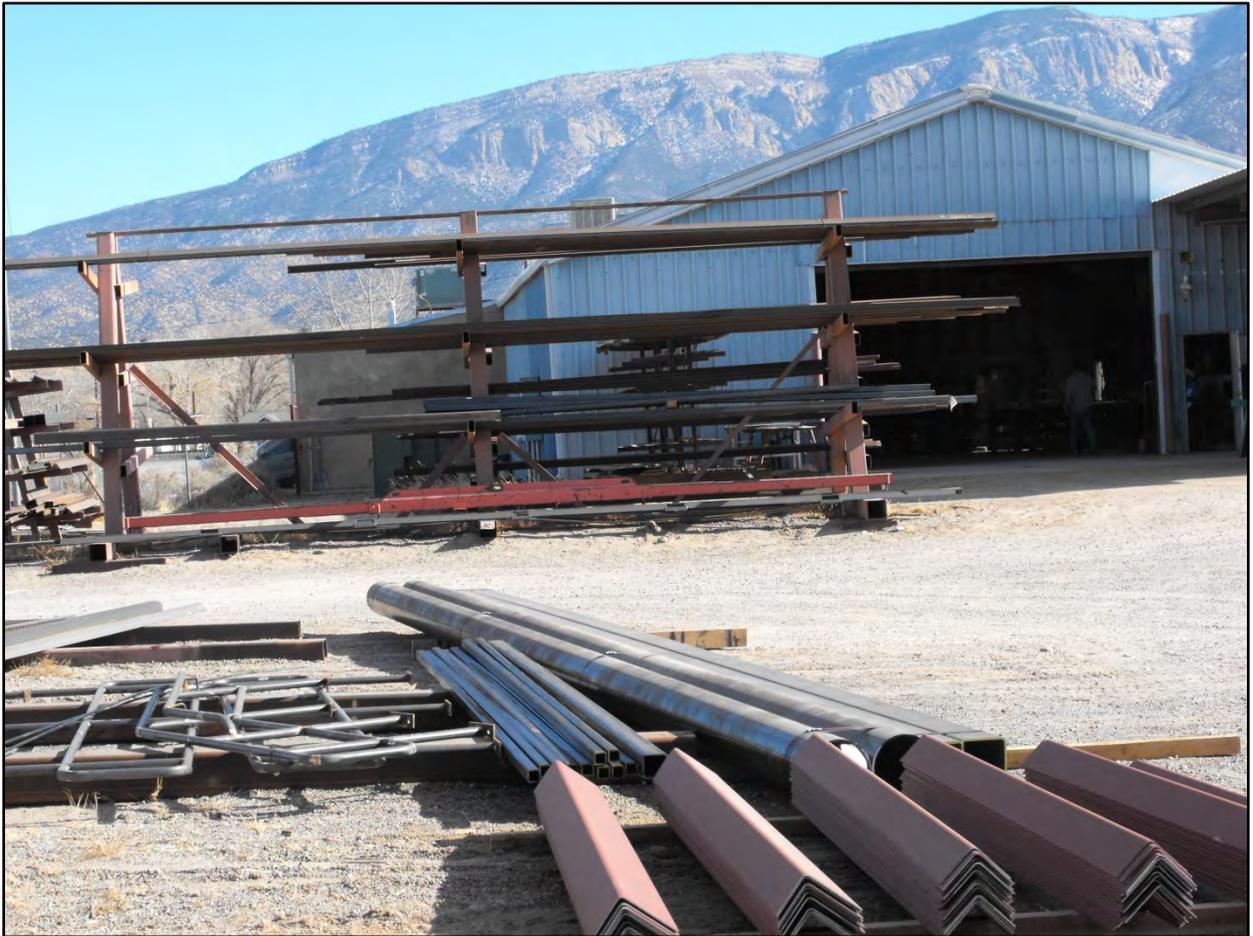
Photo # 1

Photographer: Daniel Valenta	Date: 1/9/2013	Time: 1317 hours
City/County: Bernalillo/ Sandoval County		
Location: 101 Calle Industrial, Bernalillo, New Mexico, facing east.		
Subject: Storage yard of raw steel materials and finished items.

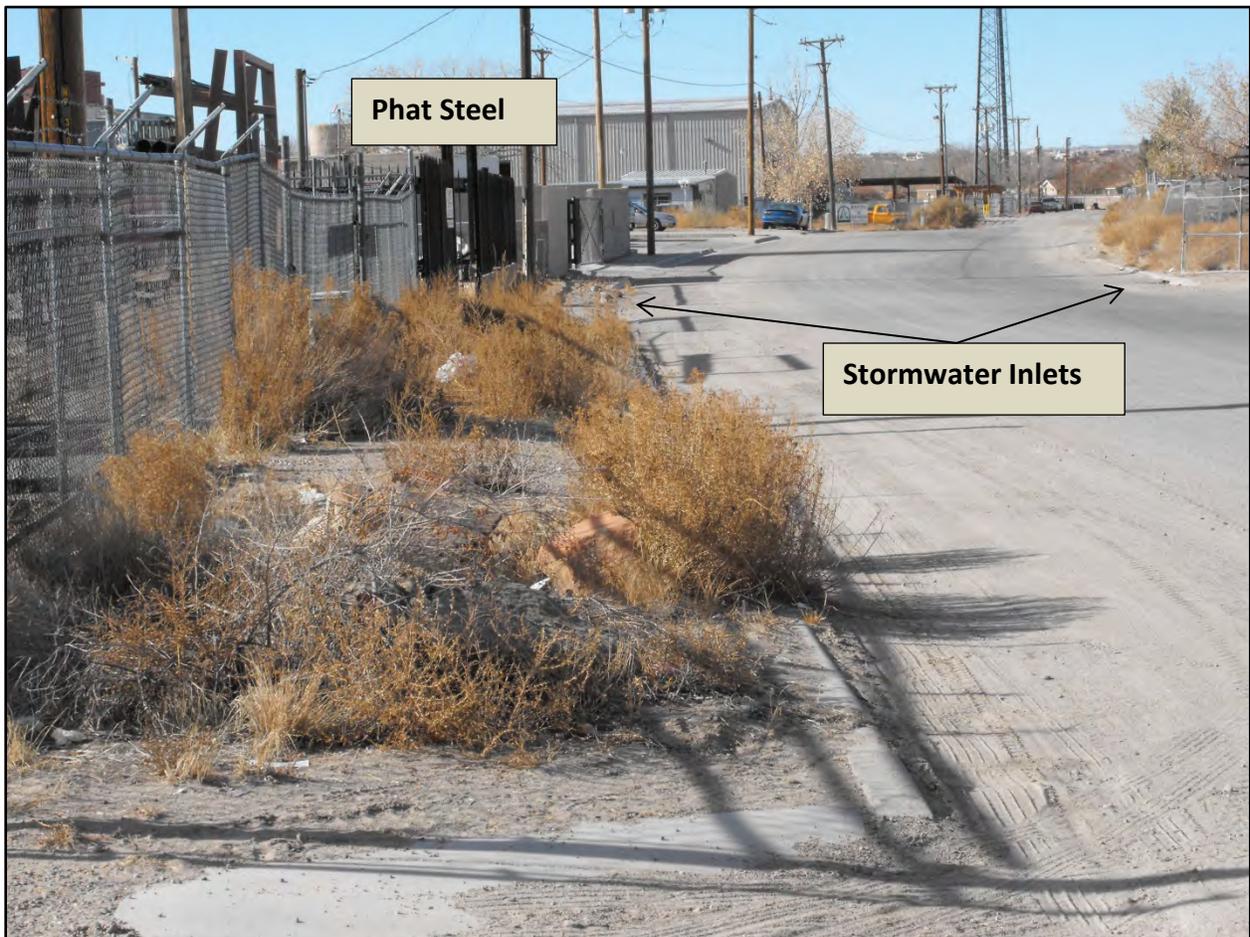
Photo # 2

Storm water may discharge from the facility into the stormwater inlets on the north side of the property (see photo 2) or into the City of Bernalillo stormwater system. This area may discharge to the Rio Grande in the Rio Grande Basin in Segment 20.6.4.106 of the State of New Mexico Standards for Interstate and Intrastate Surface Waters, New Mexico Administrative Code (NMAC). Designated uses are irrigation, marginal warmwater aquatic life, livestock watering, wildlife habitat and primary contact; and public water supply on the Rio Grande.

Photographer: Daniel Valenta	Date: 1/9/2013	Time: 1316 hours
City/County: Bernalillo/ Sandoval County		
Location: 101 Calle Industrial, Bernalillo, New Mexico, facing west.		
Subject: West entrance of Phat Steel facility.
