Surface Water Quality Bureau

Re: Industrial Storm Water, SIC 3275 or 3295, NPDES Compliance Evaluation Inspection, Southwest Fireproofing and Acoustical Co., Inc., NMU001846, February 5, 2013

Compliance Evaluation Inspection
Southwest Fireproofing, Sector E
NPDES Permit #NMU001846, February 5, 2013

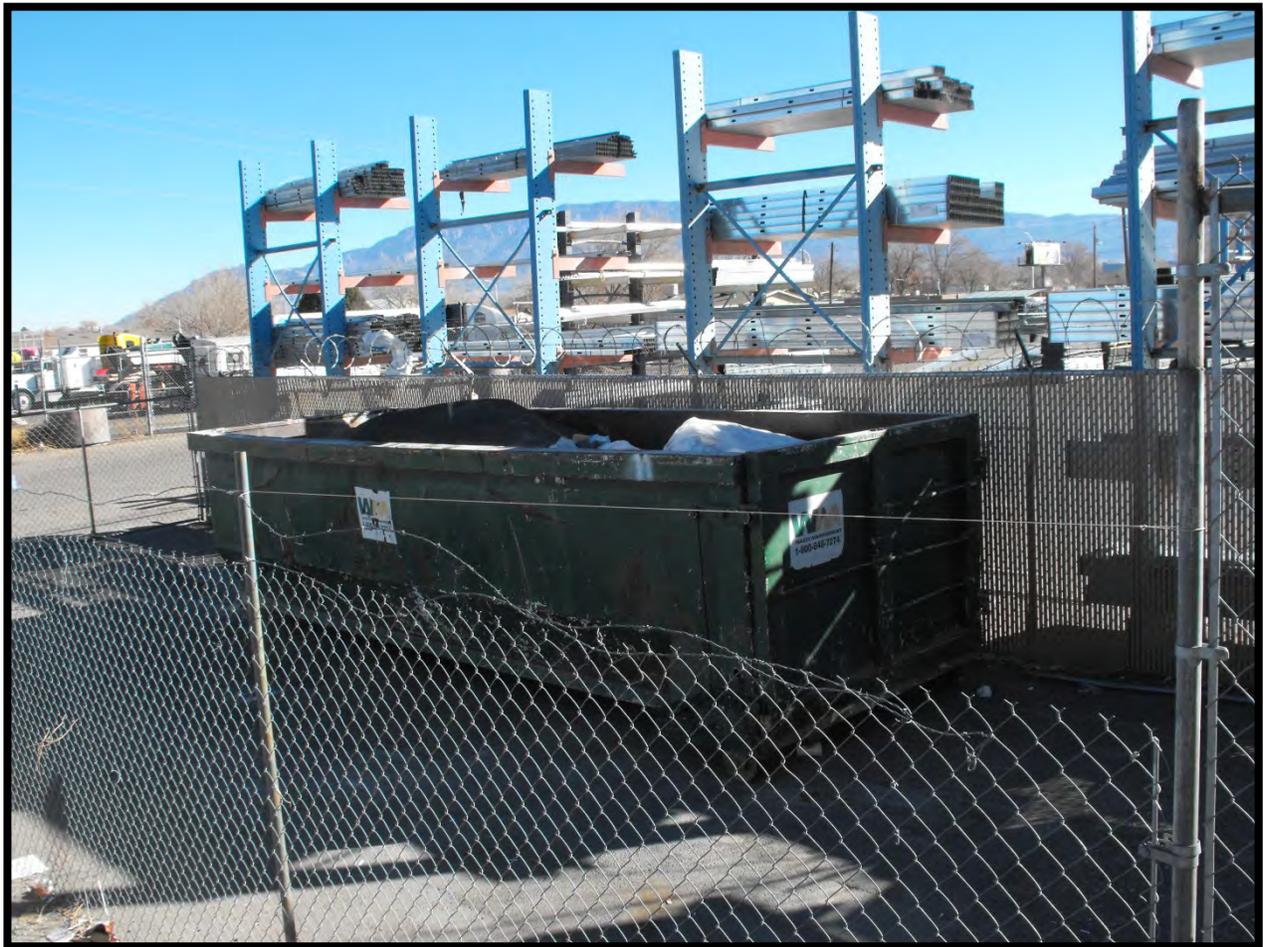
Photo # 1

Photographer: Sarah Holcomb	Date: 2-5-2013	Time: 1003 hours
City/County: Albuquerque, Bernalillo County		
Location: Southwest Fireproofing, Edith Blvd.		
Subject: Outdoor trash receptacle.

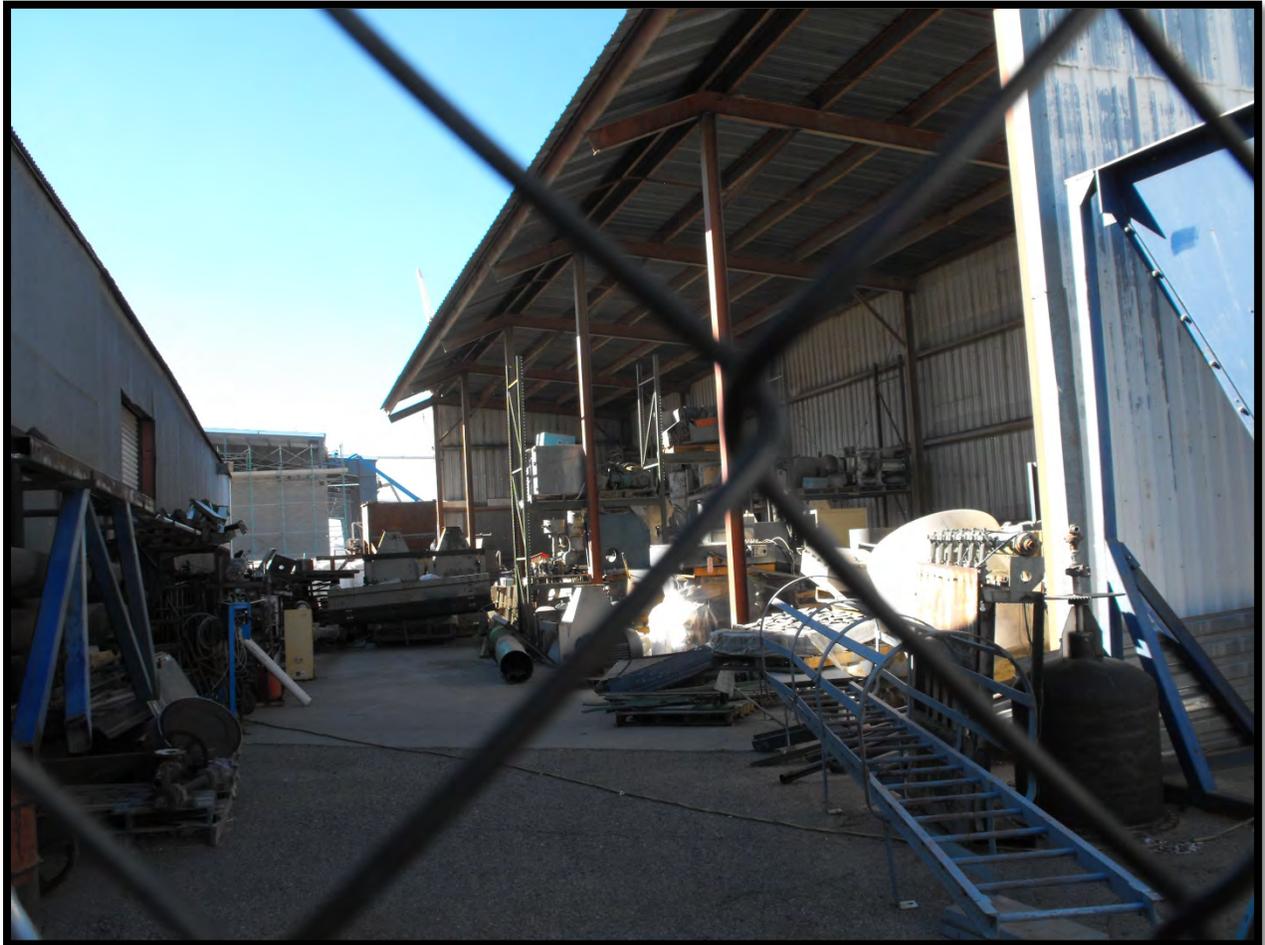
Photo # 2

On the day of the inspection, some pollutant sources observed on site that were exposed outside and could potentially come into contact with storm water included: 1) outdoor storage of raw materials (please see Photo #2), and 2) loading areas (although these generally appeared to be under cover). The materials stored outside refuse from the process (in an uncovered dumpster) and various metal parts which are pieced out for equipment repairs as needed. Otherwise, it appeared all industrial processes were located inside the facility's building. Raw materials are delivered via rail spur but are offloaded immediately into the building.

Photographer: Daniel Valenta	Date: 1-29-2013	Time: 1006 hours
City/County: Albuquerque, Bernalillo County		
Location: Southwest Fireproofing, Edith Blvd.		
Subject: Outdoor storage of metal and old equipment stored for parts.

An exit interview to discuss the preliminary findings of this inspection was conducted onsite with Mrs. Wright at approximately 1010-1015 hours. The inspectors informed the Mrs. Wright of the requirements under the NPDES storm water program regarding permitting requirements, preparation of a SWPPP and installation of appropriate storm water runoff control practices (per the SWPPP). The inspector also discussed the availability of the No Exposure Certification, if all of the outdoor material was stored under cover.
