**NEW MEXICO  
ENVIRONMENT DEPARTMENT**

**Re:** Montego Bay Corporate; Major; Construction Stormwater; SIC 1623; NPDES  
Compliance Evaluation Inspection; NPDES Permit NMU001862; September 4, 2013

NPDES Compliance Evaluation Inspection  
Raintree Apartments Construction  
Permit No. NMU001862  
September 4, 2013

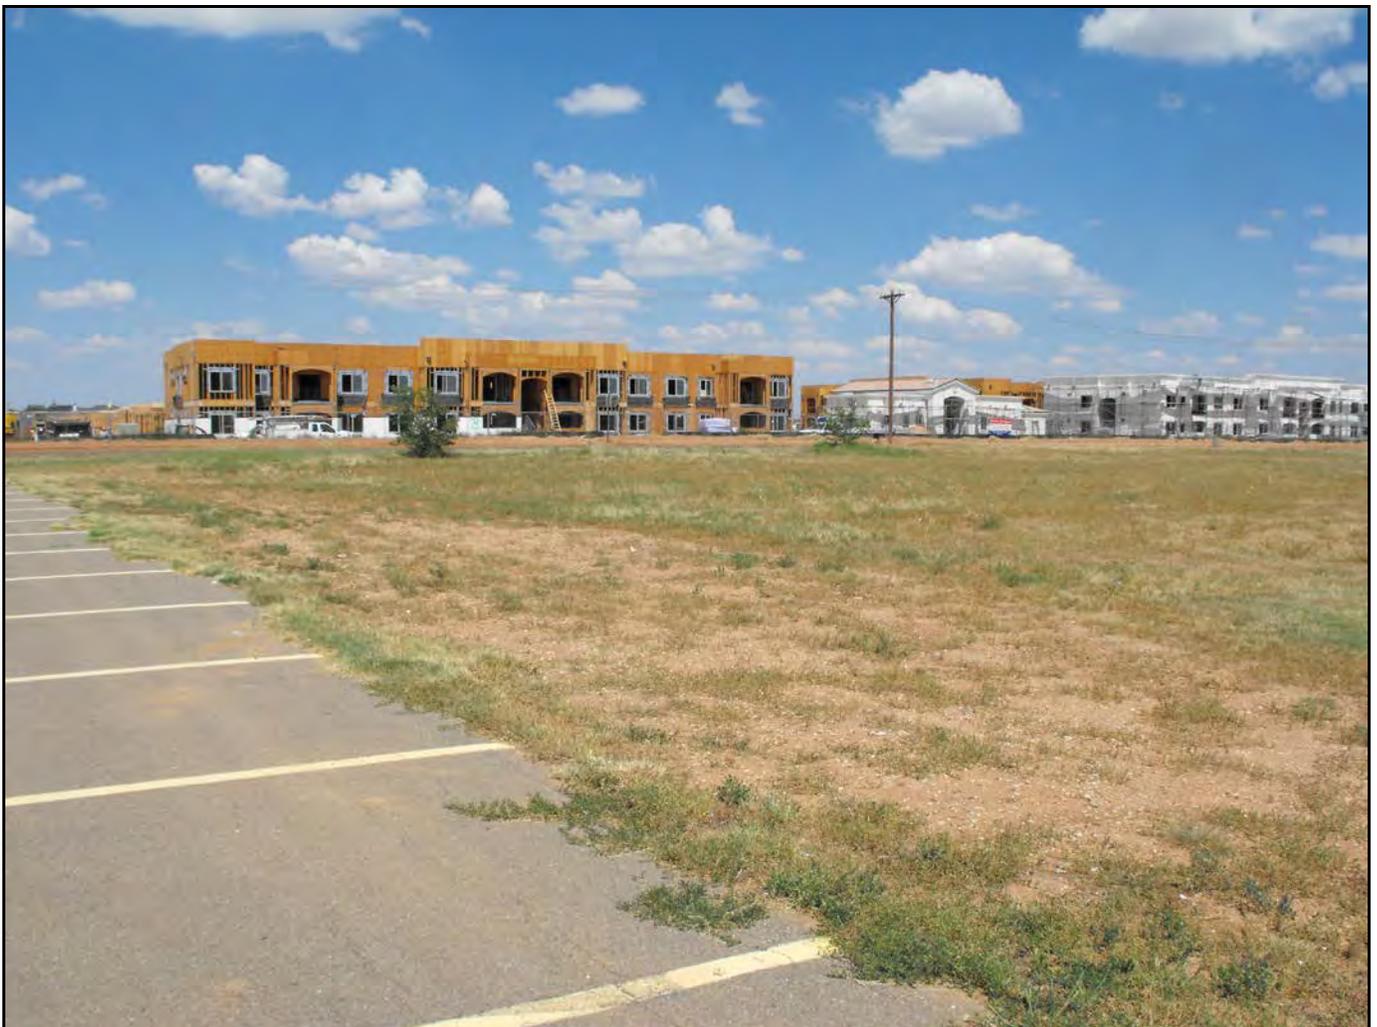
Photo # 1

Photographer: Daniel Valenta	Date: 9/4/2013	Time: 1345 hours
City/County: Clovis/Curry County		
Location: Raintree Apartment construction site, 2400 East Llano Estacado Blvd, Clovis NM 88101, Facing northeast.		
Subject: Raintree Apartments construction site.

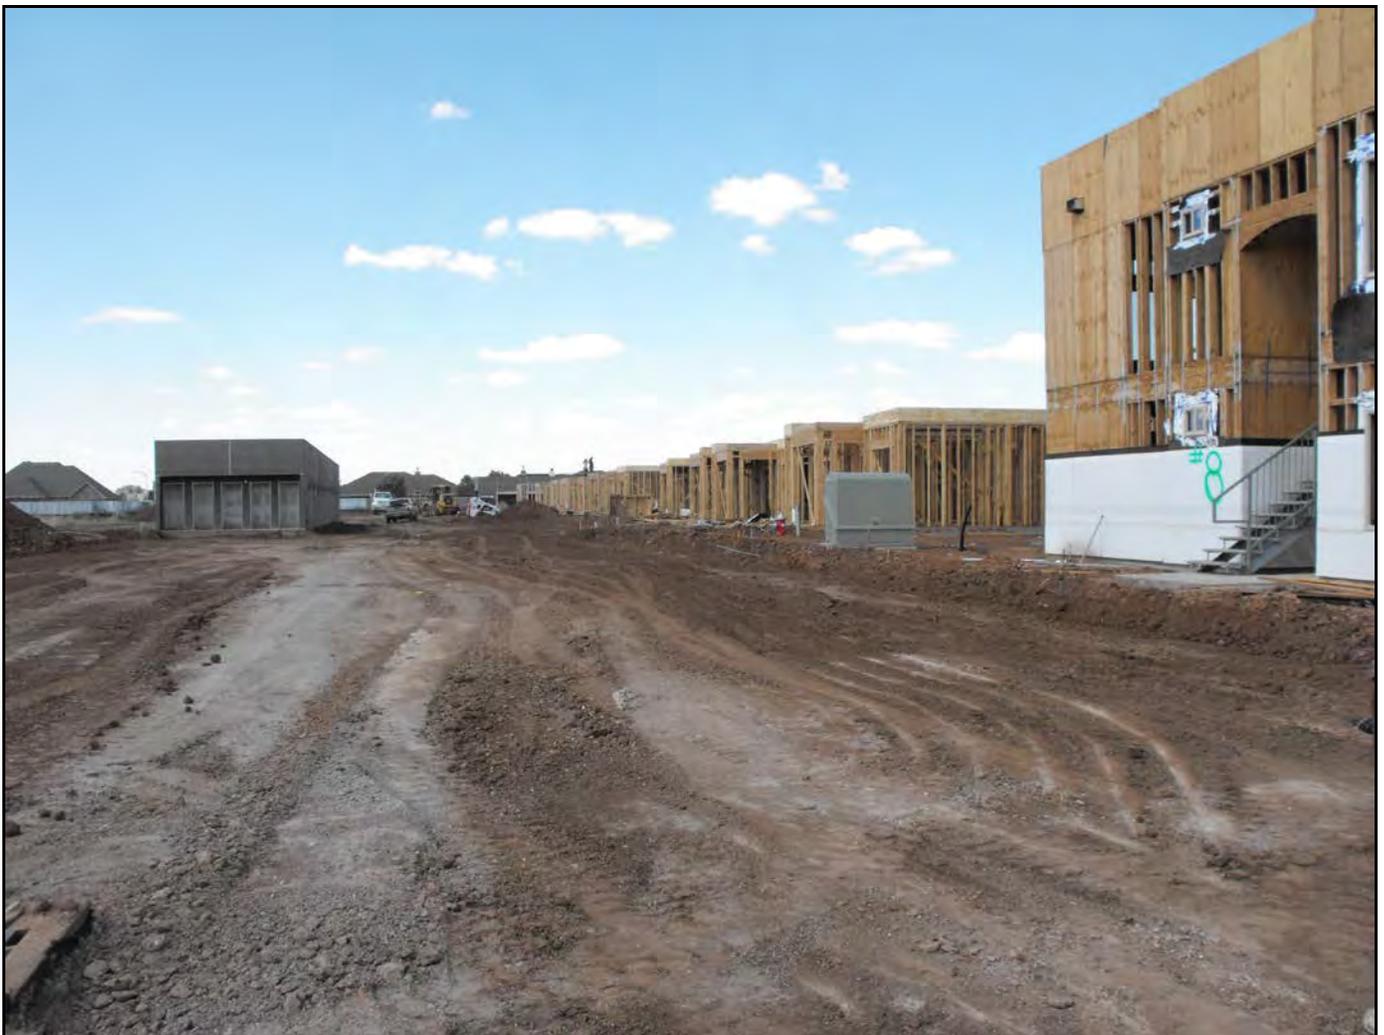
Photo # 2

Photographer: Daniel Valenta	Date: 9/4/2013	Time: 1457 hours
City/County: Clovis/Curry County		
Location: Raintree Apartment construction site, 2400 East Llano Estacado Blvd, Clovis NM 88101, facing north.		
Subject: Raintree Apartments construction site.

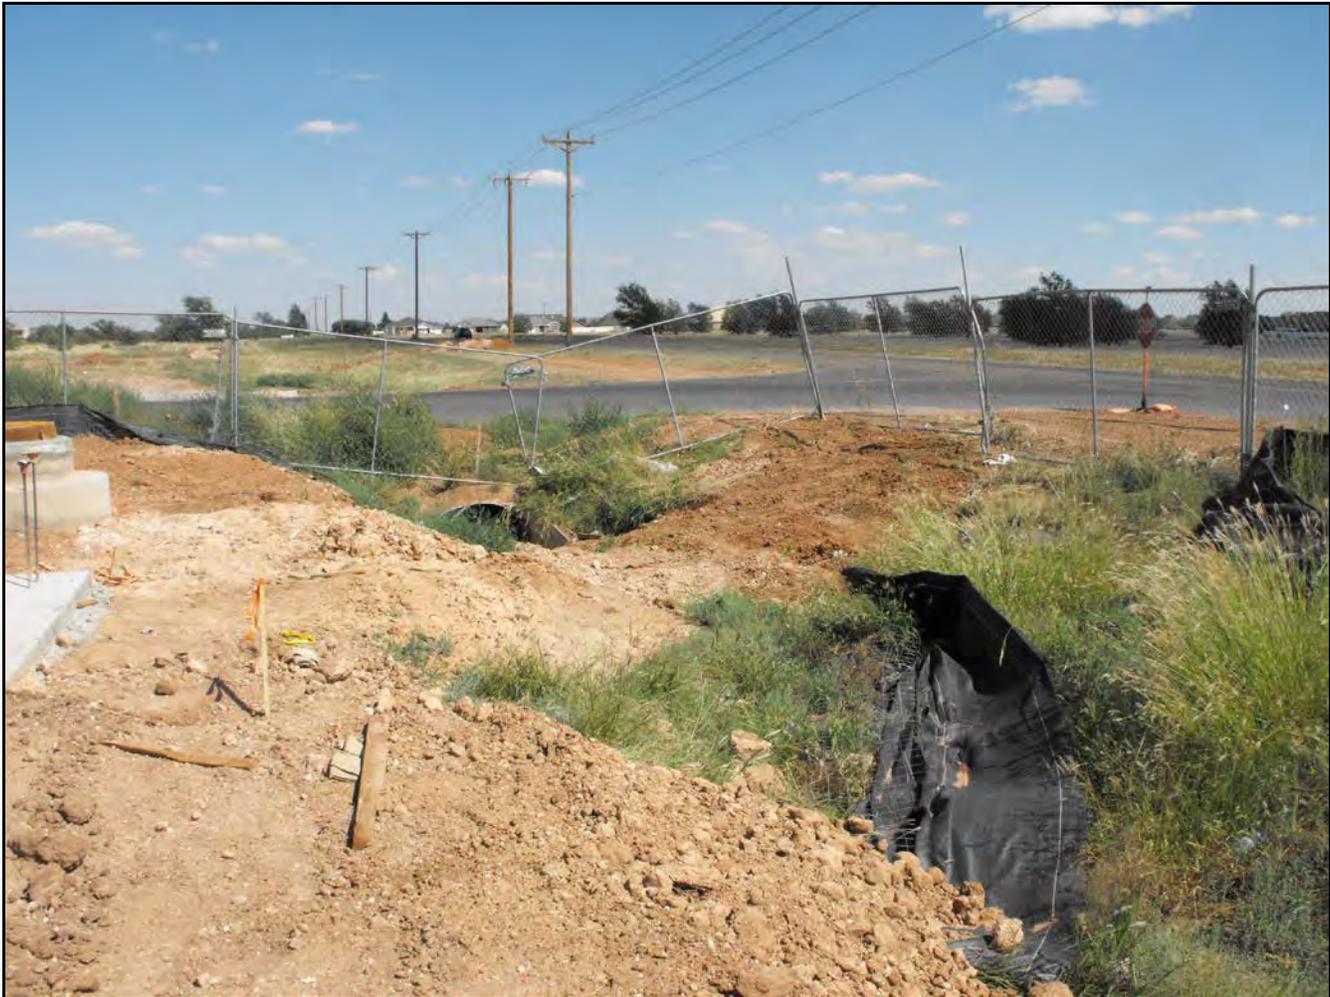
Photo # 3

Photographer: Daniel Valenta	Date: 9/4/2013	Time: 1453 hours
City/County: Clovis/Curry County		
Location:	Raintree Apartment construction site, 2400 East Llano Estacado Blvd, Clovis NM 88101, facing east.	
Subject:	Raintree Apartments construction site. Bar ditch which runs along the road on the south side of the construction site.

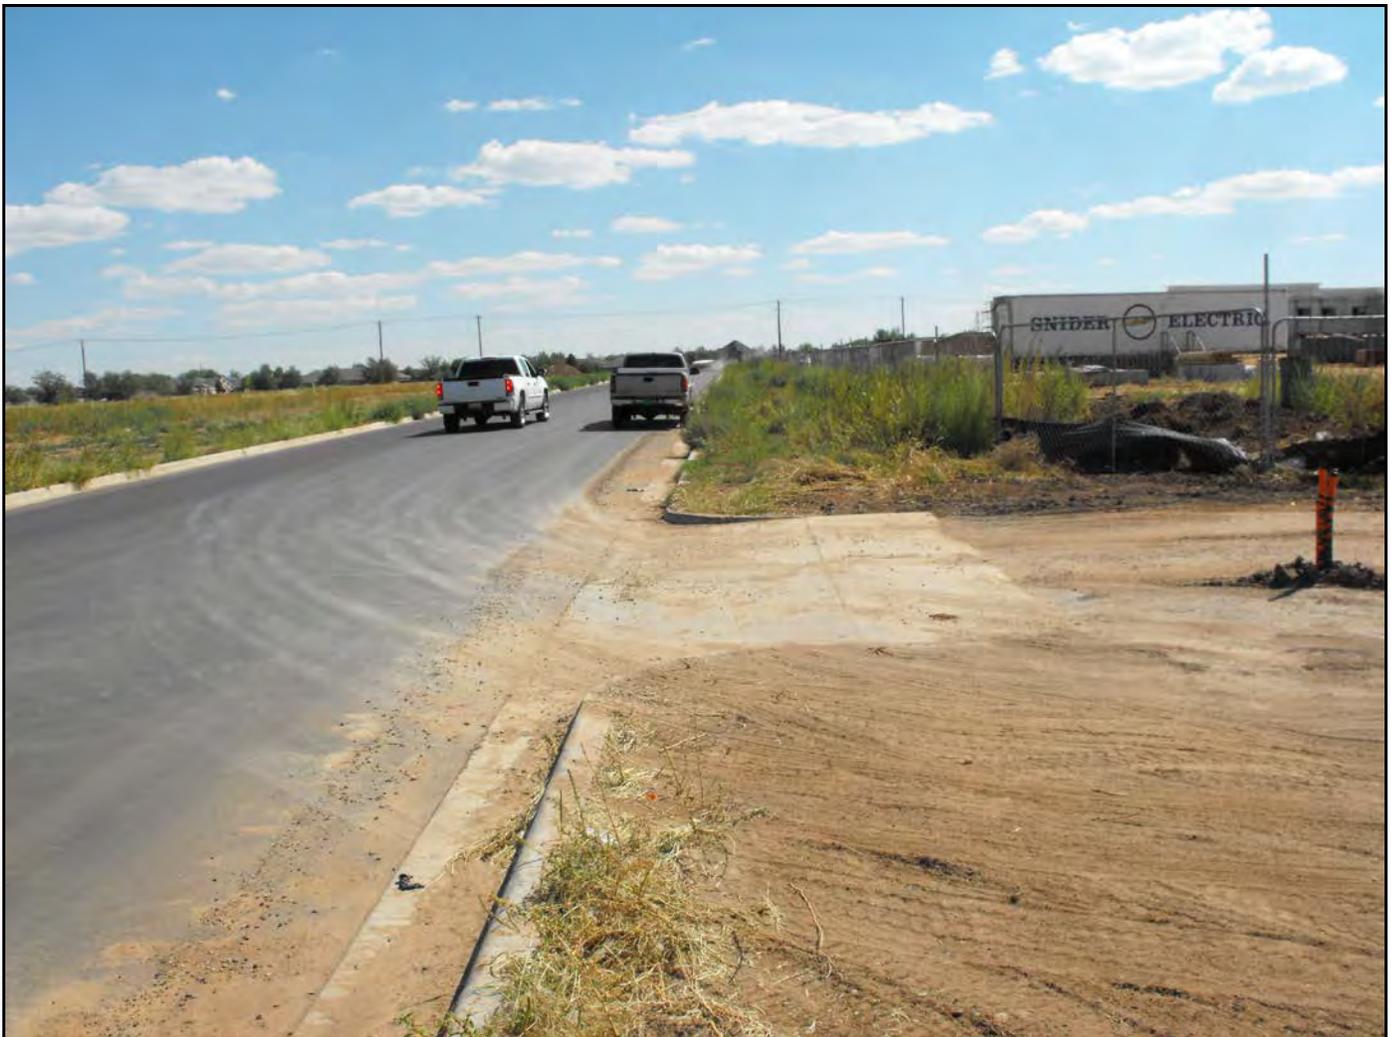
Photo # 4

Photographer: Daniel Valenta	Date: 9/4/2013	Time: 1448 hours
City/County: Clovis/Curry County		
Location: Raintree Apartment construction site, 2400 East Llano Estacado Blvd, Clovis NM 88101, facing south.		
Subject: Entrance/exit to Raintree Apartments construction site.

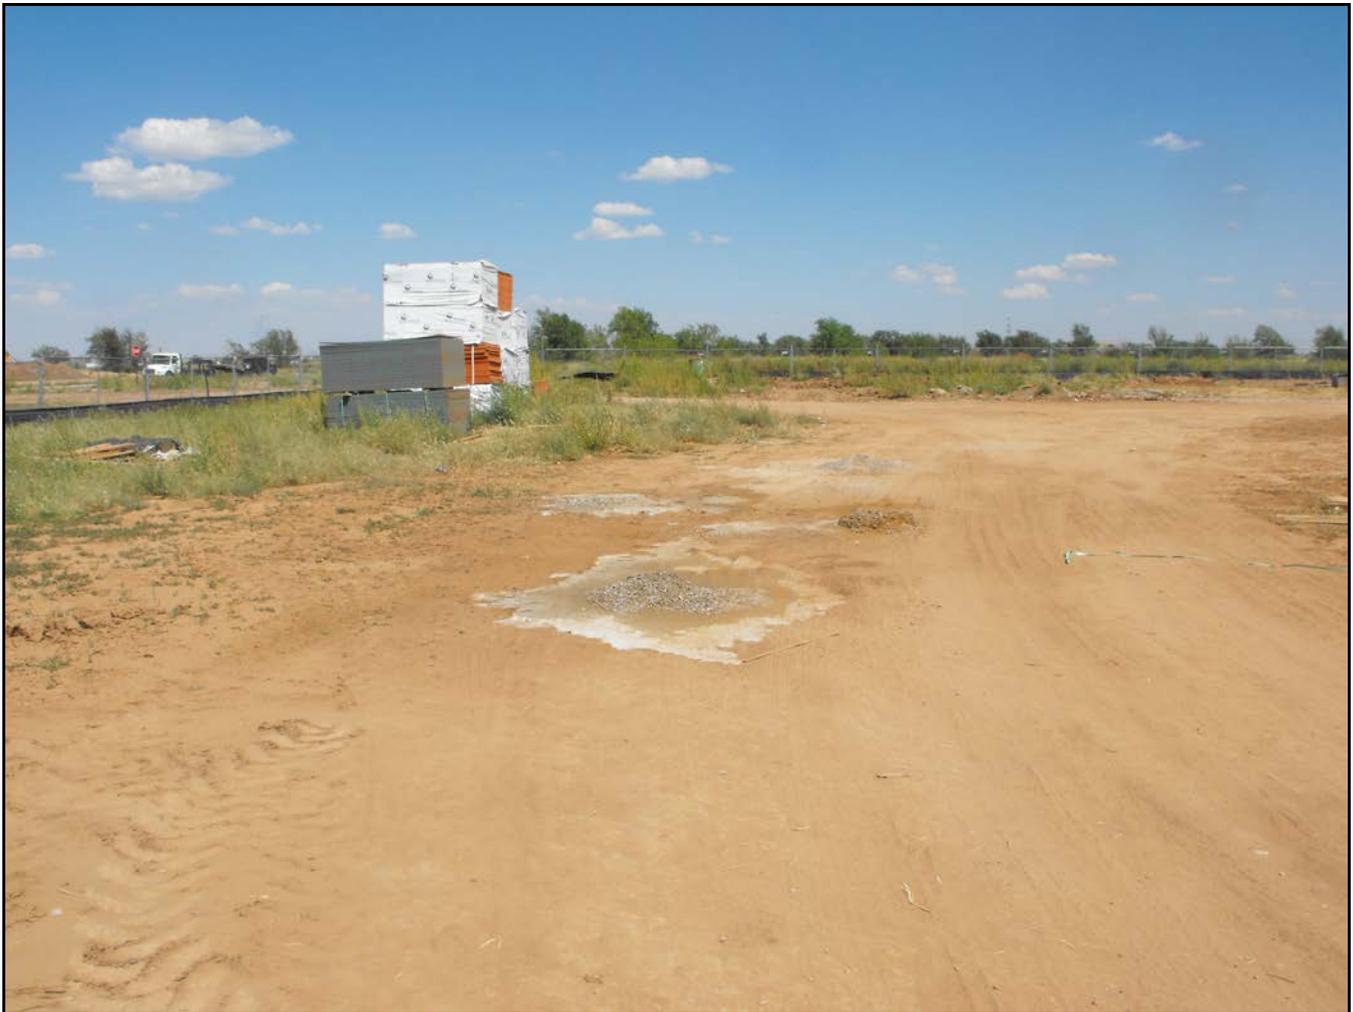
Photo # 5

Photographer: Daniel Valenta	Date: 9/4/2013	Time: 1432 hours
City/County: Clovis/Curry County		
Location: Raintree Apartment construction site, 2400 East Llano Estacado Blvd, Clovis NM 88101, facing east.		
Subject: Concrete wash out along road to site entrance/exit.

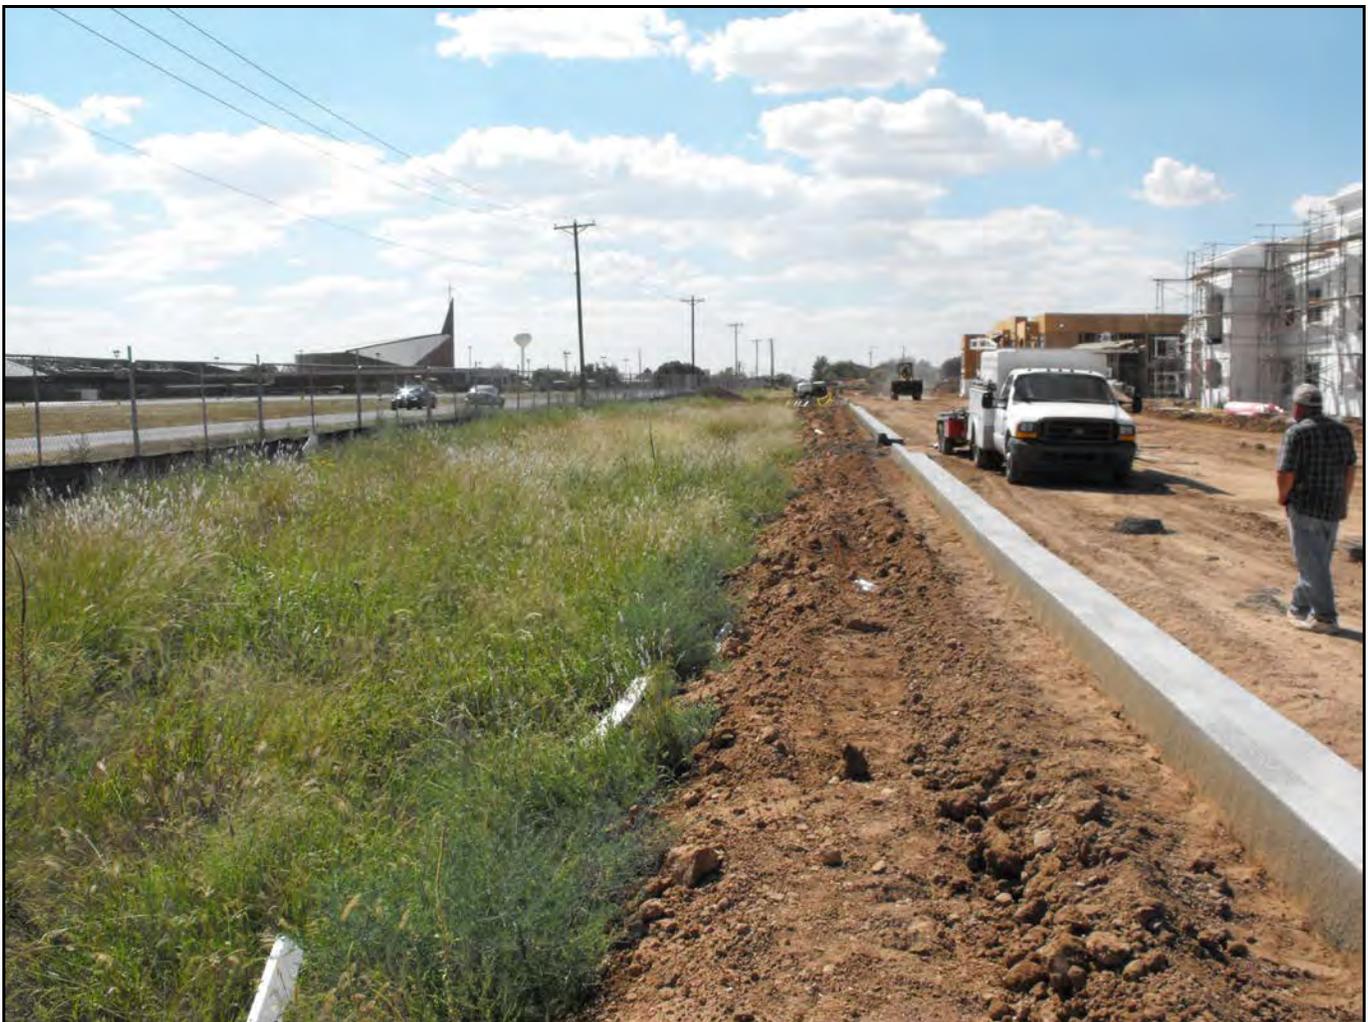
Photo # 6

Photographer: Daniel Valenta	Date: 9/4/2013	Time: 1453 hours
City/County: Clovis/Curry County		
Location: Raintree Apartment construction site, 2400 East Llano Estacado Blvd, Clovis NM 88101, facing west.		
Subject: Undisturbed buffer zone on southwest side of property
