New Mexico Environment Department

Cleanup Actions Update Radioactive and Hazardous Materials Committee

November 12, 2021

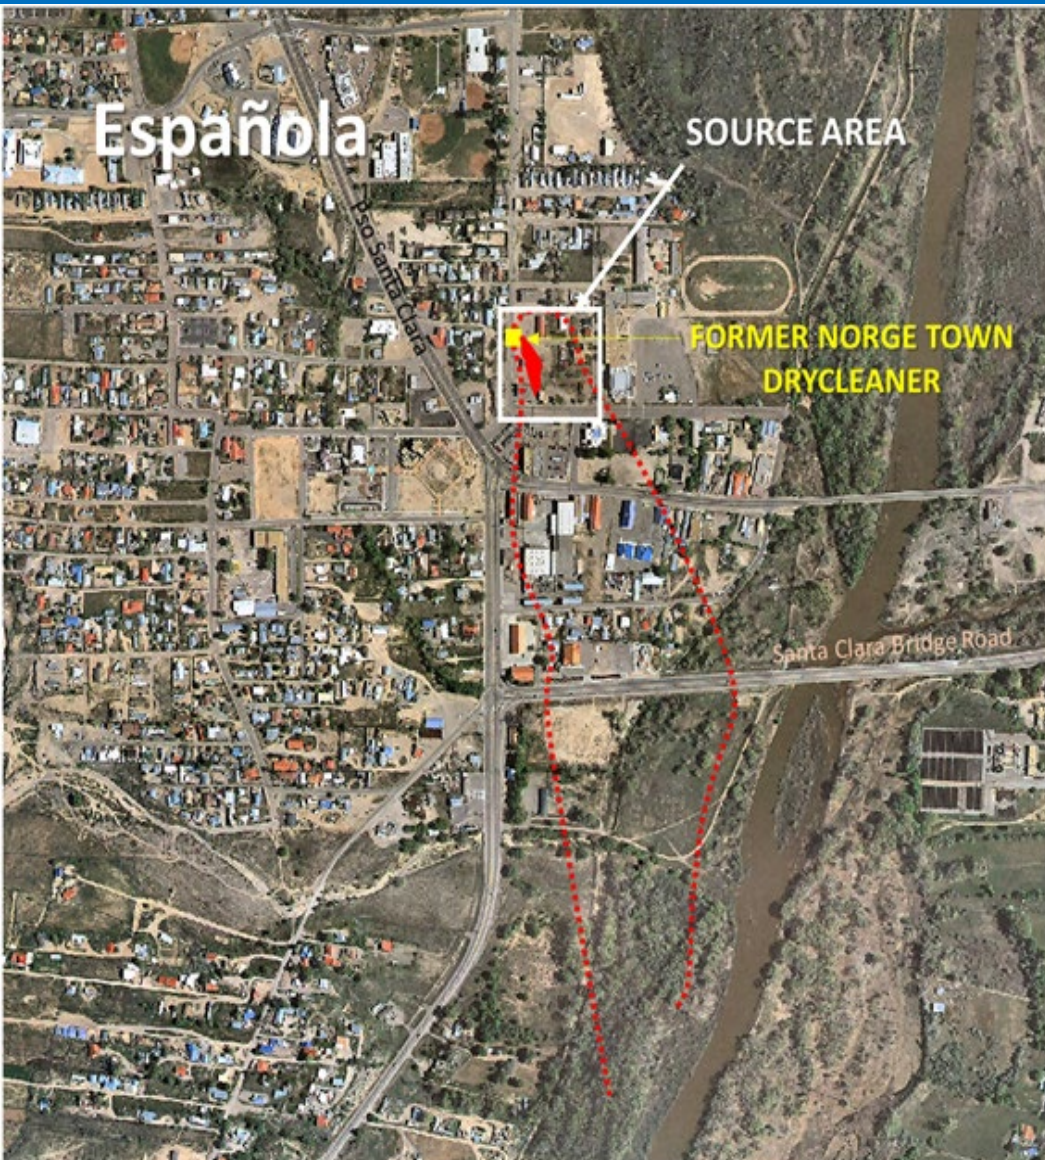
Progress from 2009-2020:

- Shallow Zone plume area decreased from 60 acres to less than one acre.
- Tetrachloroethylene (PCE) concentrations decreased by more than 90 percent from maximum of 40,000 $\mu\text{g/L}$
