**Re: City of Farmington / Farmington Wastewater Treatment Plant, MSGP; SIC 4952; NPDES Compliance Evaluation Inspection; NPDES #NMR053104; July 10, 2018**

## NPDES Industrial Storm Water Checklist (MSGP)

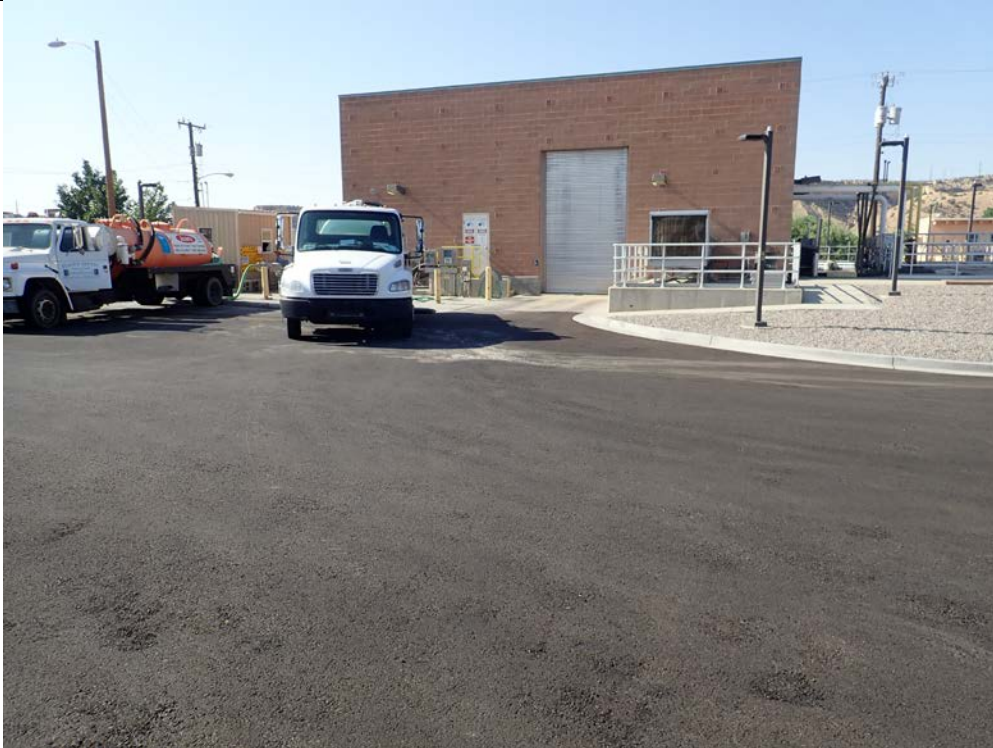
Subject: Septage receiving drains primarily to south but some also to west

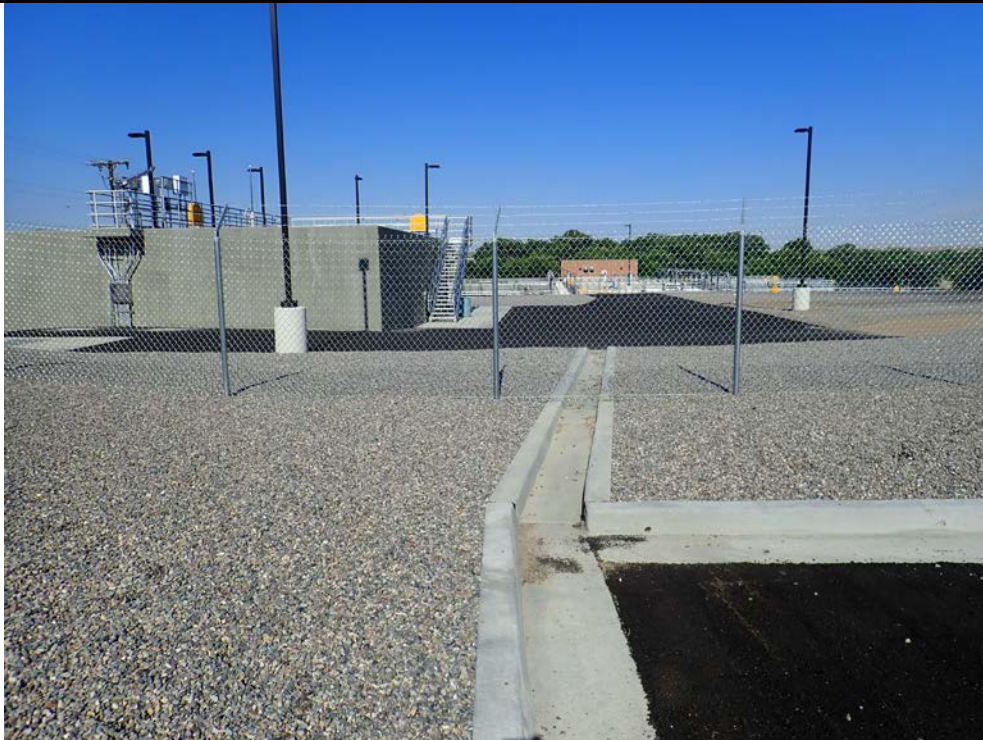
**NMED/SWQB  
Official Photograph Log  
Photo # 2**

Subject: new rundown from septage receiving, flows to west then north of new MRAS Basins

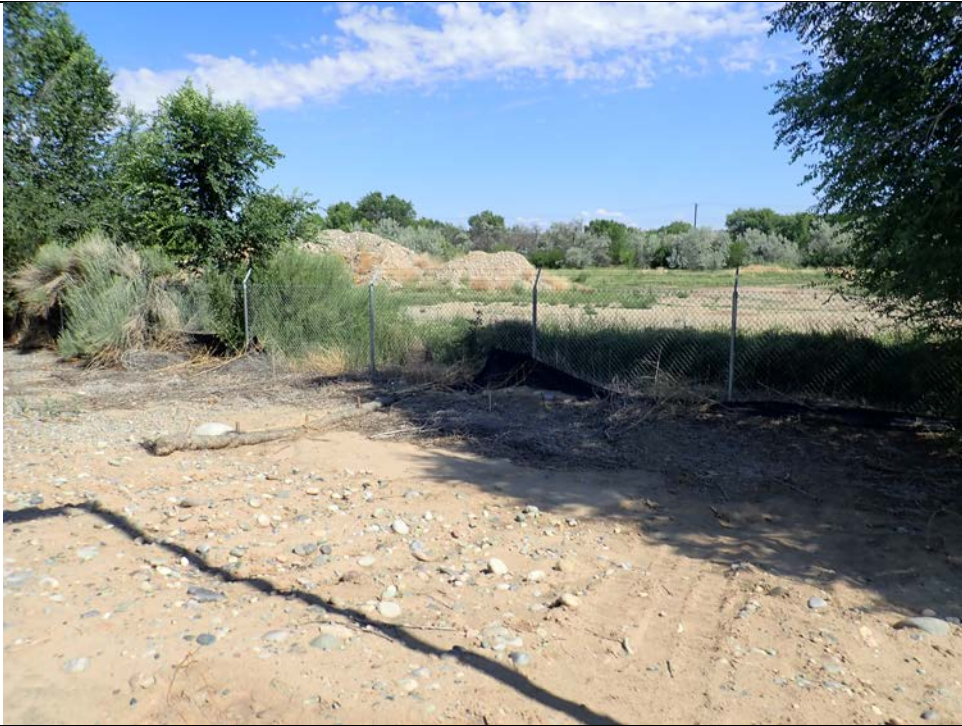
**NMED/SWQB  
Official Photograph Log  
Photo # 3**

Subject: Swale on north west side of facility. BMPS from construction have not yet been removed

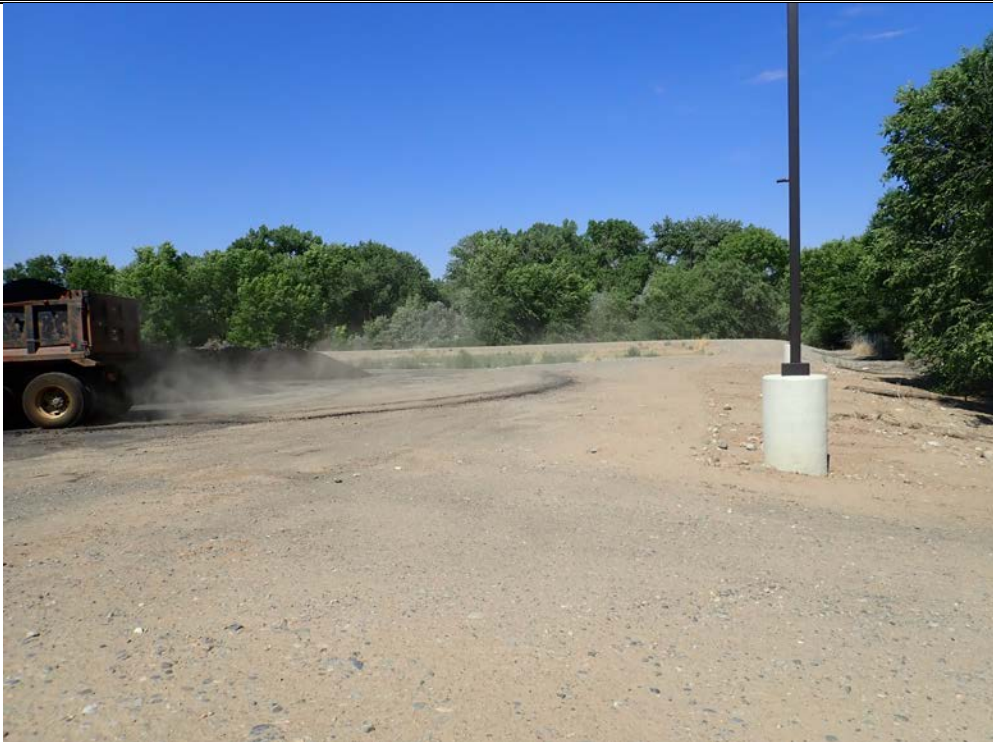
**NMED/SWQB  
Official Photograph Log  
Photo # 4**

| SWPPP Implementation | |
|---|---|
| <b>Measures to minimize the exposure of manufacturing, processing, and material storage areas (including loading and unloading, storage, disposal, cleaning, maintenance, and fueling operations) to rain, snow, snowmelt, and runoff</b> | <p><i>(e.g., use grading, berming, or curbing to prevent runoff of contaminated flows and divert run-on away; locate materials, equipment, and activities so that leaks are contained in existing containment and diversion systems; clean up spills and leaks promptly using dry methods (e.g., absorbents) to prevent the discharge of pollutants; use drip pans and absorbents under or around leaky vehicles and equipment or store indoors where feasible; use spill/overflow protection equipment; drain fluids from equipment and vehicles prior to on-site storage or disposal; perform all cleaning operations indoors, under cover, or in bermed areas that prevent runoff and run-on and also that capture any overspray; and ensure that all washwater drains to a proper collection system)</i></p> <p>Some runoff from transportation to sludge drying area may flow to the north swale rather than to the pond after construction activities regraded the area.(photo 4)</p> |

| SWPPP Implementation | |
|---|---|
| <b>Management of Runoff</b> | <p><i>(e.g., divert, infiltrate, reuse, contain, or otherwise reduce storm water runoff, to minimize pollutants in discharges)</i></p> <p>SWPPP states that facility is bermed to prevent discharge. There is one location at the gate to the outfall where it appears water could overflow during high flows(at least one quarterly inspection is done during rain events to monitor). The northwest part of the facility was regraded during construction and there is currently no berm in that area(photo 4) .</p> |

Subject: Berm on northwest side of facility has not been installed yet, sludge may runoff with stormwater to northwest via swale and bypass pond.

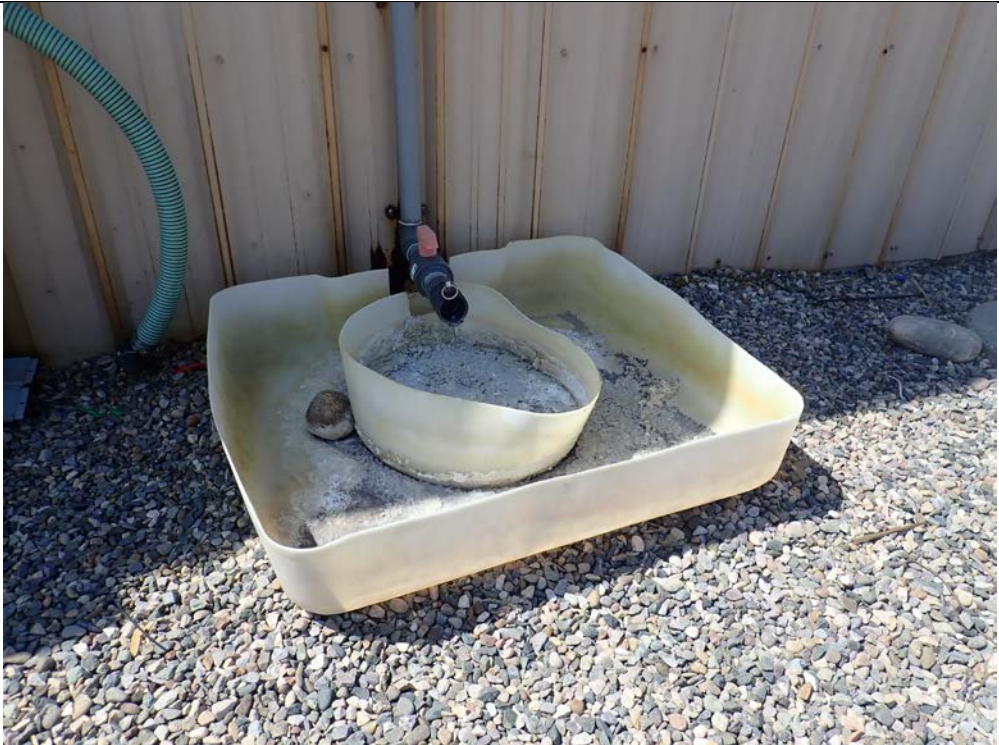
| <b>NMED/SWQB</b><br><b>Official Photograph Log</b><br><b>Photo # 5</b> | | |

| Subject: fill port for sodium hypochlorite with drip pan | | |

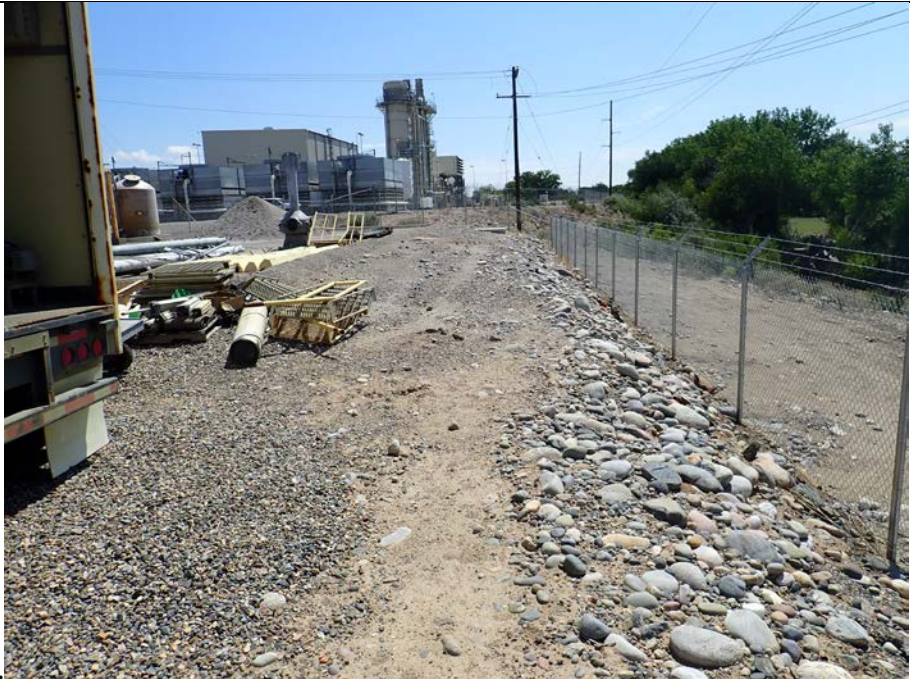
| <b>NMED/SWQB</b><br><b>Official Photograph Log</b><br><b>Photo # 6</b> | | |

| Subject: some storage occurring outside of curbed/bermed areas | | |
