State of New Mexico Nonpoint Source Management Program

2005 Annual Report

*New Mexico Environment Department's
Surface Water Quality Bureau
Watershed Protection Section*

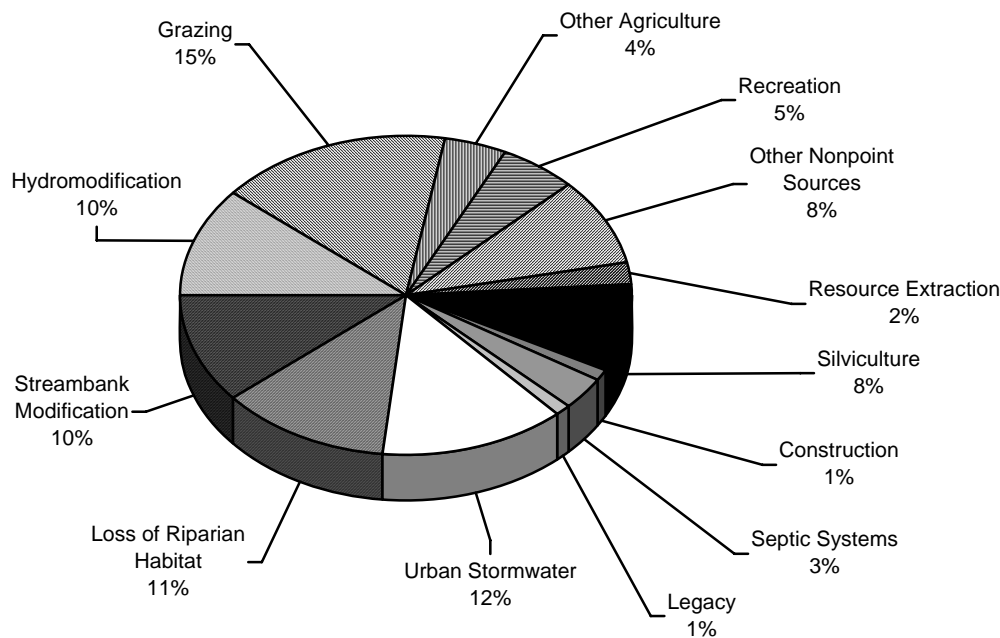
Chart from 2004-2006 State of New Mexico Integrated Clean Water Act §303(d)/§305(b) Report

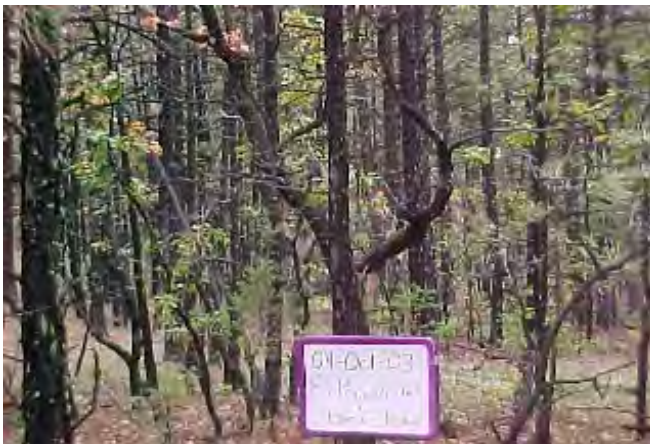
Before Thinning: typical over-stocked stand of trees in 2003

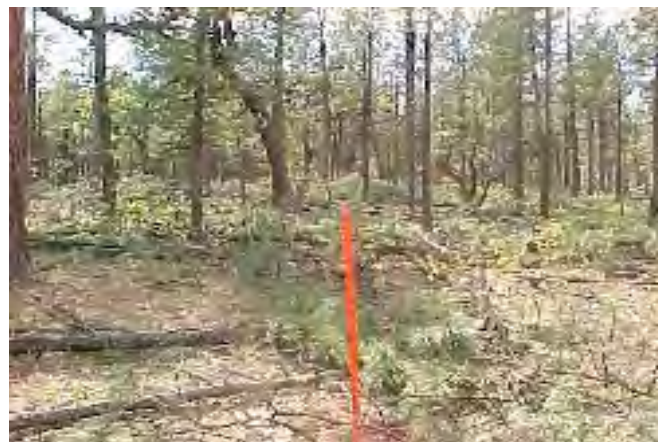
After Thinning: Reduction of over-story shading provides opportunity for herbaceous and shrubby vegetation to cover the ground instead of pine needles.

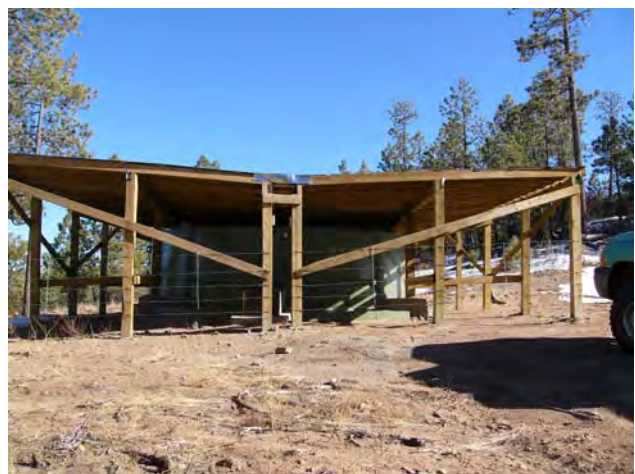
Trick Tank constructed to draw livestock and wildlife from riparian areas of Rio Gallina.

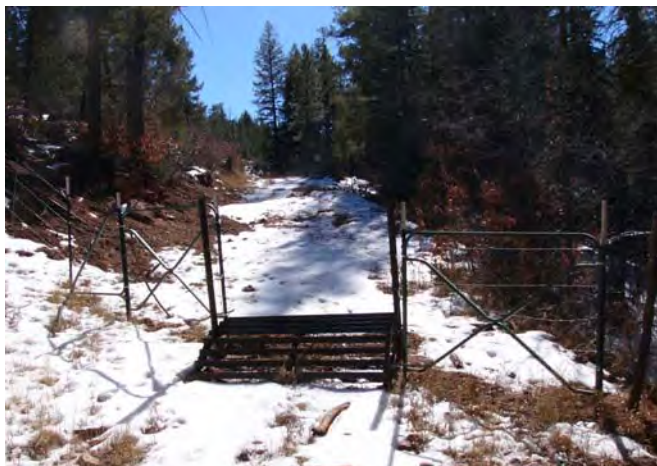
Hand made ATV cattle guard to keep cattle from the Rio Gallina.

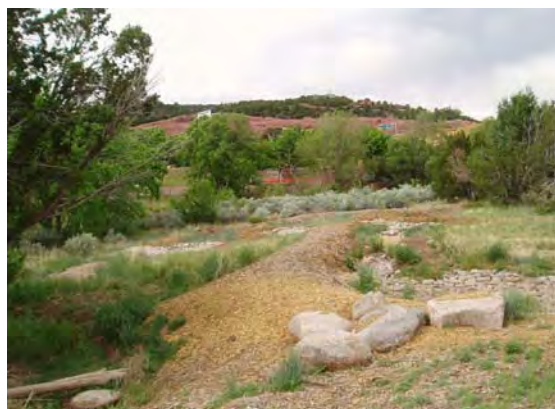
BMPs included rundowns from sidewalk cuts, surge basins, and other erosion control features to remove energy from flows exiting culvert outlets or overflowing spillways, building contour berms and swales, in-ground “sponges,” and wicks.

Staff and volunteers planted native trees and shrubs in moisture-retaining areas. Students installed a small water-harvesting structure for their upland plantings.

- BMPs included: rundowns from sidewalk cuts, surge basins, and other erosion control features to remove energy from flows exiting culvert outlets or overflowing spillways, building contour berms and swales, in-ground “sponges,” and wicks. Staff and volunteers planted native trees and shrubs in moisture-retaining areas. Students installed a small water-harvesting structure for their upland plantings

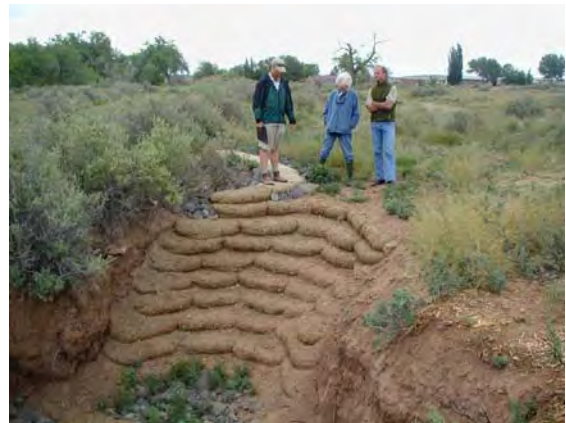
A sand bag erosion control technique: Large jute bags, filled with partly decomposed wood chips and on-site dirt, native seed mixes (jute-bag technique developed & tested at EWI ranch in 2004 & 2005—applied at 2 demonstration sites. Promises to be effective, but needs to be tested and monitored for several years to prove long-term viability.

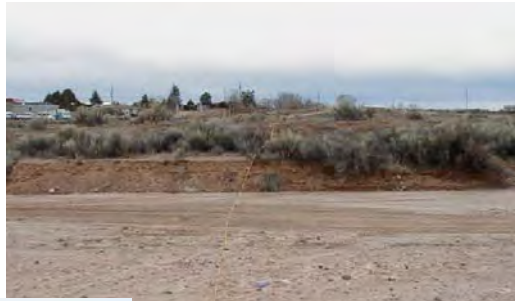
Before...

After...

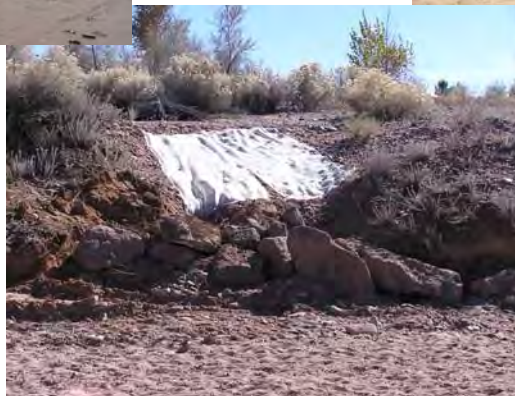
Erosion control seed mat and boulders placed to minimize erosion.

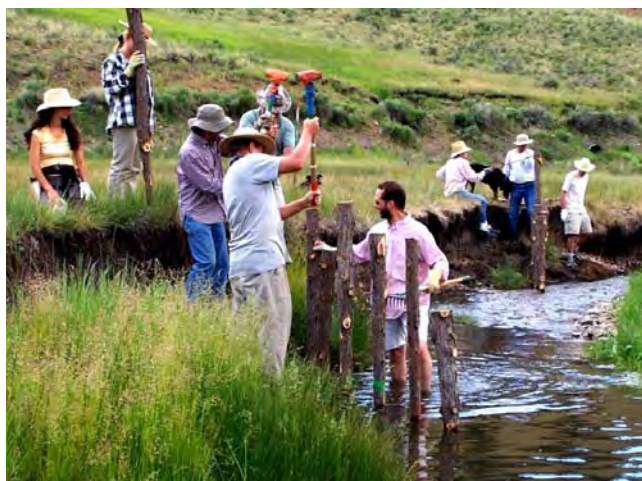
NM Trout volunteers installing vane structure in Comanche Cr. during a work weekend.

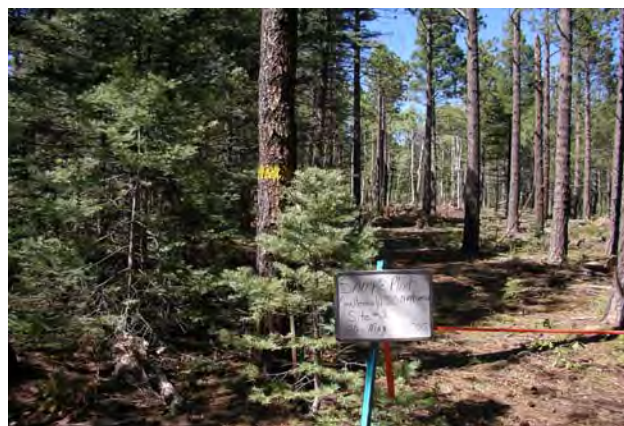
Forest Thinning in Mora River Watershed: The left is a control plot with a dense over story. The right is treatment plot with an open over story, large diameter trees, and ladder fuels have been removed.
