NEW MEXICO  
Nonpoint Source  
Management Program  
Annual Report

# State of New Mexico Nonpoint Source Management Program

## 2007 Annual Report

New Mexico Environment Department  
Surface Water Quality Bureau  
Watershed Protection Section  
1190 St. Francis Dr.  
Santa Fe, NM 87502

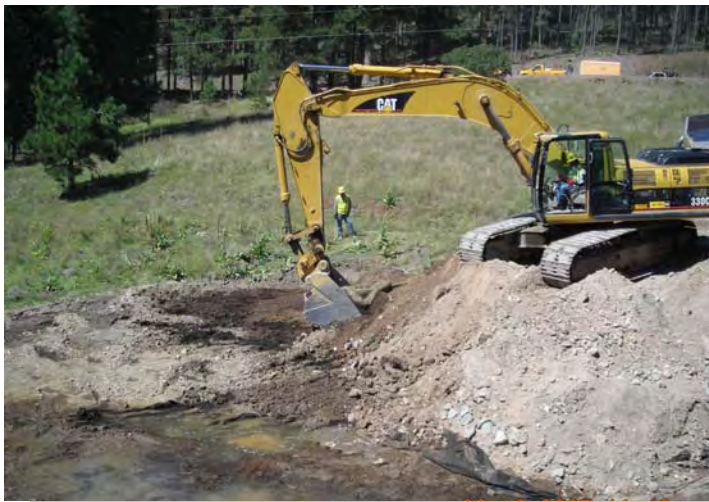
Federal Highway Administration Central Federal Lands Project, NM State Rt. 126. Skilled equipment operators remove temporary mats and fill with minimal disturbance to original wetland surface elevations.

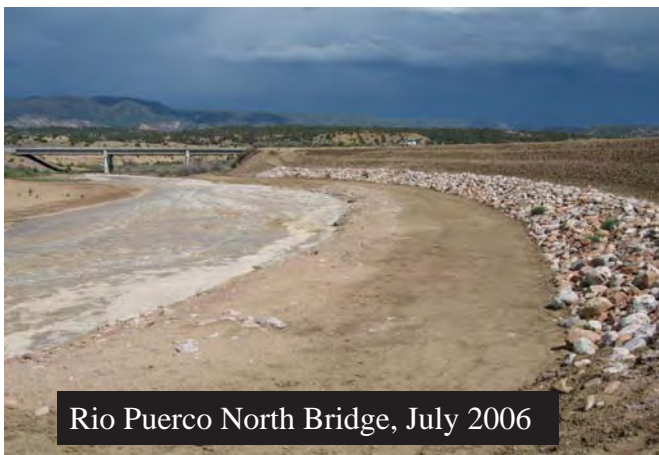
Rio Puerco North Bridge, July 2006

Three newly constructed river segments, using hard and soft embankment features, transplanted hundreds of willow poles and installing many seedlings and containerized plants to initiate a phase that will assist the river in redeveloping riparian vegetation along its banks and restoring wildlife, avian, and aquatic habitat. That revegetation and seeding efforts, along with construction of in-channel flow management structures is designed to reduce long-term excessive sediment transport.

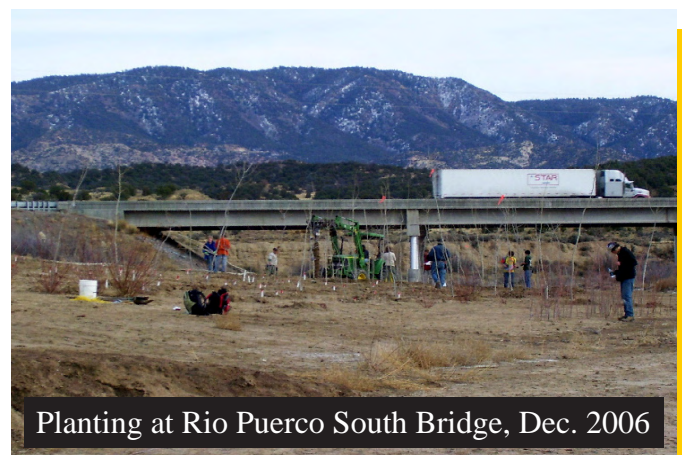
Planting at Rio Puerco South Bridge, Dec. 2006

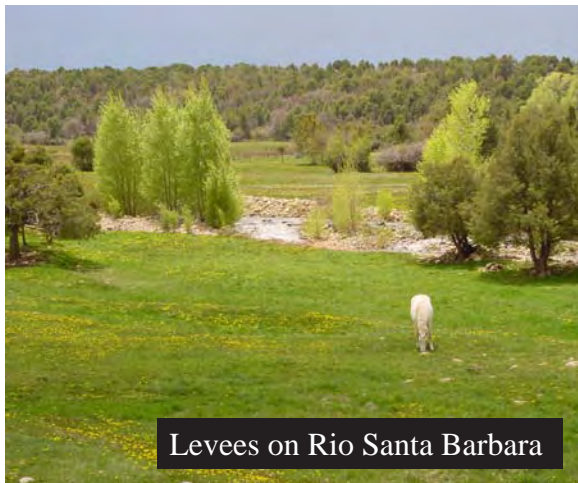
Levees on Rio Santa Barbara

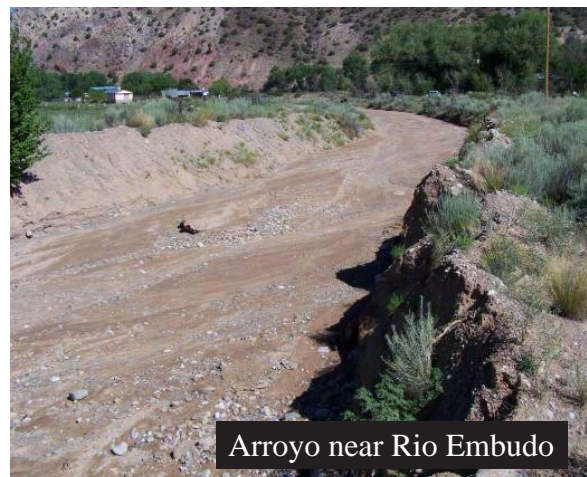
Arroyo near Rio Embudo

- Effects of potential wildfires due to fire suppression and resulting unnatural fuel accumulations.
- Large amounts of sediment and turbid water delivered to the Rio Grande and lower Rio Embudo from arroyos, OHV use, and watershed disturbance from current and past grazing practices.
- Degraded wetland and riparian conditions
- Loss of woody riparian vegetation on private grazing lands riparian grazing lands contributes to turbidity and sediment loading.
- Continuing loss of the agricultural base and accompanying acequias
- Illegal dumping
- Wastewater management (large number of unregulated septic systems in use)
- Gravel mining

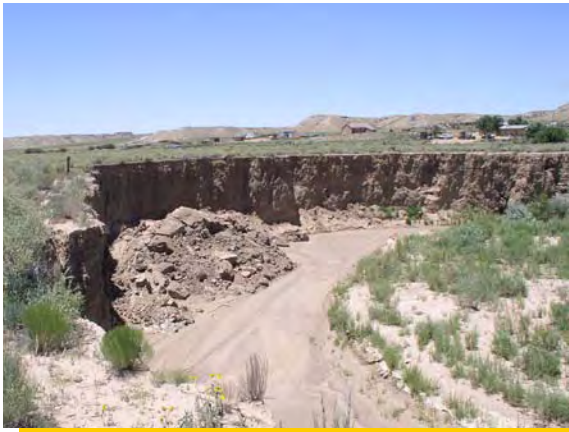
Rio Puerco near Cabezon:  
Mass failure of a 35-foot high arroyo  
wall into the active channel.

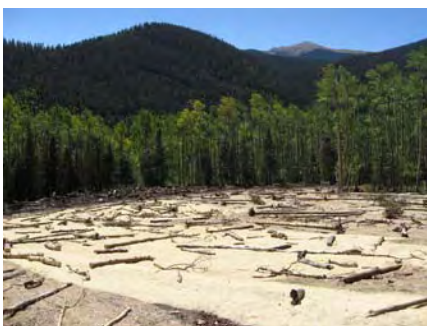
Placer Creek consolidation cell – final grade with erosion control measures in place.

In the Placer Creek Watershed, the project included the excavation and removal of approximately 6,690 cubic yards of waste material, the reconstruction of approximately 200 feet of stream bank.

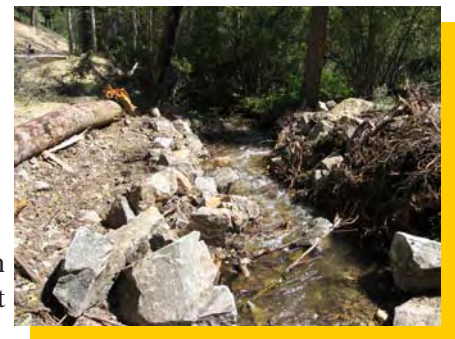
Streambank re-constuction utilizing rock and root wads at Midway Tunnel Prospect.

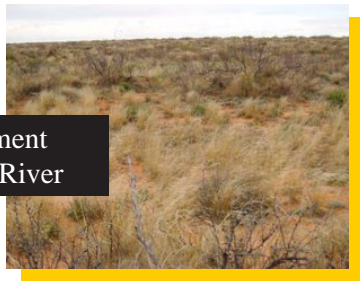
Post brush treatment along Delaware River

Upper Pecos-Black, Rio Penasco, Delaware, Lower Pecos-Red Bluff	Brush Control – treated across CFO to reduce/eliminate mesquite, creosote, catclaw, tarbush	Reduce shrub species, increase grass species; Reduce bare ground, increase cover; Reduce runoff, increase infiltration.

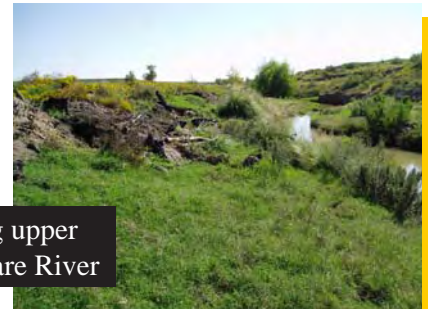
Typical area along upper reaches of Delaware River
