State of New Mexico Nonpoint Source Management Program

2010 Annual Report

**New Mexico Environment Department
Surface Water Quality Bureau
Watershed Protection Section**

319(h) Project Spotlight - Santa Fe River Restoration

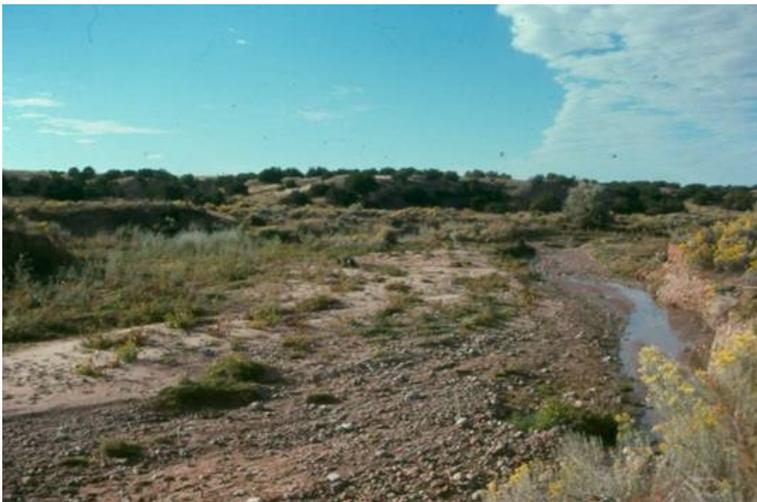
Santa Fe River in 2000 prior to restoration (photopoint G).

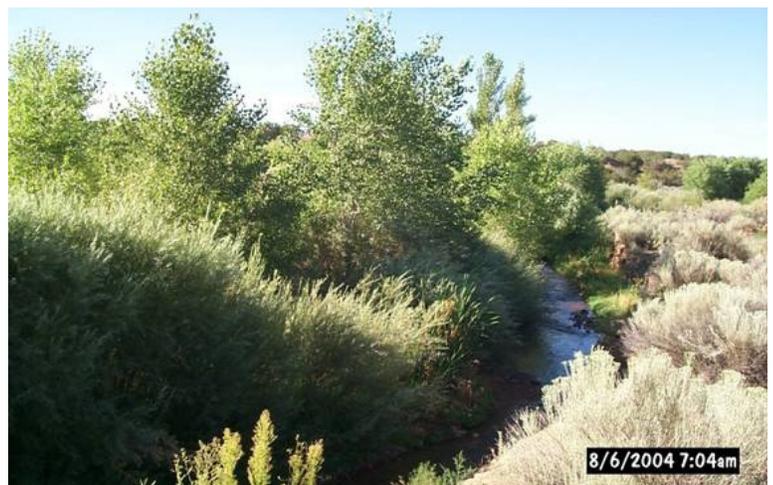
Santa Fe River in 2004 following initial restoration (photopoint G).

Restoration efforts on the Santa Fe River Preserve have improved water quality by establishing and protecting an abundant native riparian corridor. Restoration was conducted along a 1.5 mile reach of the river and included fencing to reduce the impacts from livestock grazing, inhibit unauthorized motorized vehicle use within the riparian area, and to prevent illegal dumping along the river. The floodplain was restored by removing earthen berms and non-native plants, and planting native riparian vegetation including 5,000 cottonwood poles, and 15,000 willow whips, as well as other shrubs, grasses and forbs. This created a buffer to filter stormwater, strengthened the streambank, and facilitated the formation of riparian wetlands, which reduced sediment loading and increased canopy cover. Increasing canopy cover and reducing available sunlight can have a direct impact on algal growth, and algae are known to be directly related to fluctuations in dissolved oxygen and pH in many aquatic ecosystems.

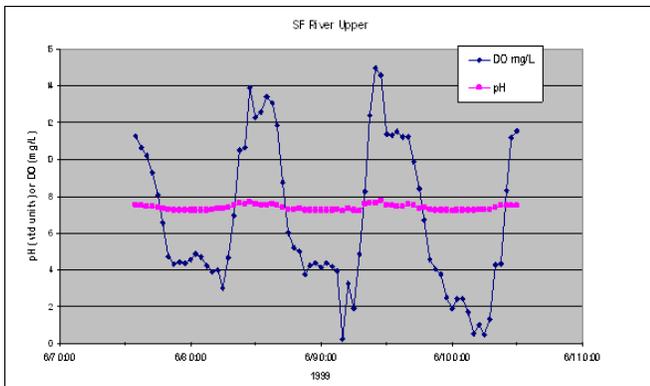
Dissolved oxygen and pH in the Santa Fe River in 1999 prior to restoration.

In 2002, 9 out of 11 grab samples exceeded the pH criterion (pH range from 6.6 to 9.0). In 2008, out of the 10 grab samples collected none exceeded the pH criterion. In addition, sondes deployed at both the station immediately below the Santa Fe waste water treatment plant in July 2005 and at the USGS gage above Cochiti Lake in October 2007 indicated full support for pH (minimum to maximum recorded pH values were 7.37 to 8.68 and 7.25 to 8.78, respectively). Therefore, pH was removed as a cause of impairment on the *2008-2010 State of New Mexico CWA §303(d)/§305(b) Integrated Report*. Furthermore, sedimentation/siltation was removed as a cause of impairment on the upstream reach which includes the Santa Fe River Preserve. It is also anticipated that dissolved oxygen will be removed as an impairment in the *2010-2012 State of New Mexico CWA §303(d)/§305(b) Integrated Report* based on data collected during the summer of 2010.

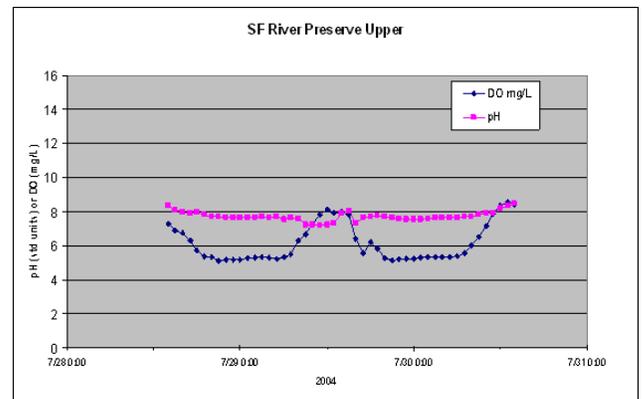
Dissolved oxygen and pH in the Santa Fe River in 2004 following initial restoration.

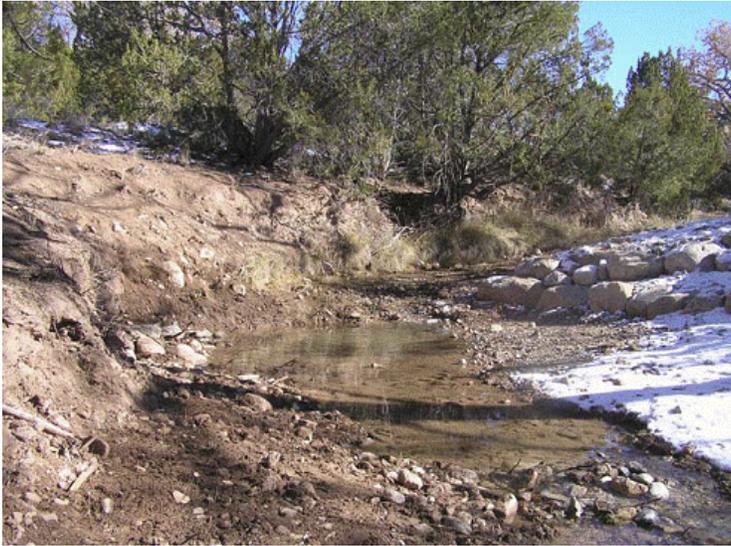
Rock baffle on Las Huertas Creek.

A total of 27 machine-built and 8 hand-built in stream structures were completed over 11,000 feet of river during the course of this project. These included, boulder vanes, post vanes, cross vanes, one rock dams, rock baffles, Zuni bowls, picket baffles, and cobble rundowns. An additional 3,000 feet of improved road drainage wetland rehabilitation were also completed. Approximately 2 miles were treated to improve riparian vegetation. This involved the removal of tamarisk, Siberian elm, Russian olive, and one seed juni-

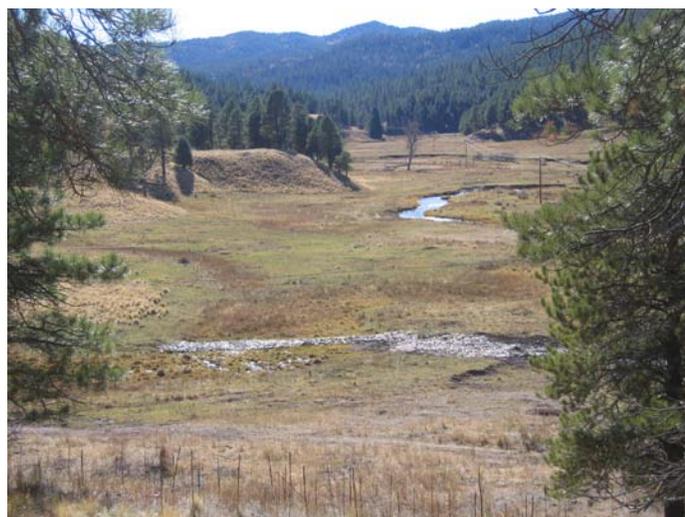
Flow-splitter to protect the wetlands from erosion.

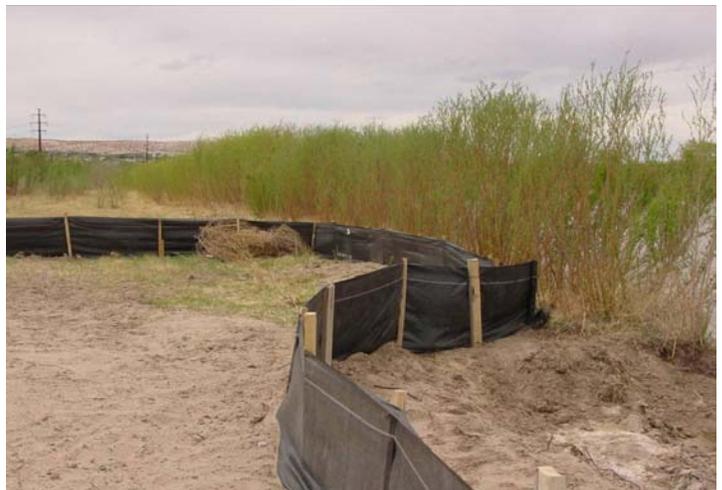
Silt fence to minimize sediment input to the river.

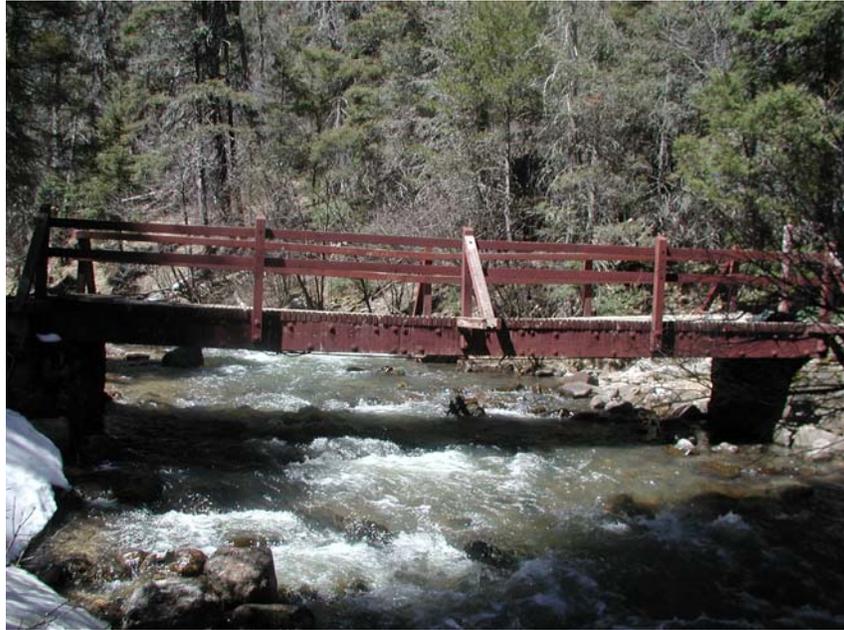
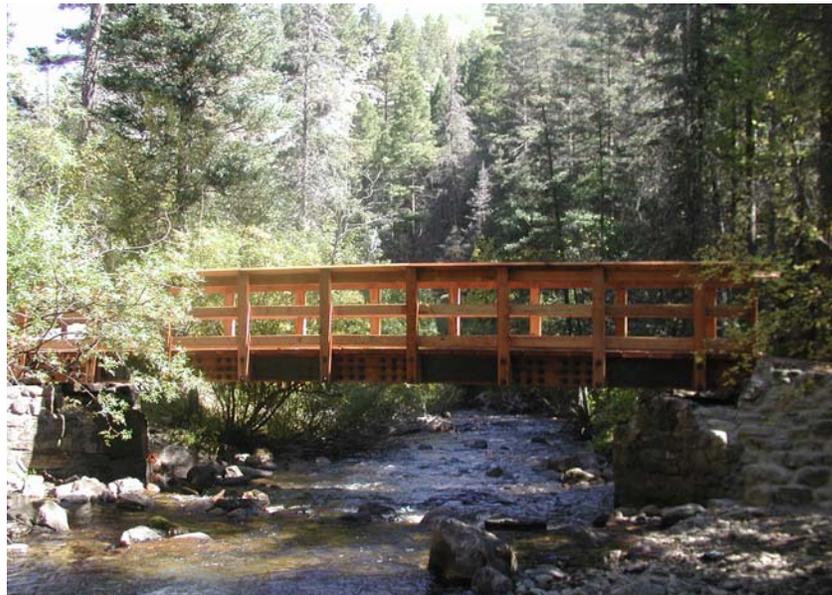
The Carson National Forest replaced the deteriorated bridge across the Rio Santa Barbara, an ONRW, to reduce impacts to water quality from the numerous stream crossings in the area.

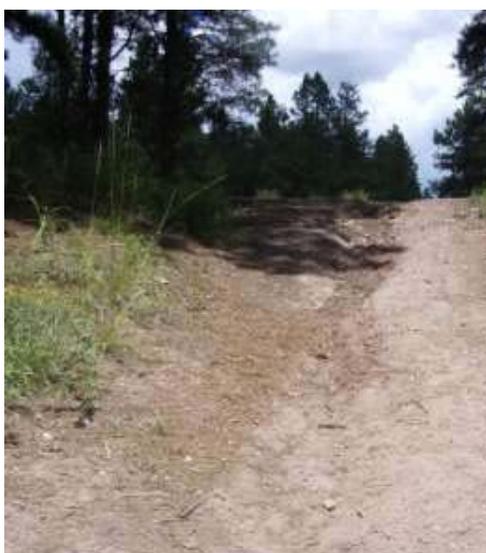
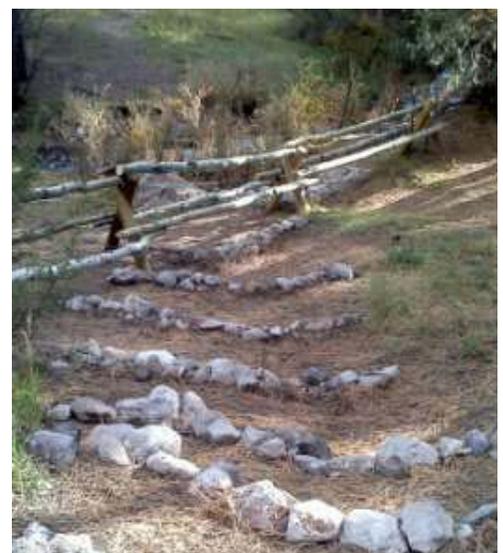
Members of the New Mexico Peace Corps in cooperation with the Santa Fe National Forest constructed rock water bars, buck and pole fence, planted willows, and spread grass seed to reduce erosion. This portion of the project stabilized a hillside to reduce erosion to the Rio Cebolla.
