State of New Mexico Nonpoint Source Management Program

2011 Annual Report

**New Mexico Environment Department
Surface Water Quality Bureau
Watershed Protection Section**

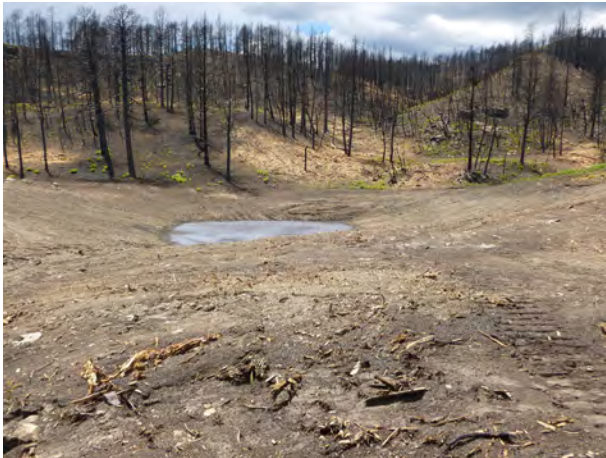
A sediment retention basin constructed above Lake Maloya.

ash concentration of 35%, it is estimated the eight sediment retention basins prevented over 29,000 tons of sediment from entering Lake Maloya. A decision was also made to sacrifice Lake Dorothy in an attempt to trap ash and sediment upstream of Lake Maloya. Water quality continues to be monitored by the City of Raton and the efforts have proven successful for the most part.

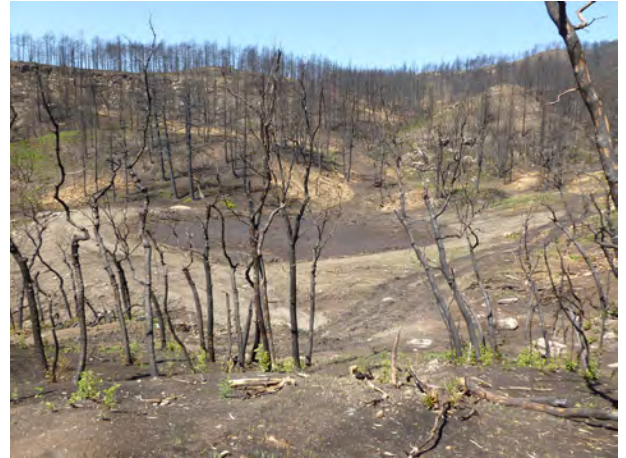
The same sediment retention basin filled following the first good rain after the fire.

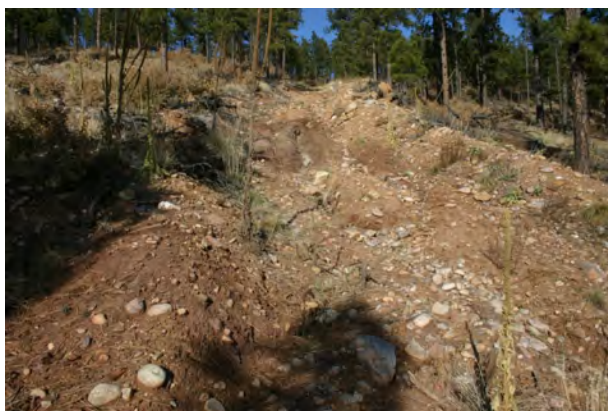
Road prior to reclamation to reduce sediment runoff.

Load reductions were estimated utilizing the STEPL model for all BMPs except those applied to roads. The WEPP model was used to estimate load reductions from improvements to road drainage. The project is estimated to have reduced erosion by 14.2 tons of sediment per year (78 lbs/day on average). This is relative to the TMDL for the Sapello River of 88.8 lbs/day of total suspended solids.

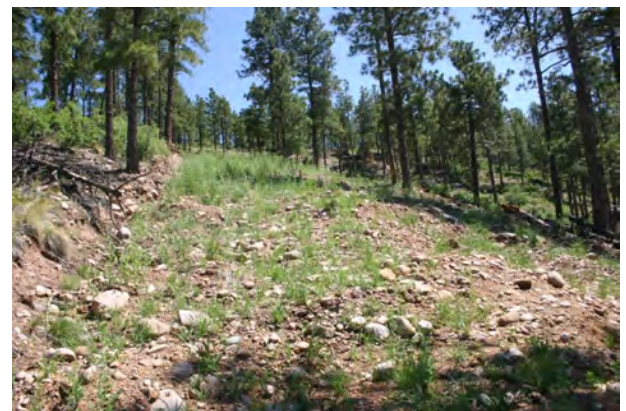
The same road after reclamation.

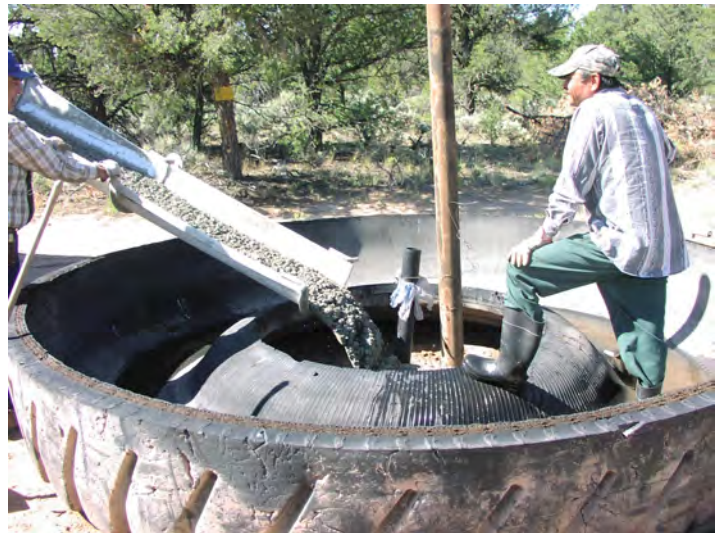
Construction of a "large tire" drinking trough.

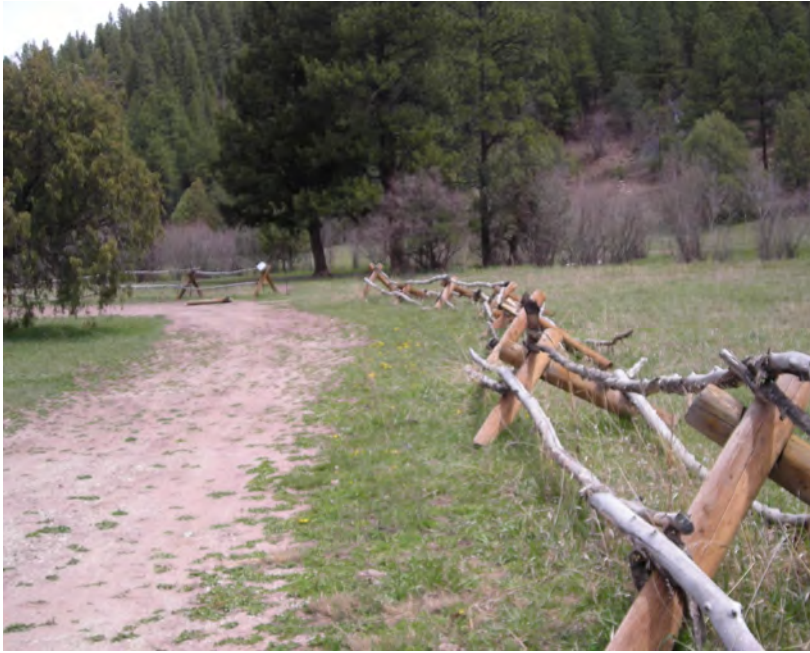
Buck and pole fence, an aesthetic solution to limit vehicular access.

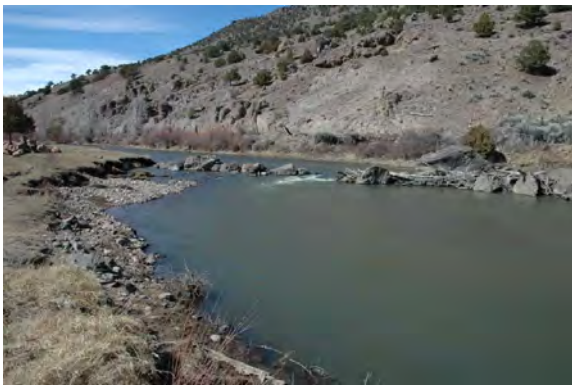
Failed irrigation diversion structure and associated bank erosion.

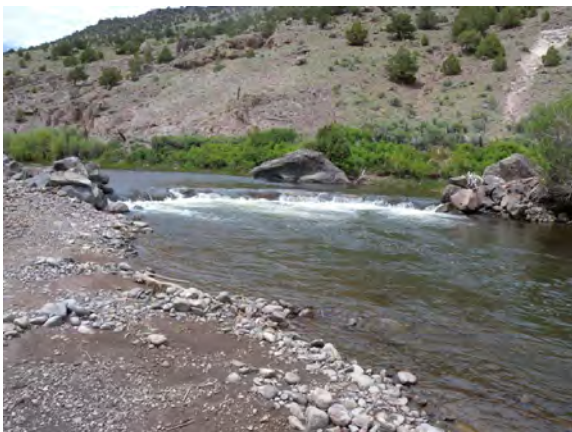
New diversion structure delivers water more efficiently and reduces erosion.

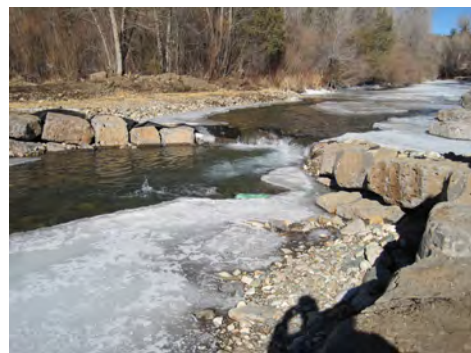
Cross vane on the Pecos River reduces erosion and creates fish habitat.

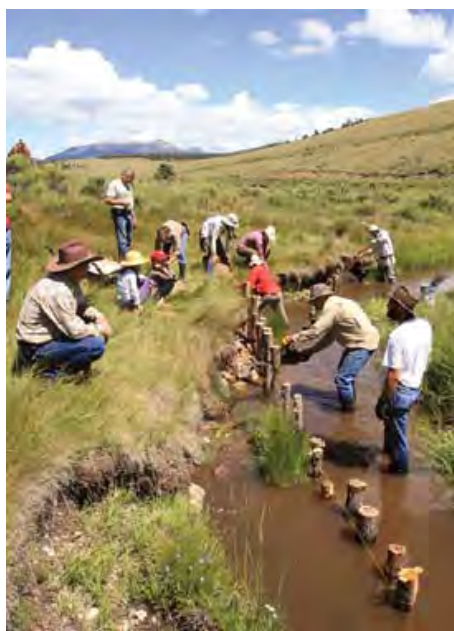
Volunteer crew constructs post vane in Comanche Creek to mitigate stream bank erosion.

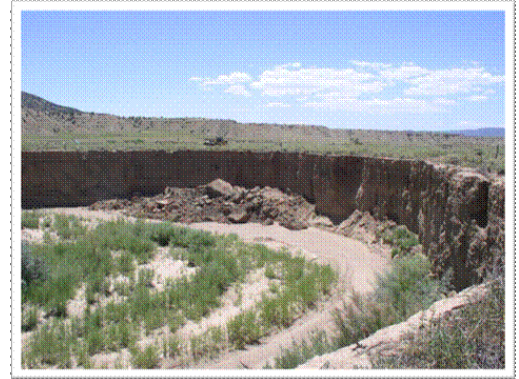
Eroding bank on a meander bend in the Rio Puerco.

Several 35-foot-high arroyo walls along bends of the Rio Puerco near Cabezón, NM were identified for stabilization efforts because they had continued to cut outward with no sign of stopping. They produced large sediment inputs to the river through mass failures and continued to erode private and public land adjacent to the town of Cabezón. Seasonal patterns had developed where the accumulated fallen soil and bank materials would be washed away by the Rio Puerco's considerable intermittent or ephemeral discharges. The flows further undercut the toes of the banks, setting the stage for subsequent bank collapses, the channel-clearing flows, and so on. Left un-stabilized, one of the bends was about to form a meander cutoff that would have bypassed about 2000 feet of river channel and its floodplain.

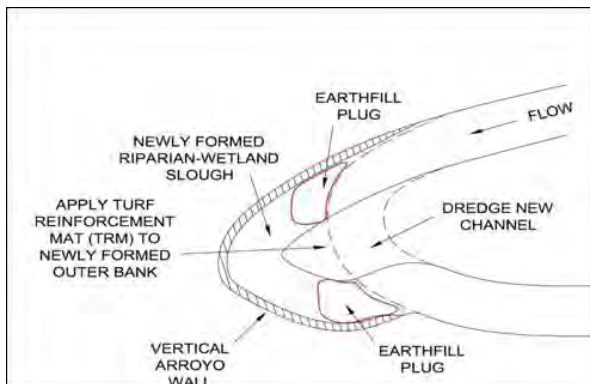
The primary design objective was to stop the retreat of the arroyo walls. To achieve this, the river was re-directed by dredging a new channel through the existing point bar while maintaining a meander of similar geometry, but shifting the radius point of the bend. With this design, a second objective was made possible: creating a riparian/wetland slough in the abandoned channel at the foot of the arroyo wall. Because the dredged material is divided and placed at the ends of the abandoned channel bend - forming two earthfill plugs with a surface elevation at floodplain level - the slough will be flooded when the river exceeds bankfull stage. With vegetation established in the abandoned channel (sloughs) and on the plugs, the design actually results in a net increase in the area of vegetated floodplain within the arroyo walls due to the slightly shorter length of the new channel.

Project design.

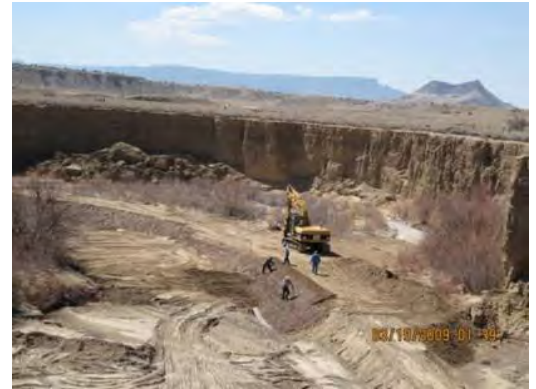
Project under construction.

The project was completed in March 2009 with the application of turf reinforcement mat (TRM) on the outside banks of the newly-excavated stream channels and earthfill plugs. Re-positioning the active channel away from the foot of the arroyo wall has resulted in eliminating the undercutting of the arroyo walls and the mass failures into the river.

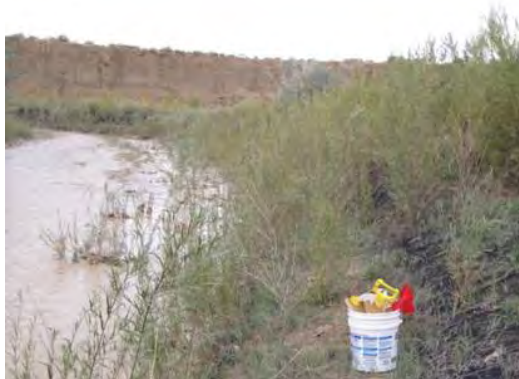
Healthy stand of willows growing on the new riverbank.

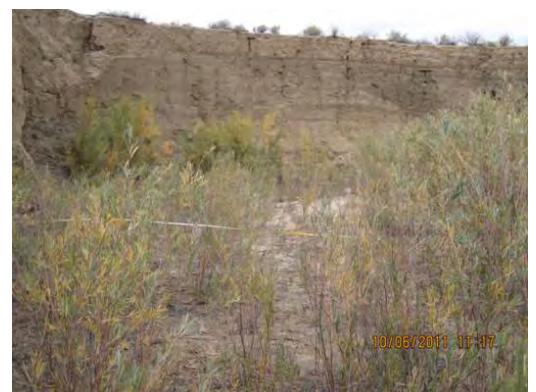
Willows colonizing the wetland slough.
