State of New Mexico Nonpoint Source Management Program

2012 Annual Report

**New Mexico Environment Department
Surface Water Quality Bureau
Watershed Protection Section**

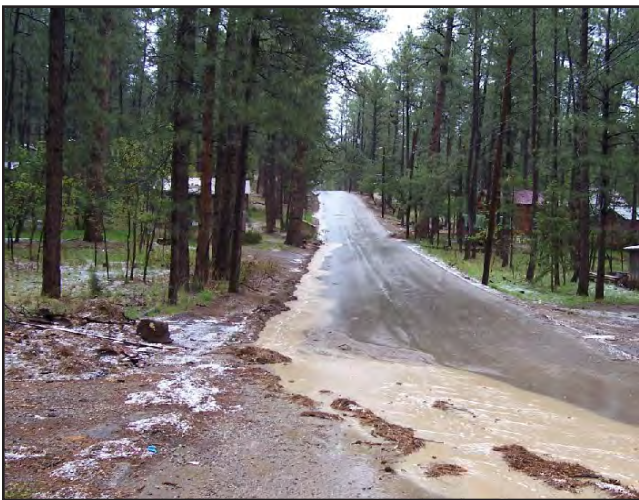
Sediment laden stormwater.

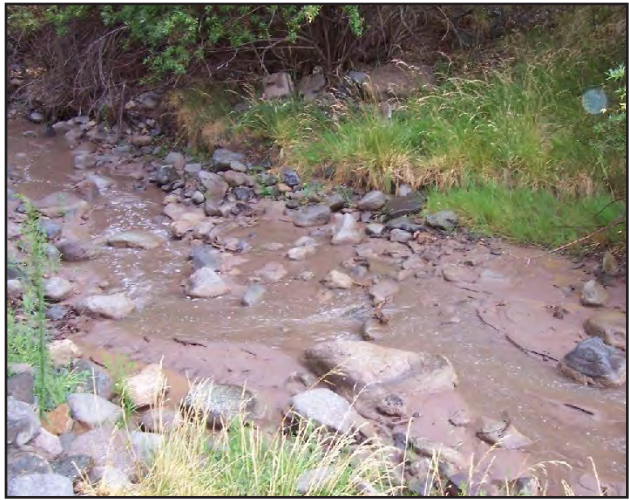
Sediment choking stream bottom.

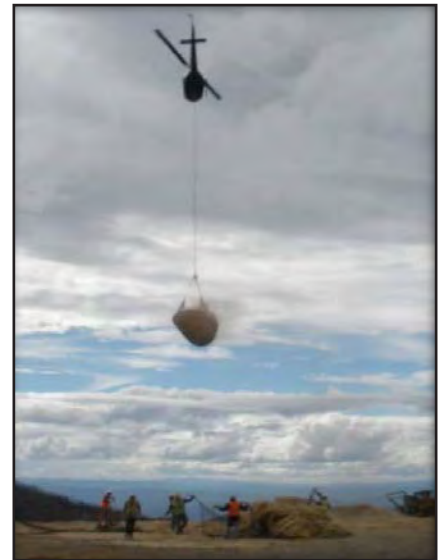
Helicopter with a load of straw mulch for the aerial mulching operation. (USFS photo)

Several actions outlined in the BAER reports have been carried out. These typically include aerial seeding and mulching, removal of infrastructure that may impede flood flow, and pumping of campground vault toilets near streams. 26,200 acres in the Whitewater Baldy Complex Fire area were aerially seeded, at a cost of \$1.7 million. 14,204 acres of the Whitewater Baldy Complex Fire burned area were mulched, at a cost of \$11.4 million. NRCS funded 1,500 acres of aerial seeding on private lands in the Little Bear Fire area, through the Emergency Watershed Protection Program. The Gila National Forest evacuated isolated populations of Gila Trout, and relocated them to the Mora Fish Hatchery and fishless streams elsewhere in the region.

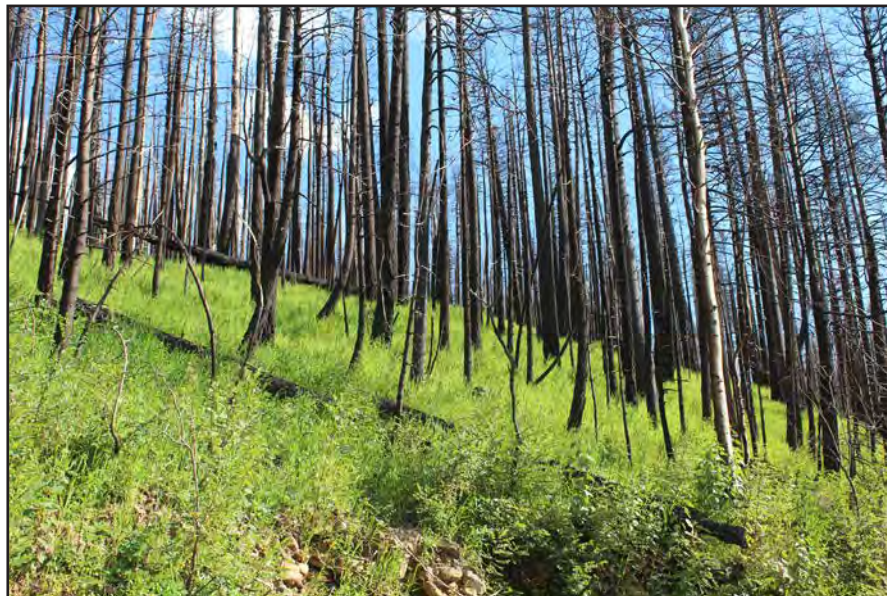
High severity burn area in the Mineral Creek Watershed that was aerial seeded with certified noxious weed-free seed mixture of native perennial grasses and annual barley, which is a quick growing non-persistent annual that provides protective ground cover in a short period of time.

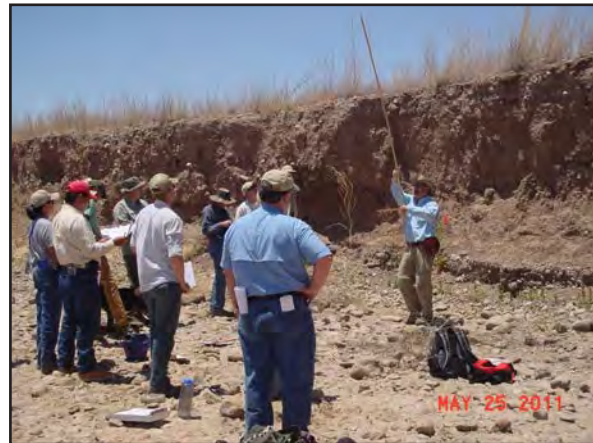
Bank Erosion Hazard Index field exercise during Streambank Stabilization Workshop with Dr. Barry Southerland (NRCS).

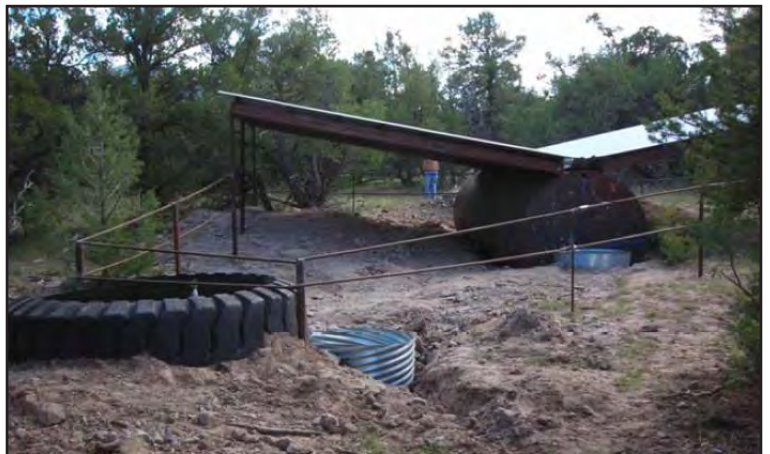
Completed trick tank

- *Allotment Management.* Two trick tanks were constructed as alternative water sources on the uplands of the 14,500 acre Polvadera Creek allotment in an effort to relocate livestock use away from the sensitive riparian areas.

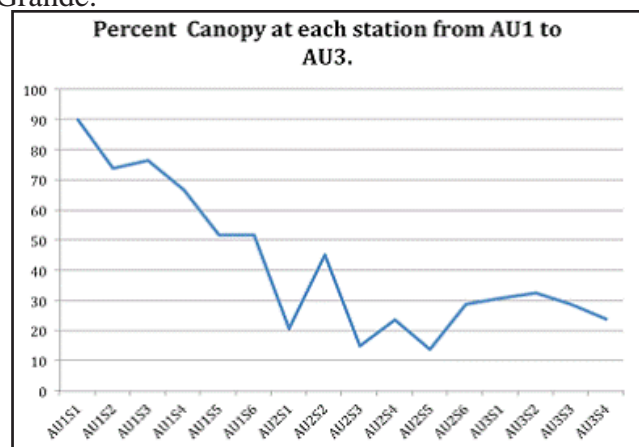
Percent shade measured on the Rio Pueblo de Taos, from upstream to downstream.

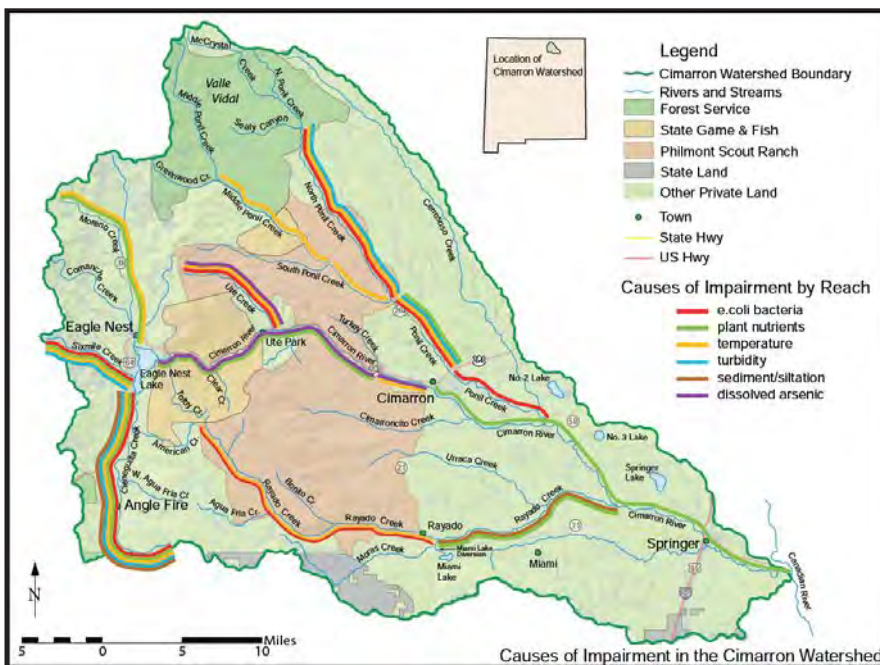
Impairments: Each of the fifteen stream sections has one or more parameters that exceed water quality standards, and for which TMDLs have been developed (see figure below).

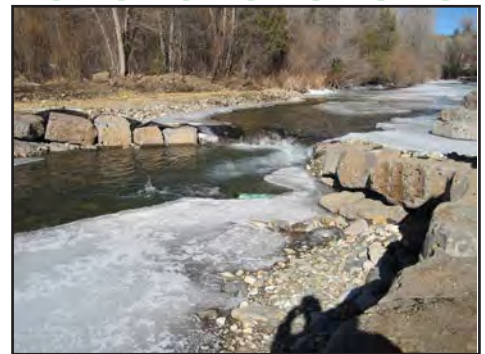
Cross vane on the Pecos River reduces erosion and creates fish habitat.

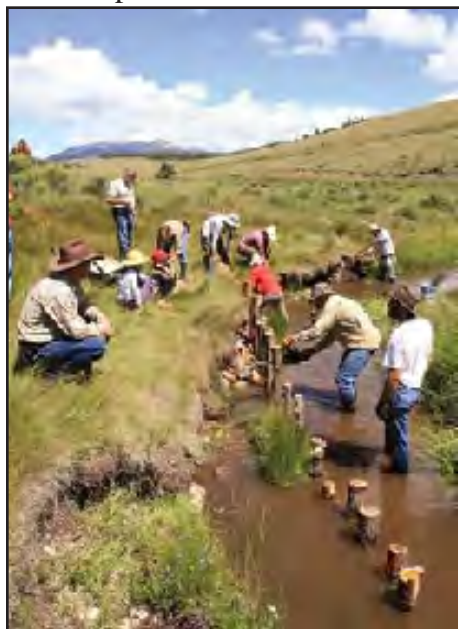
Volunteer crew constructs post vane in Comanche Creek to mitigate stream bank erosion.

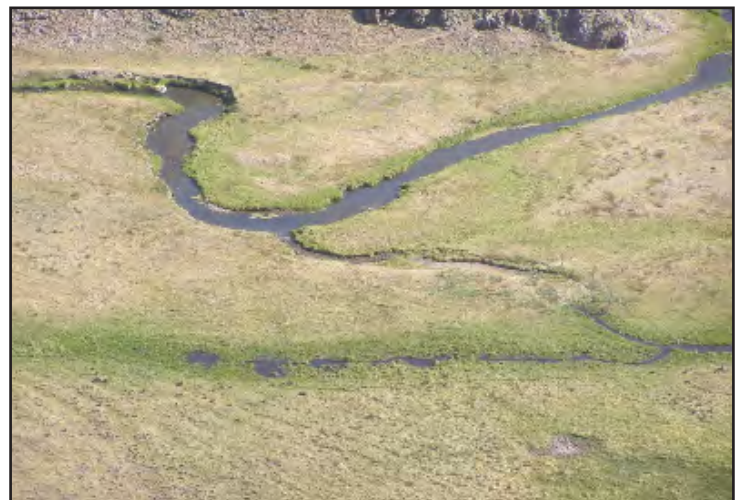
Emerging wetland along San Antonio Creek (channel in foreground) only two weeks after construction.

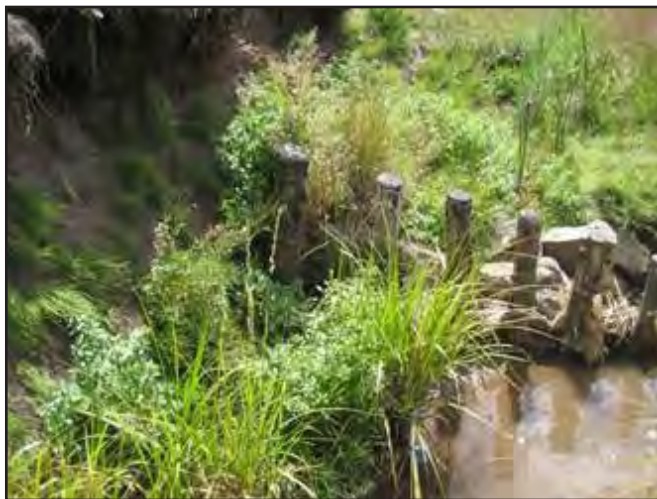
A post vane constructed on Cieneguilla Creek to divert high velocity flow away from a cutbank. Photo courtesy Cimarron Watershed Alliance.

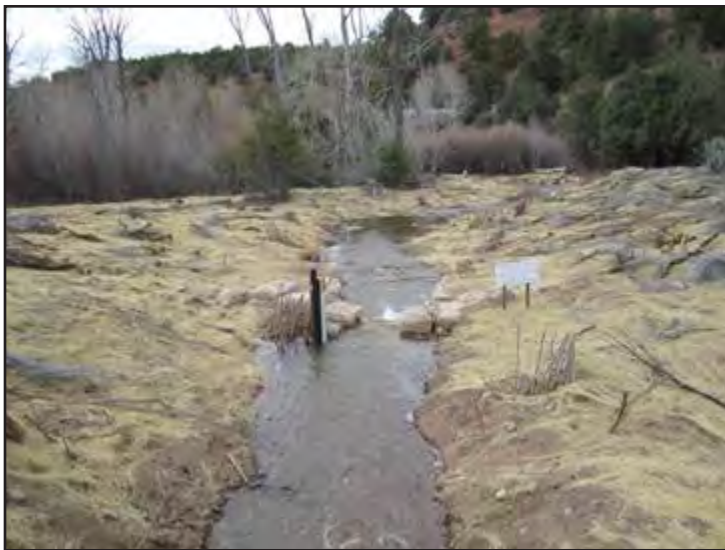
The new Santa Fe River channel, immediately following construction and planting. Photo by Santa Fe Watershed Association.

A 1,200 foot river channel featuring riffles and pools was constructed with heavy machinery. A new irrigation diversion structure was built, 300 native shrubs and trees were planted by volunteers, and the disturbed area was hydro-seeded with grass and mulched. In addition, the underground pipes were cut to re-route the water into the channel, and a flow meter was installed to measure discharge along the stream. The success of the project is supported by the City of Santa Fe's 2012 Living River Ordinance which commits to a release of 1,000 acre-feet from the reservoir to the river bed (pro-rated in drought years).

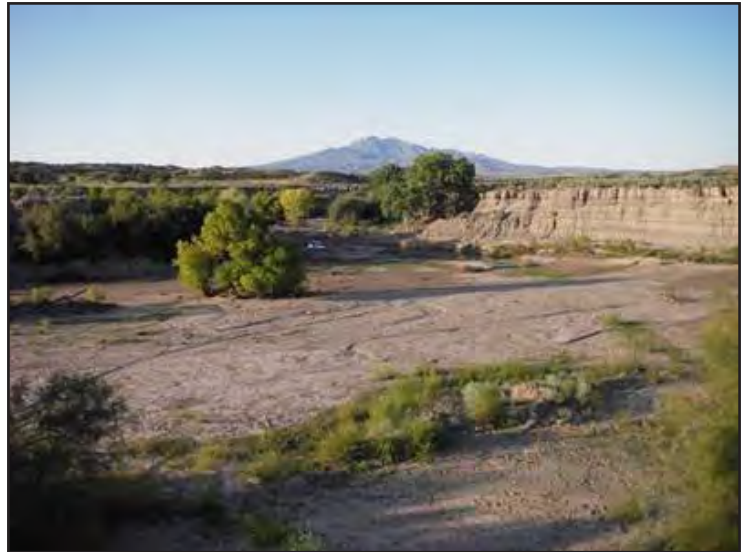
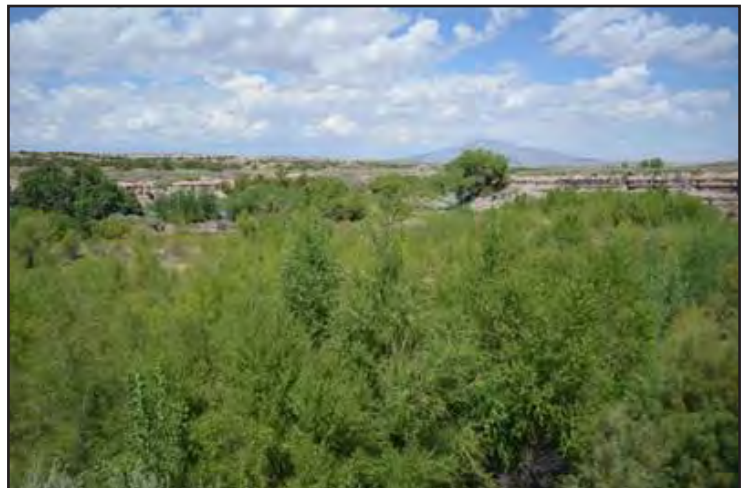
La Jencia Creek before restoration (2006-top) and after restoration (2012-bottom).

WildEarth Guardians removed non-native vegetation (salt cedar and Russian olive) from the riparian area, and planted 10,000 willows, 1,500 cottonwoods, and 200 native forage species. Densely planted willow thickets proved effective in holding stream meanders in place while withstanding a subsequent flash flood. Students from Colorado College assisted annually with the riparian plantings, providing volunteer labor and the opportunity for service learning about riparian desert ecosystems. Two additional grants from the US Fish & Wildlife Service (US FWS) focused on creating two wetland ponds and planting native riparian vegetation in the main cienega. These areas provide habitat for a wide range of aquatic, terrestrial and avian species. In 2010, 38 northern leopard frogs were introduced to the area by the USFWS as part of plans to establish a frog refugium.

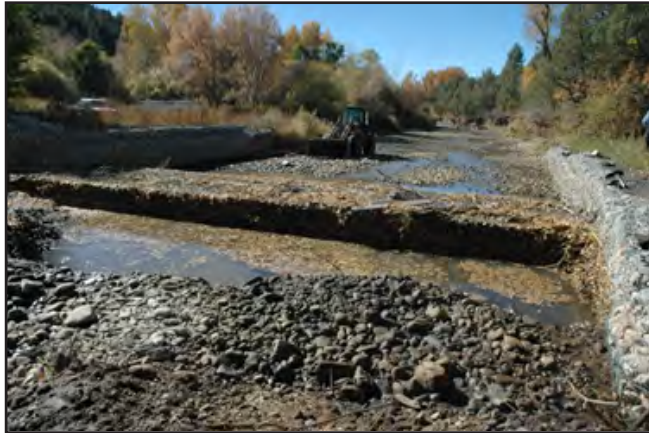
Project area before restoration, looking downstream at the old gabion dam in the west channel. Photo courtesy of Upper Pecos Watershed Association.

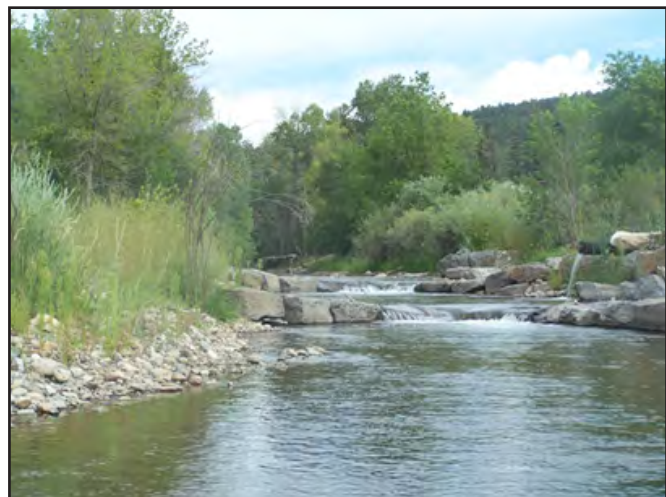
Project area looking upstream in west channel. Photo courtesy of Upper Pecos Watershed Association.

The Upper Pecos Watershed Association managed the project that included permitting, monitoring, construction, and planting work in both river channels. All of the construction objectives were met, resulting in a narrower, deeper river in the west channel and a new wetlands area with a small stream channel in the east channel. The boulder cross vanes are oxygenating the water and reducing water temperature, and the vegetation in both areas is providing increased canopy cover to reduce water temperature. In addition, the wildlife habitat benefits of the project have been significant.

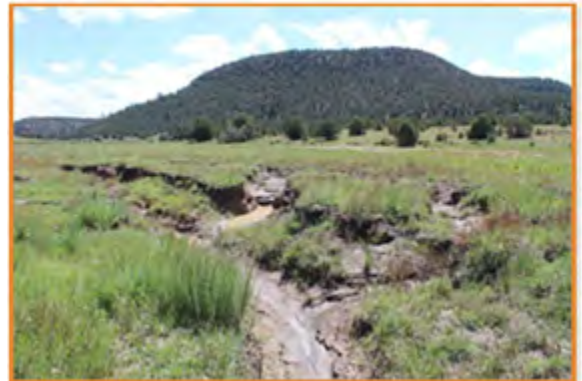
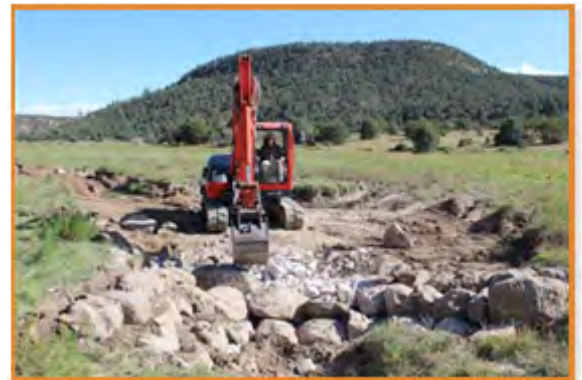
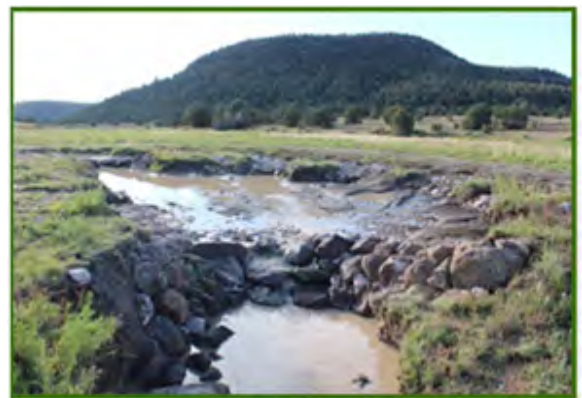
Before (top), during (middle), and after (bottom) construction of a Zuni Bowl to arrest headcut migration that was draining valley wetlands.

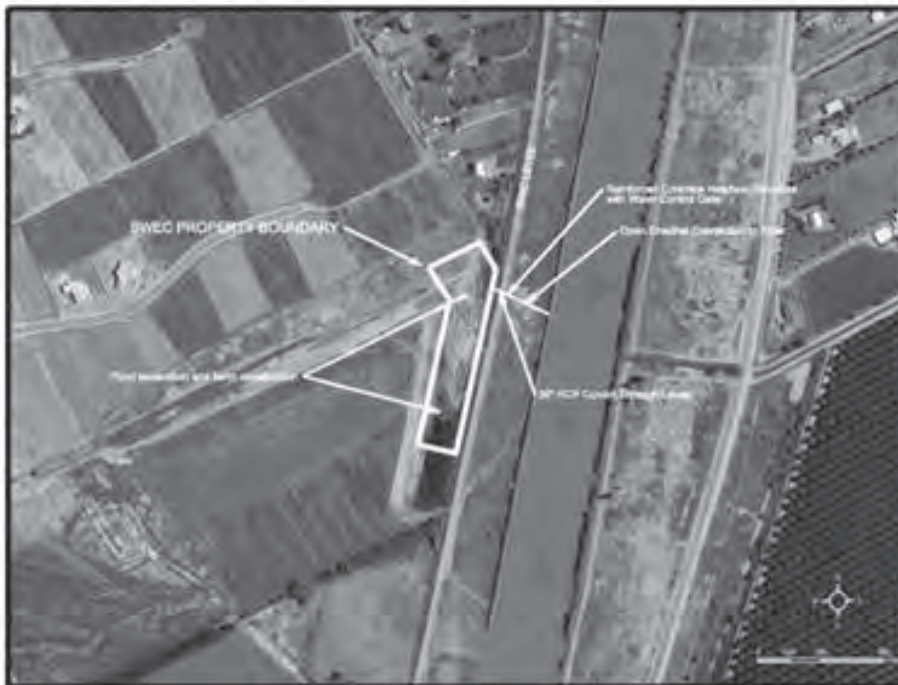
Aerial photo of the La Mancha Wetland site adjacent to the Rio Grande River south of Las Cruces, New Mexico. Labeled photo courtesy of Southwest Environmental Center.

The La Mancha Wetland project is located on three acres of land owned by the Southwest Environmental Center and adjacent federal land along the Rio Grande near Mesilla, NM. When completed, it will consist of ponds that are connected to the river, simulating a side channel of the river, and creating year-round backwater habitat that is extremely important as fish spawning, nursery and feeding grounds for native fish. This type of slow-water habitat has largely been eliminated from the Rio Grande in southern New Mexico and west Texas. Southwest Environmental Center oversaw the excavation of the La Mancha Wetland with 2008 RERI funds. A second allocation of (2010) RERI funding will complete the project in 2014. The project was delayed by administrative processes in acquiring water rights. When completed, the project will provide wildlife habitat and environmental education and public recreation opportunities.

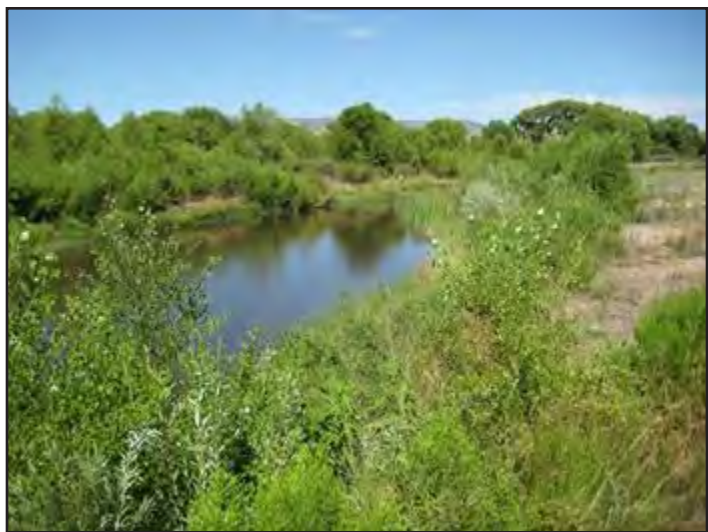
Summer 2007 (top photo) and Summer 2012 (bottom photo) at the Iron Bridge Tract, Gila River. Photos courtesy of The Nature Conservancy.

The Nature Conservancy restored 1.5 miles of river bank and 238 acres of floodplain habitat on three riverfront properties (Gila Farm, Agnew Tract, and Iron Bridge Tract). Trespass livestock were fenced out of the riparian area, allowing riparian vegetation to re-generate naturally. Exotic trees (salt cedar, Siberian elm, and tree of heaven) were removed using cutting and herbicide treatments. Native trees, shrubs and grasses were planted. The work was performed by numerous local subcontractors and by volunteers from the Upper Gila Watershed Alliance. The outcomes of the project are improved plant, animal and hydrologic diversity along the Gila River. As the trees and willow thickets mature, the river channel will narrow and deepen, and water temperature will be reduced by shaded river banks.

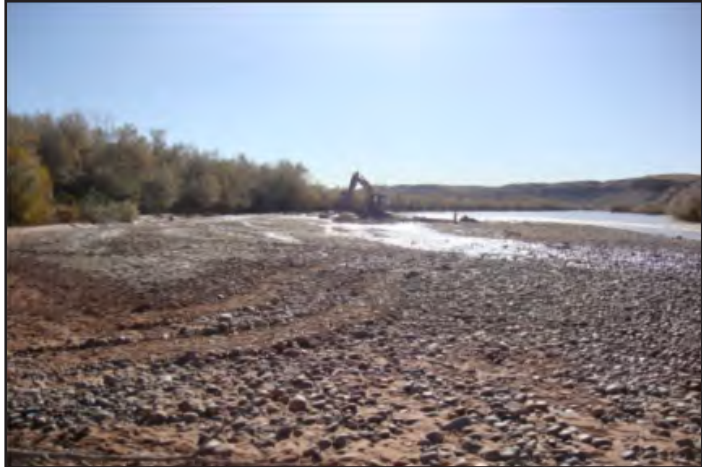
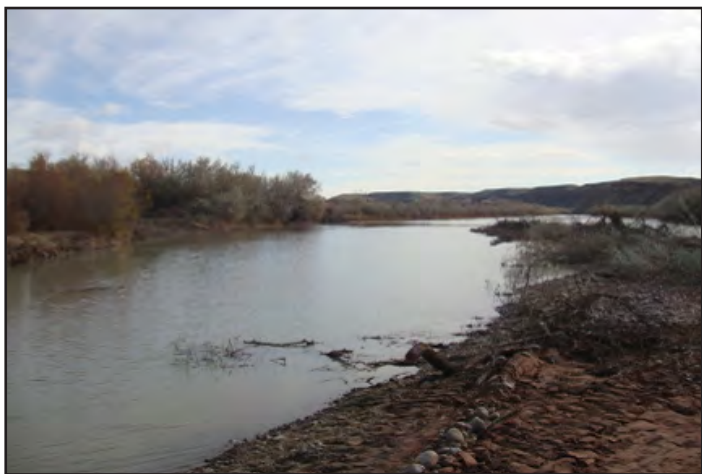
San Juan River Inlet (#127.2N) before (top photo) and after (bottom photo) channel reconnection. Photo courtesy Keller-Bliesner Engineering.

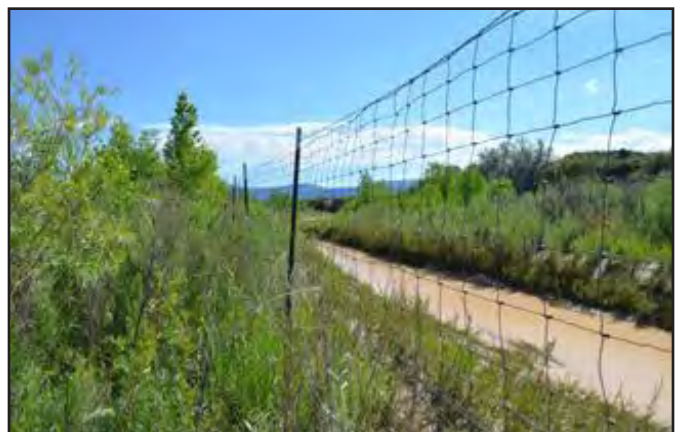
*The same location as the above photo in 2012.
Riparian vegetation is flourishing.
Photo courtesy WildEarth Guardians.*

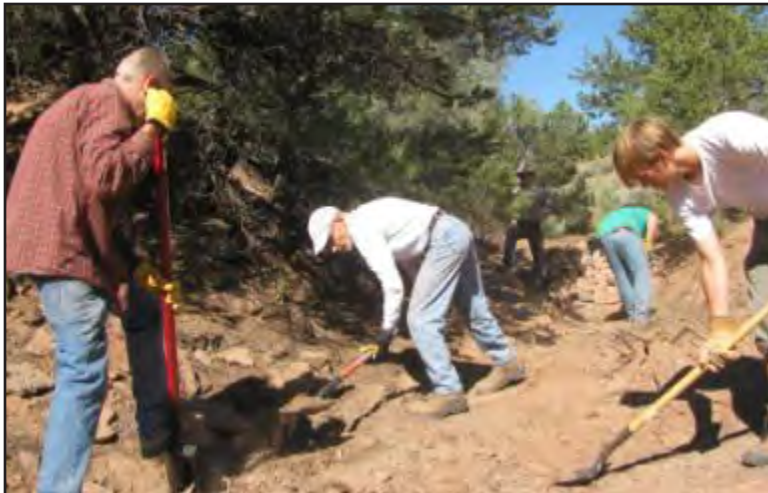
Community work event at Galisteo Creek in October 2010. Volunteers are building rock structures for erosion control. Photo courtesy of EarthWorks Institute.

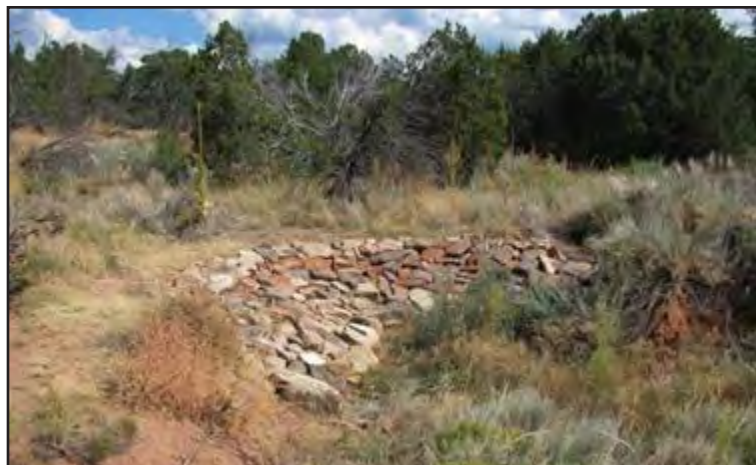
A media luna rock structure constructed at Galisteo Creek to disperse flow. Photo courtesy of EarthWorks Institute.

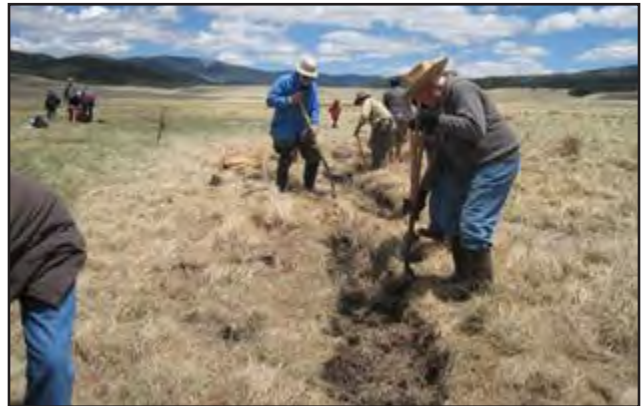
*Project volunteers from Los Amigos de Valles Caldera dig and haul sod to form a channel plug.
Photo by Karen Menetrey, NMED.*

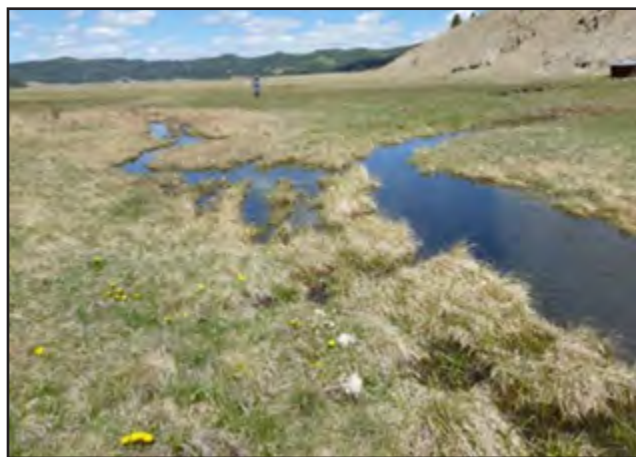
*The plug re-routes water to the new channel, raises the water table and expands wetlands.
Photo by Van Clothier, Stream Dynamics.*

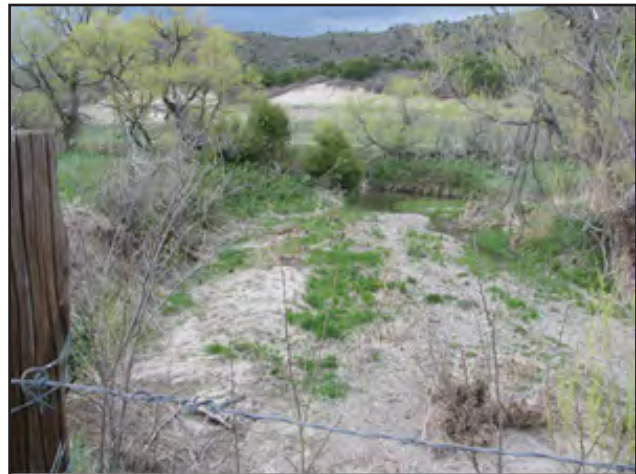
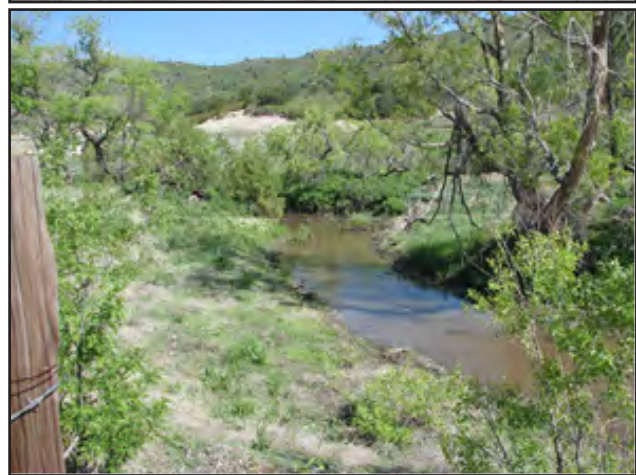
Meander reinstatement #1 on the Dry Cimarron before construction, May 2010 (top photo) and after construction showing dramatic recovery, May 2012 (bottom photo). Photos by the Quivira Coalition.

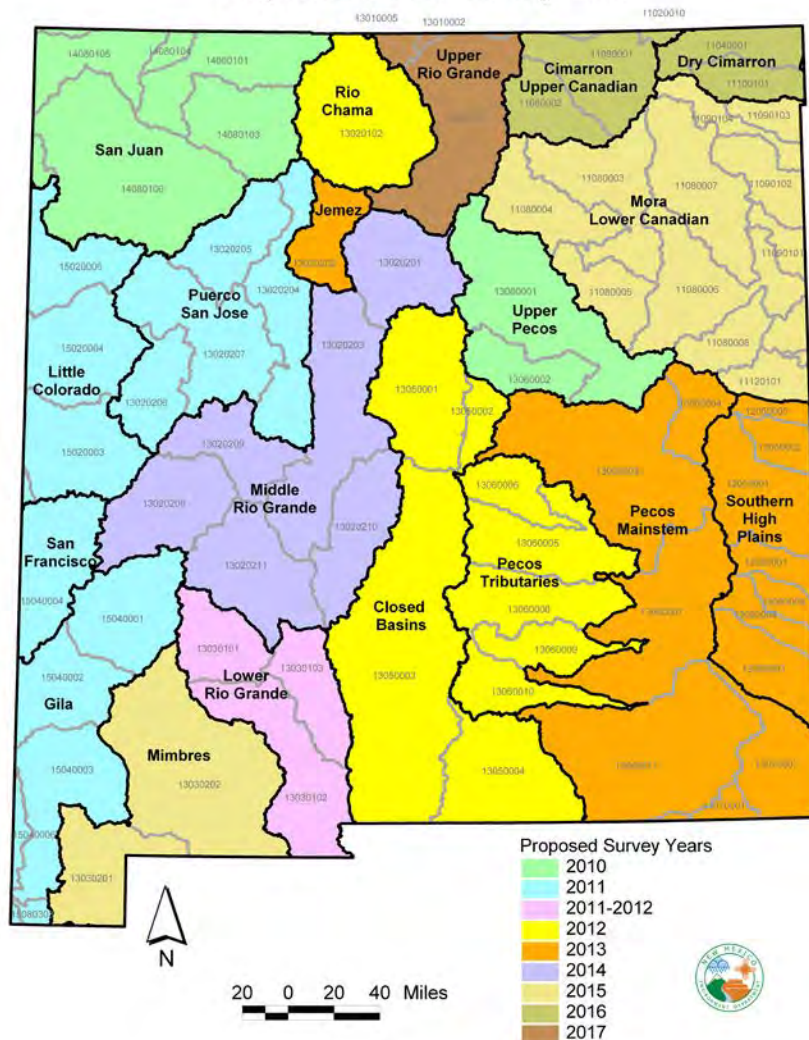
Proposed 8 Year Survey Plan

The Monitoring, Assessment, and Standards Section conducted two primary water quality surveys in 2012, collecting water quality data from 112 monitoring locations within 63 stream assessment units and 8 lake assessment units covering 888 stream miles and 14,848 lake acres. The watersheds surveyed included the Rio Chama (598 miles, 14,798 acres) and the Sacramento Mountains (290 miles, 50 acres). These surveys are part of an eight year rotation throughout the state (see Figure). In 2013, the SWQB will focus on the Jemez and Lower Pecos river basins.

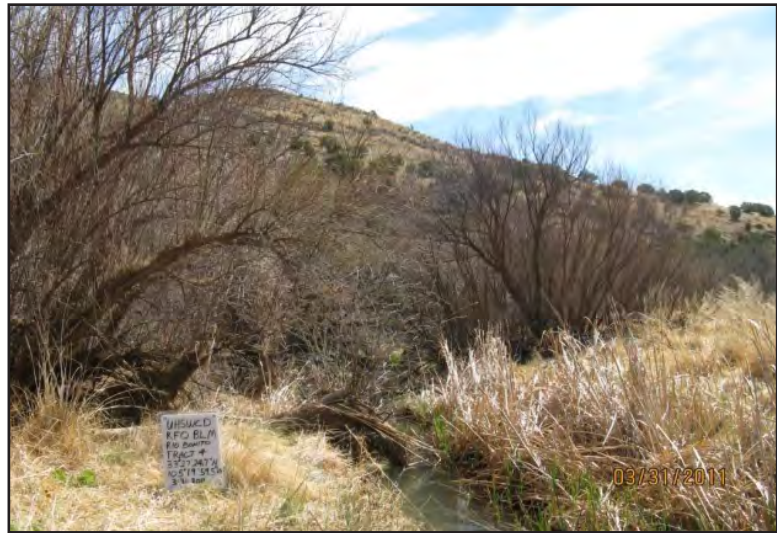
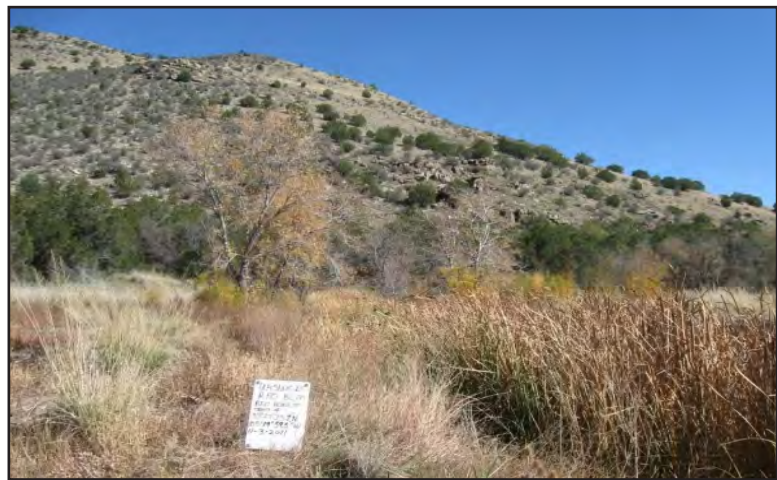
Before (top) and after (bottom) photos of the extraction of salt cedar on Rio Bonito.

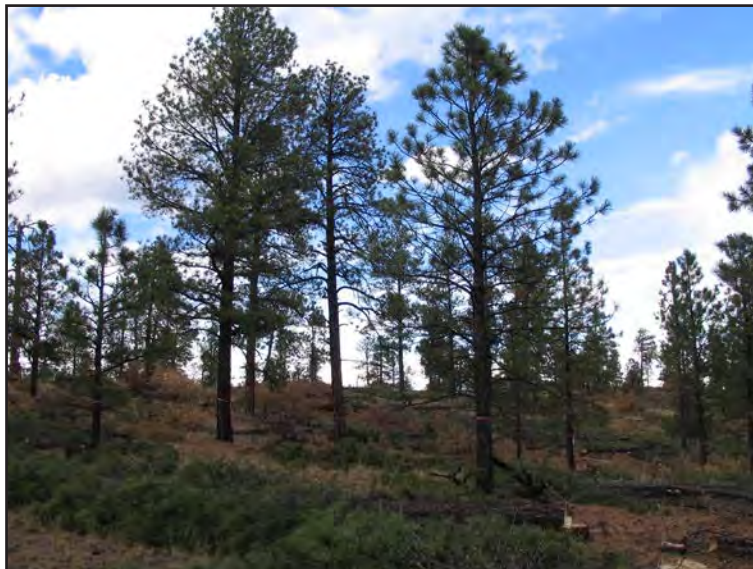
Lop & Scattering of Slash

Watersheds	Project Description	Watershed Benefits
Canadian Headwaters (Chicorica Creek- Canadian River)	Timber harvests (595 ac) mixed conifer forests. Waterbarring of access roads and skid trails, lop & scattering of slash and seeding of critical areas.	<ul style="list-style-type: none"> • Reduce runoff, erosion, sedimentation due to increased herbaceous ground cover and waterbars. • Increase water infiltration.
Rio Chama (Chavez Creek)	Timber Harvests (270 ac) in ponderosa pine and mixed conifer forests Graded dips, waterbarring of access roads and skid trails, lop & scattering of slash and seeding of critical areas.	<ul style="list-style-type: none"> • Reduce runoff, erosion, sedimentation due to increased herbaceous ground cover and waterbars. • Increase water infiltration.
Rio Chama (Chavez Creek – Rio Chama)	Timber harvests (200 ac) in ponderosa pine and mixed conifer forests Waterbarring of access roads and skid trails, lop & scattering of slash and seeding of critical areas.	<ul style="list-style-type: none"> • Reduce runoff, erosion, sedimentation due to increased herbaceous ground cover and waterbars. • Increase water infiltration.

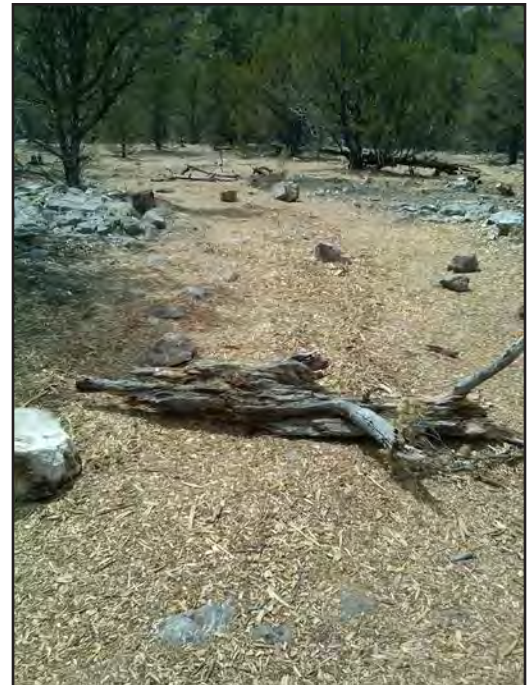
Skid Trail Rehabilitation and Closure

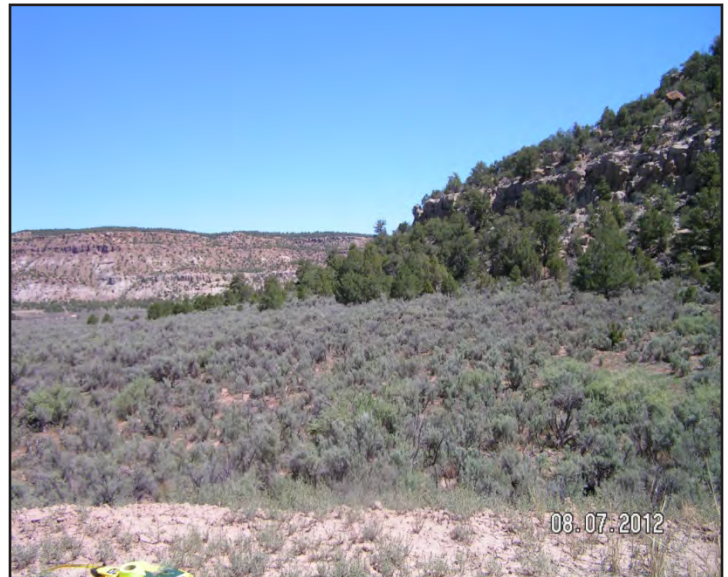
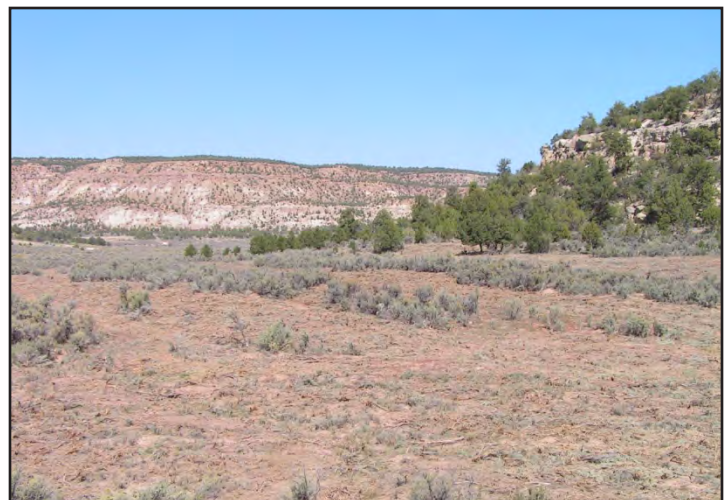
Ciruelas Canyon before (top photo) and after (bottom photo) treatment.

- Vegetation treatment - Mowed and seeded 200 acres of big and hoary sagebrush. The areas were seeded with two different seed mixes and hand seeded with winterfat.
- Livestock Distribution - Installed 3.6 miles of water line in Circules and Ahogadero canyons. Installed 4 drinking troughs and 1 storage tank in Circules and Ahogadero canyons
- Wildlife Waters – Repaired the Valencia and Ciruelas solar water wells to an operative condition; and fenced both with pipe and cable. Maintained 3 springs and 4 guzzlers for wildlife.
- Energy Development - Plugged and abandoned 4 gas wells. Reclaimed 16.4 acres of well pads and roads. Closed and reclaimed 1.44 miles of road with installation of silt traps.

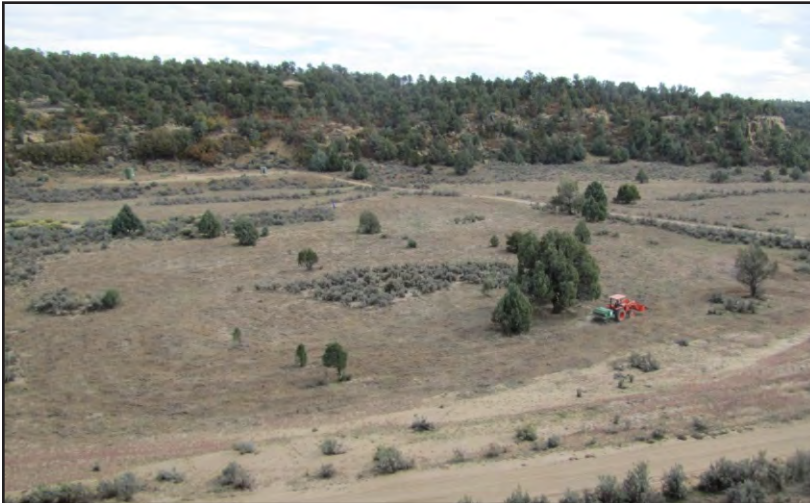
Seeding Operations in Cottonwood Canyon

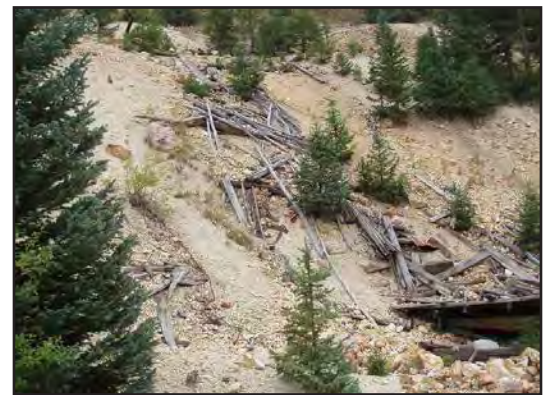
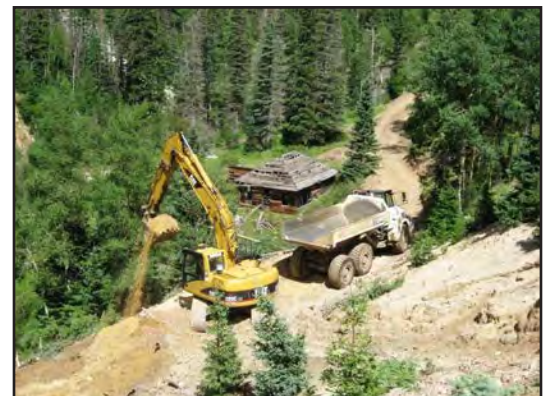
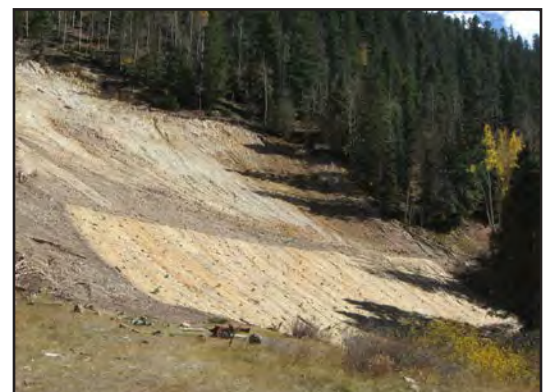
Memphis Mine before (top), during (middle), and after (bottom) remediation

The waste removal at Big Five Mine was completed in 2012 and revegetation activities will occur in 2013, which will complete all remediation work within the Bitter Creek watershed.
