# **State of New Mexico Nonpoint Source Management Program**

## **2013 Annual Report**

**New Mexico Environment Department  
Surface Water Quality Bureau  
Watershed Protection Section**

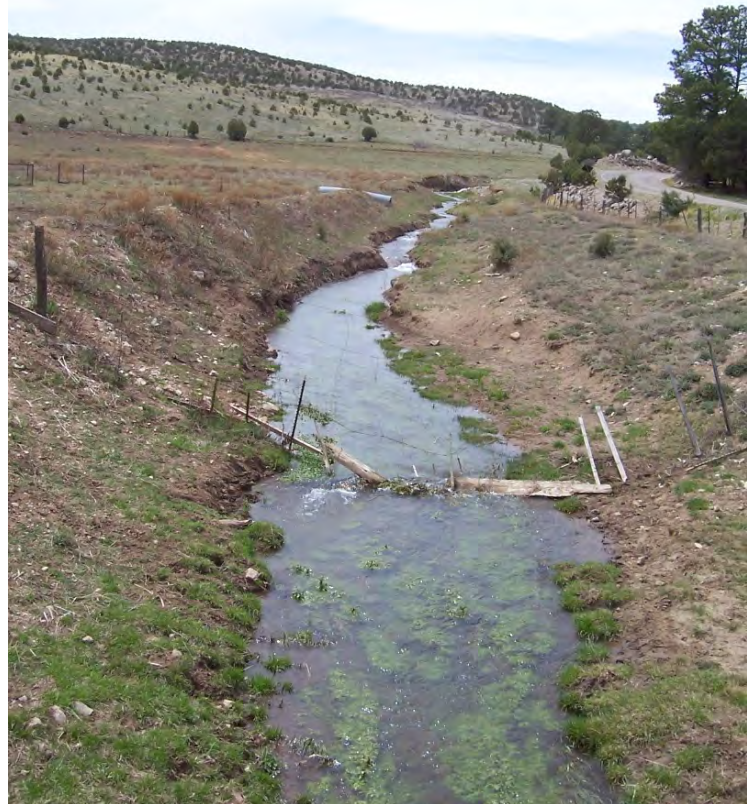
*An incised stream that has been re-located and straightened over time. It is devoid of canopy and choked with algae indicating nutrient impairment.*

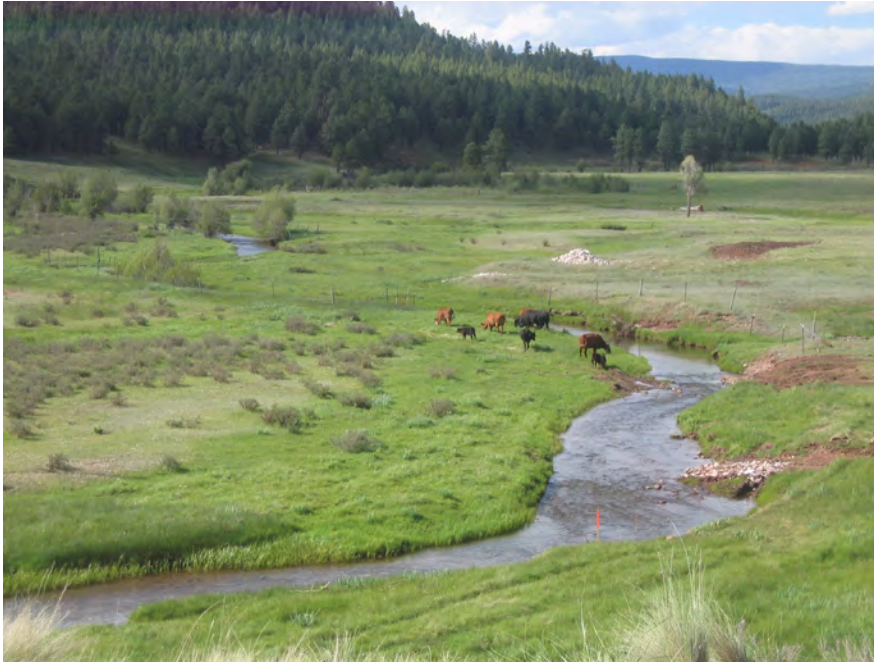
*Cattle along the stream have de-stabilized the banks causing overwidening, and loss of riparian vegetation. Fencing has been installed to direct cattle away from sensitive banks.*

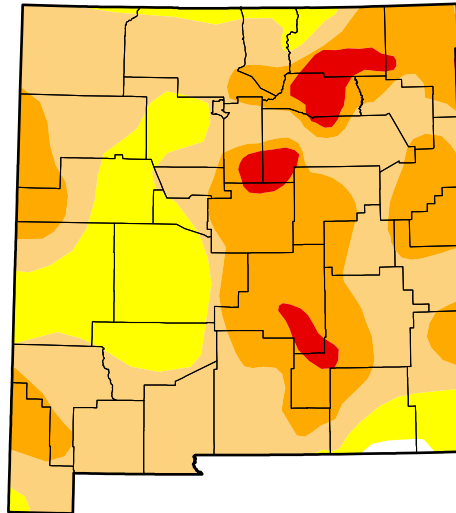
### U.S. Drought Monitor New Mexico

January 21, 2014  
 (Released Thursday, Jan. 23, 2014)  
 Valid 7 a.m. EST

Drought Conditions (Percent Area)					
	None	D0-D4	D1-D4	D2-D4	D3-D4	D4
Current	0.39	99.61	79.94	33.13	3.97	0.00
Last Week 1/14/2014	0.39	99.61	79.94	33.13	3.97	0.00
3 Months Ago 10/22/2013	1.75	98.25	73.96	37.69	3.39	0.00
Start of Calendar Year 12/31/2013	0.39	99.61	75.21	32.68	3.96	0.00
Start of Water Year	-	-	-	-	-	-
One Year Ago 1/22/2013	0.00	100.00	98.45	92.97	31.76	0.97

*U.S. Drought Monitor Map for the state of New Mexico from January 21, 2014. Map courtesy of the National Drought Mitigation Center, Lincoln, Nebraska.*

Drought conditions have persisted throughout the west for much of the last 10 years. New Mexico is no exception, and in four of the last five years the state has experienced extremely dry conditions. As the U.S. Drought Monitor map shows, New Mexico started 2013 with 93% of the state in severe drought conditions, and 32% in extreme drought conditions. These conditions improved somewhat over 2013, but 33% of the state remained in severe drought conditions by year's end.

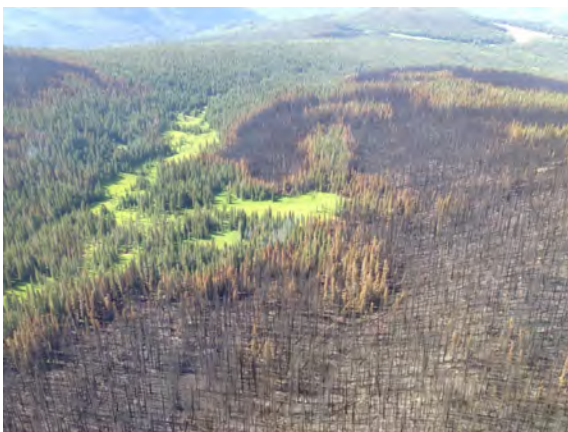
*Burned hillside in the Pecos Wilderness following the Jaroso Fire. Photo courtesy of the Santa Fe National Forest.*

considered for the most part consistent with management objectives and with normal fire behavior for the affected forest types. The 10,219 acre Tres Lagunas Fire burned closer to the Pecos River, downstream of the Jaroso Fire area, and quickly resulted in obvious negative impacts to this popular fishing stream, in the form of increased sediment loading from steep tributary canyons. 1,533 acres within the Tres Lagunas Fire burn area were classed as severe. The Tres Lagunas Fire and the Pecos River were subjects of a site visit on August 6 by EPA's Assistant Administrator for Water, Nancy Stoner, who was attending the national Association of Clean Water Administrators conference in Santa Fe.

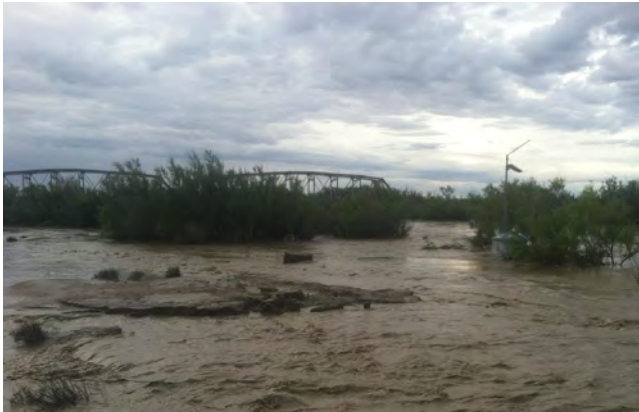
*Rio Puerco at Bernardo, New Mexico flowing approximately 8,000 cfs on September 16, 2013. Average discharge in September for the period of record is 5 cfs. Photo courtesy of the U.S. Army Corps of Engineers.*

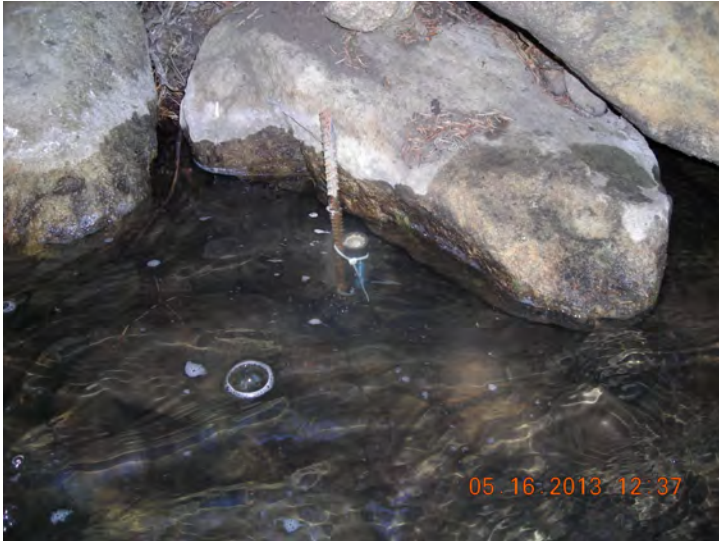
*Thermograph deployed in Middle Ponil Creek by securing to rebar with zip ties.*

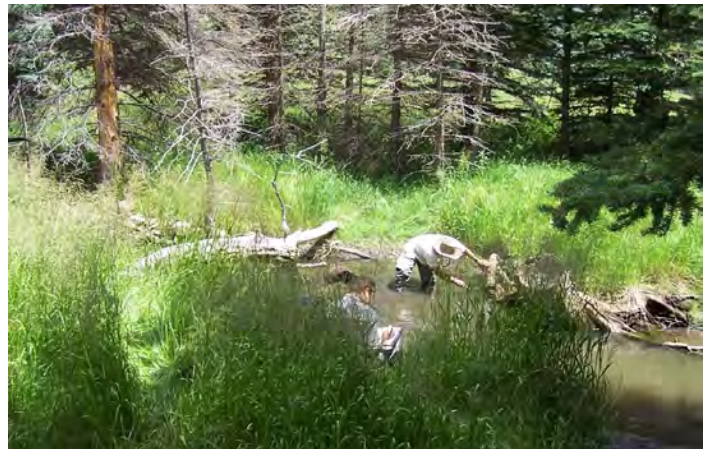
*Crew installing a thermograph on Middle Ponil Creek.*

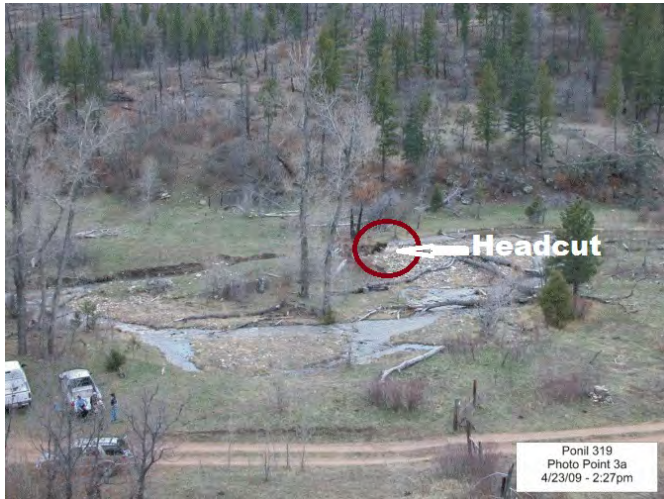
*Middle Ponil Creek before meander restoration and headcut treatment.*

To address these problems, the Cimarron Watershed Alliance, in cooperation with Philmont Scout Ranch, Vermejo Park Ranch, and the New Mexico Department of Game and Fish, built nine small elk exclosures, planted and protected twenty-one cottonwood poles, stabilized five road crossings, restored flow to a meander (which arrested upstream movement of a head cut), and stabilized two cut banks with log vanes and post vanes. The cooperators also developed more detailed designs for three potential future project areas, and conducted a monitoring workshop in 2011 to teach the basics of monitoring for eighteen stakeholders interested in stream restoration. These activities were distributed throughout eleven miles of Middle Ponil Creek.

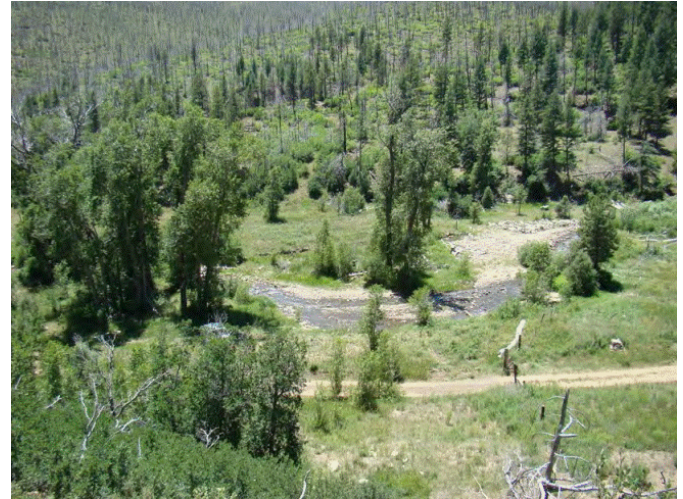
*Middle Ponil Creek after meander restoration and headcut treatment.*

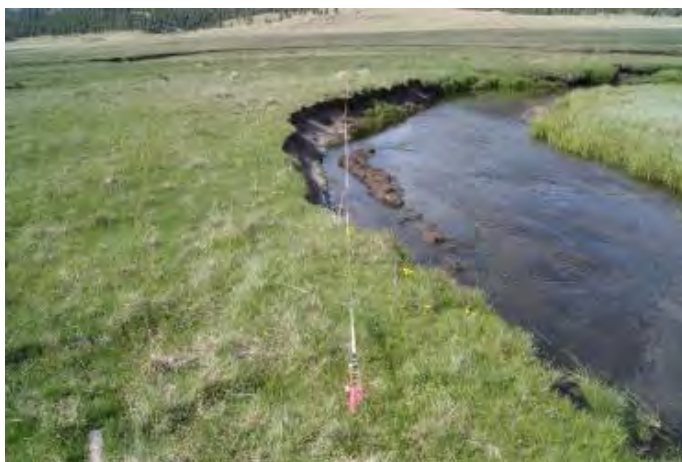
*Eroding meander bend before treatment in May 2013*

This project used innovative geomorphic stream restoration techniques to restore functioning condition. The table below describes the treatments and outcomes:

Treatment	Number	Problems Solved
Plug and pond (machine built)	13	Re-creation of wetland, water and sediment retention, raising water table.
Plug and pond (hand built)	25	Repair of small gullies, raising of water table in wetland, re-creation of fen conditions.
One rock dams, Zuni bowls, baffles (hand built)	130	Erosion control and prevention, sediment capture, raising local water table, repair of wetland gullies. Has resulted in perennial flow on the Valle Santa Rosa.
Machine-built Zuni bowls and filter dams	15	Prevention of further erosion, filter dams captured as much as 2 feet of sediment resulting from the Las Conchas wildfire.
Bank erosion, treatment with sod	25	Prevention of bank erosion and sedimentation. Reduce width/depth ratio.
Rolling dip trail drains	5	Trail along a fence had incised 3-5 feet and runoff that was directed to the river is now diverted to the adjacent meadow.

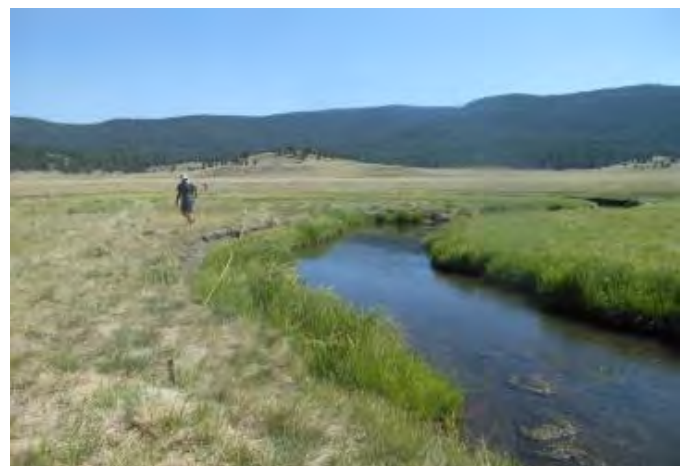
*Eroding Meander bend after treatment in June 2013.*

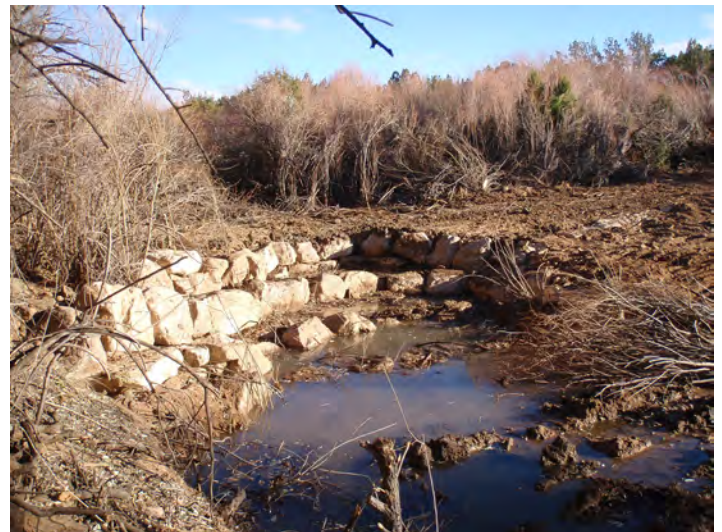
*Headcut restoration structure constructed at San Marcos by Rangeland Hands, Inc.*

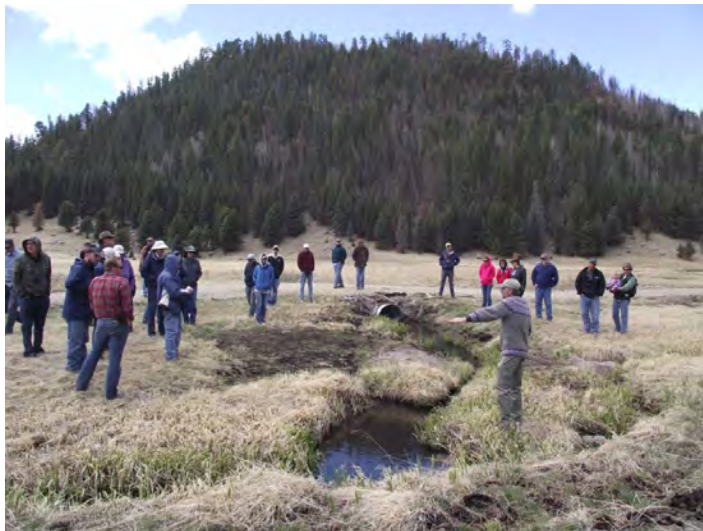
*Discussing problems associated with improper culvert design and proposing alternatives to reduce erosion.*

project design. In order to achieve some of the original goals of this task it was determined that a training principally for NMDOT personnel that would demonstrate new techniques for road work in the river environment would provide some outcomes that were expected from the project.

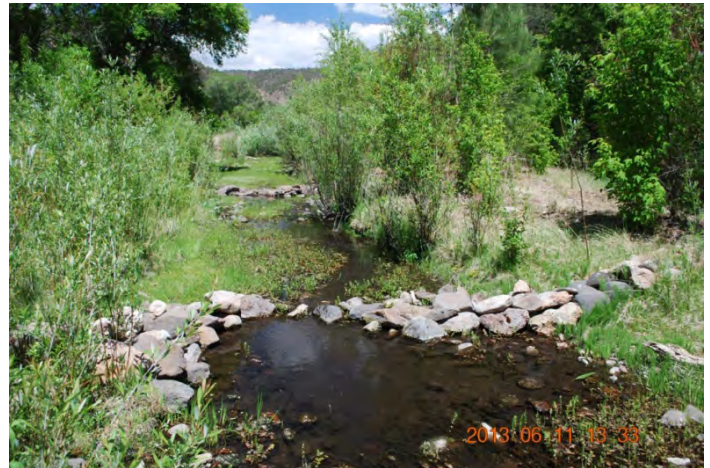
*Two of the hand constructed rock weirs in Black Canyon that focus streamflow to encourage scour pool development, enhance fine sediment deposition and riparian vegetation recruitment.*

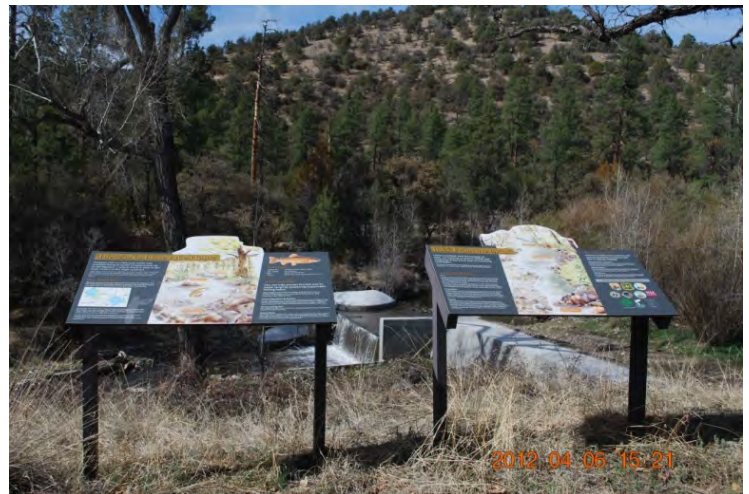
*Educational signs at the fish barrier on Black Canyon Creek that were jointly funded by CWA Section 319(h) and RERI.*

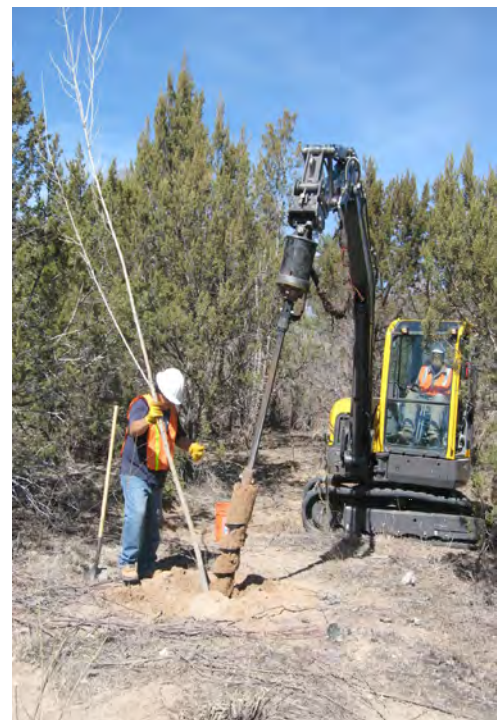
*Holes were augered eight feet to groundwater to plant cottonwood poles.*

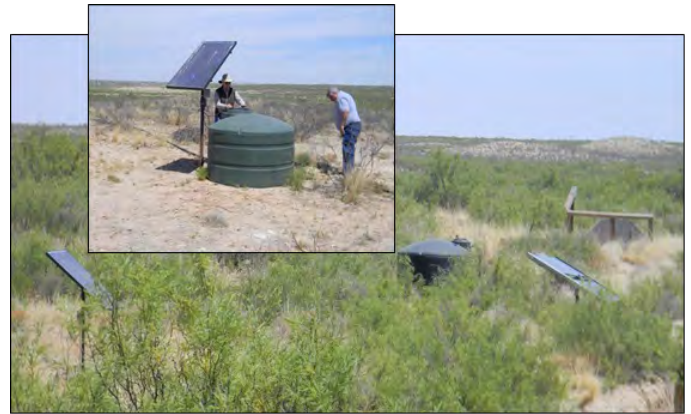
*Solar panels and pumps provide alternative water sources for livestock and wildlife along the Delaware River.*

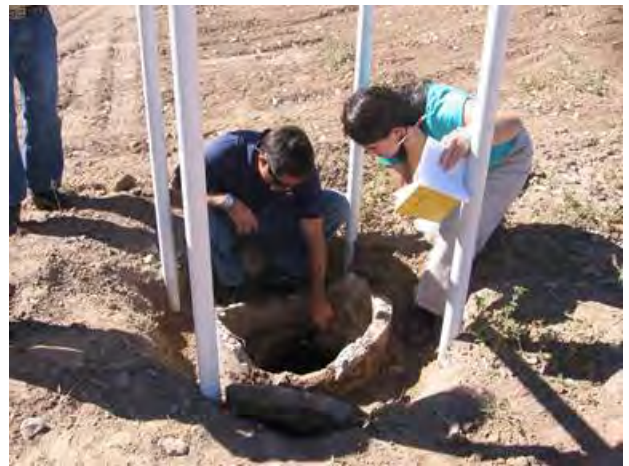
*GWQB staff inspecting a septic tank at the Santa Fe Equestrian Center.*

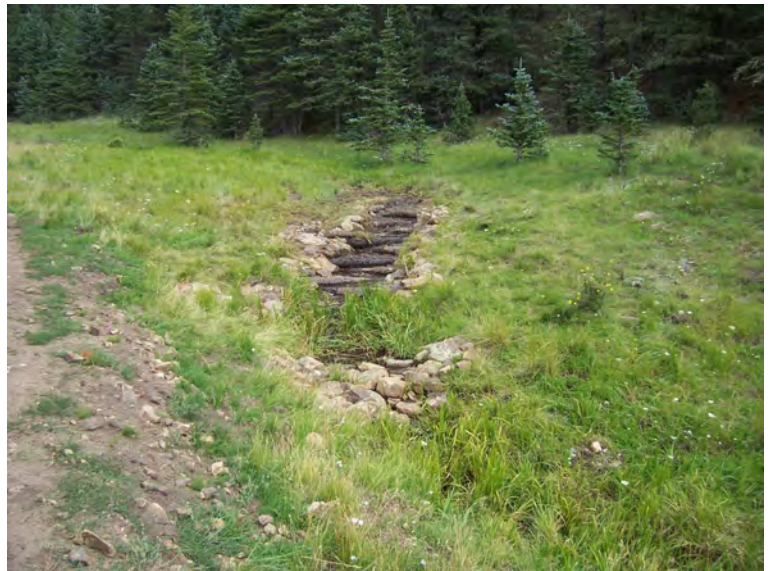
*Stream restoration structure addressing a headcut in Grassy Creek requiring a NWP 27 for Aquatic Habitat Restoration, Establishment, and Enhancement Activities.*

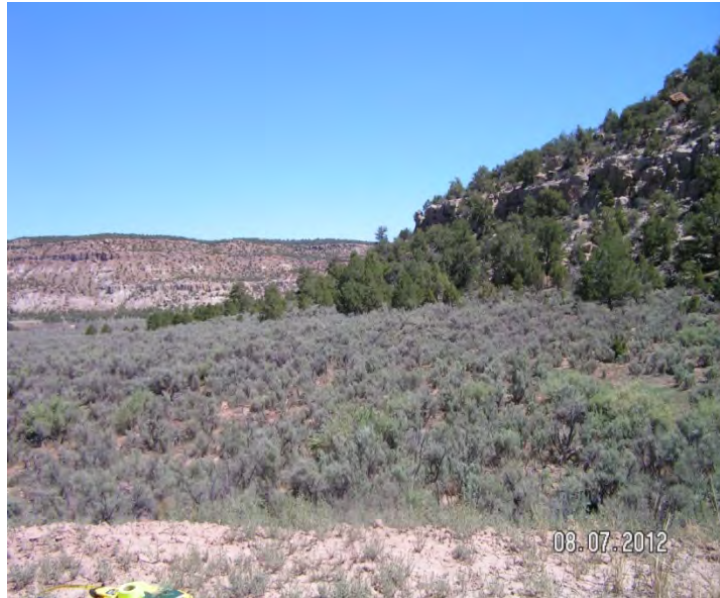
*Ciruelas Canyon prior to treatment in summer 2012.*

- Monitoring – Vegetation monitoring transects were established prior to implementation.
- Cultural Inventory and Clearance – Cultural clearance of land areas planned for brush management continued. Cultural inventory has been completed on approximately 1,000 acres.
- Vegetation treatment - Mowed and seeded approximately 350 acres of big and hoary sagebrush. The areas were seeded with two different seed mixes and hand seeded with winterfat. Areas treated are within the Ciruelas, Ahogadero and Ciruelas canyons.
- Road Improvements – in cooperation with Oil and Gas operators on the district, road improvements such as road crossings, road drainage structural improvements, and sediment retention basins were initiated in FY 2013. This work is yet to be completed, but represents a significant investment in transportation infrastructure by partners on the Jicarilla Ranger District.

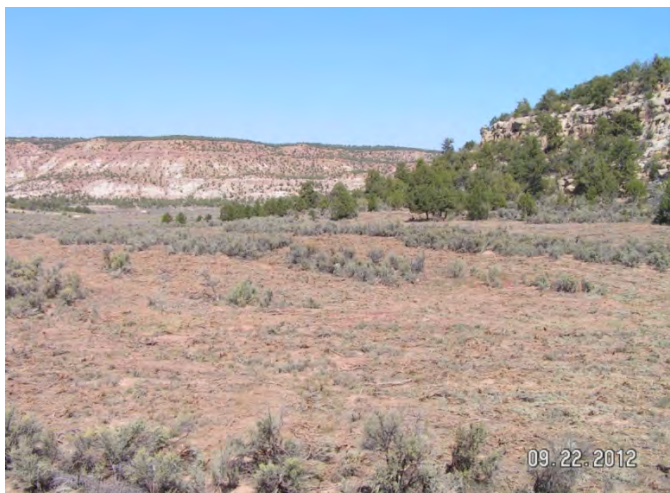
*Ciruelas Canyon immediately after brush-hogging in summer 2012.*

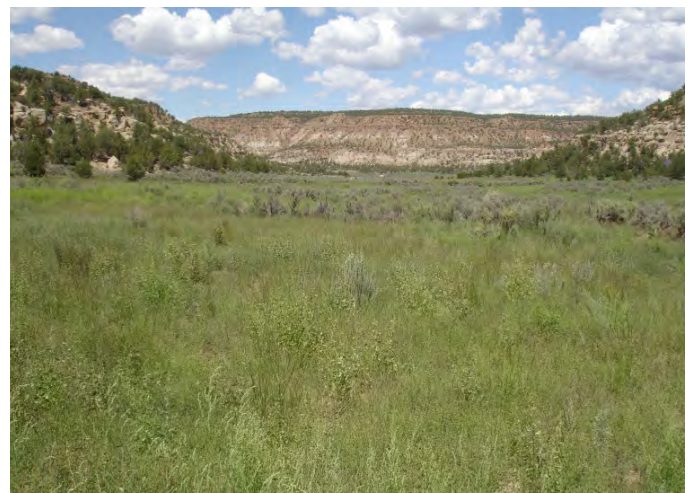
*Ciruelas Canyon in summer 2013.*

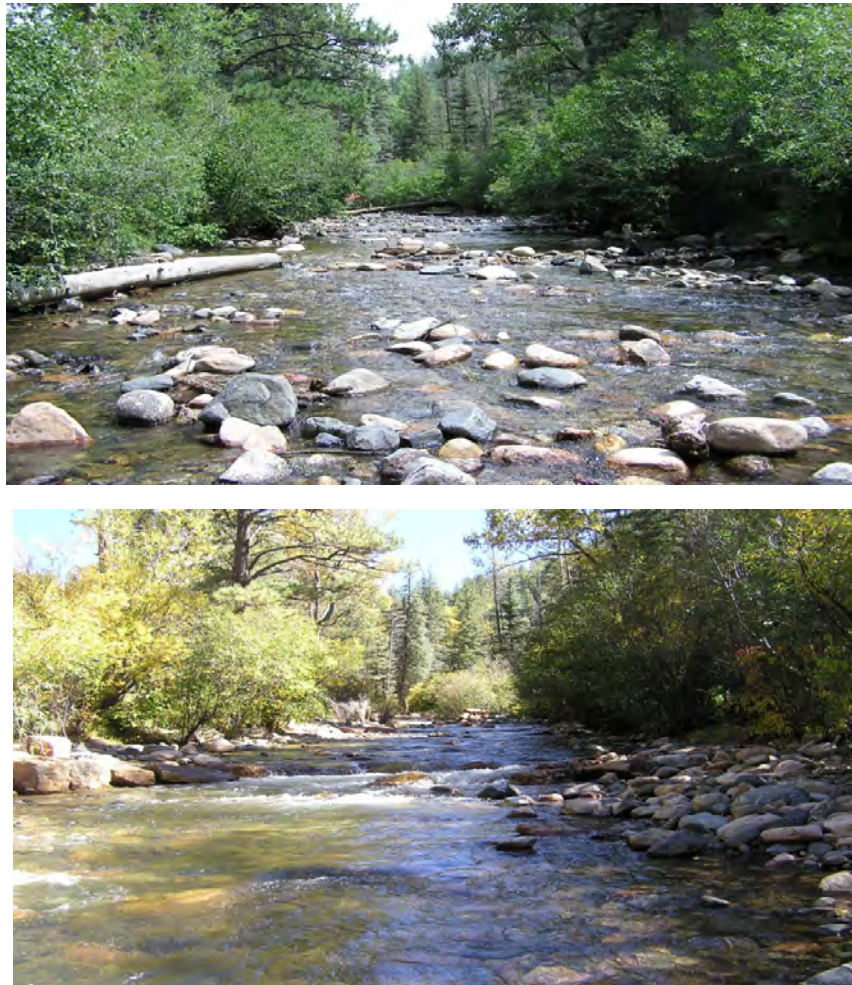
*Figure 1. Pre-construction (upper) taken in August 2012 and post-construction (lower) taken in October 2013 at photo point MMI looking upstream.*

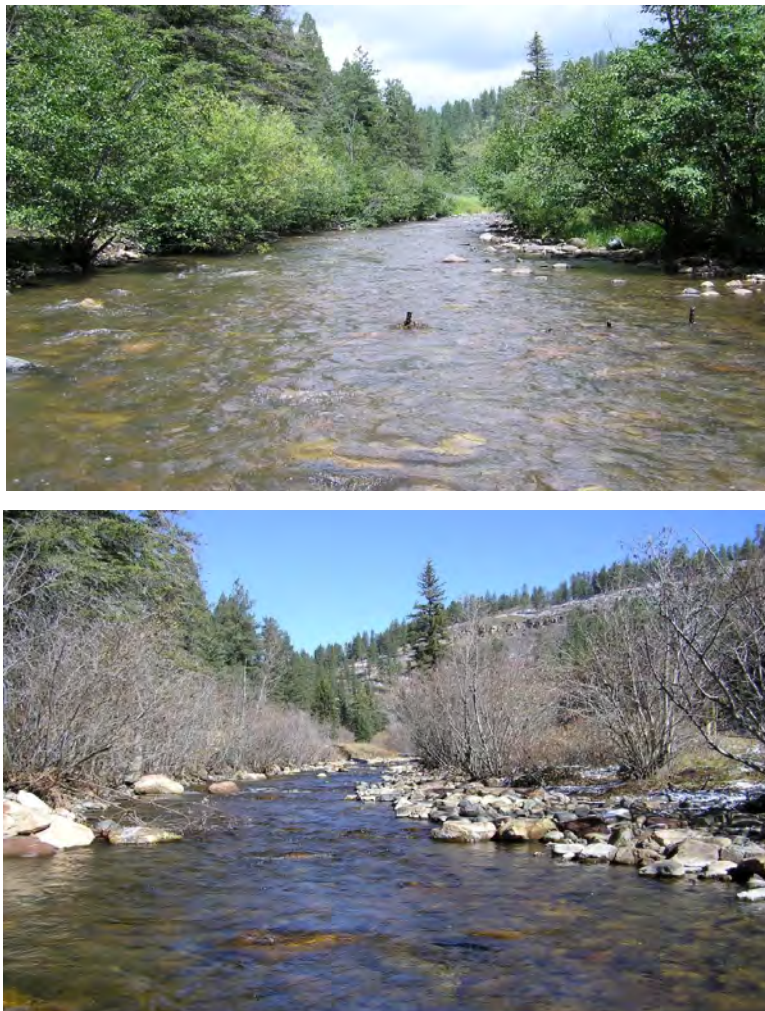
*Figure 2. Pre-construction (upper) taken in August 2012 and post-construction (lower) taken in October 2013 at photo point MP2 looking upstream. Even though flow was lower in October 2013, deeper pool habitat is present in the lower left of the photo.*

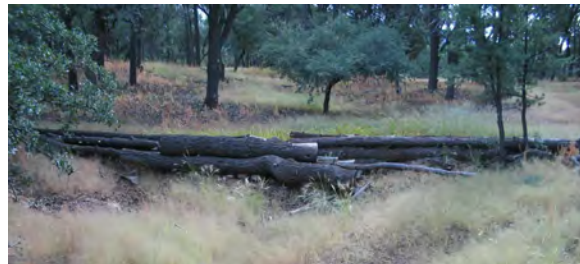
*Log Erosion Control Structure.*
