Appendix F. Examples of Floodplain Hydrological Connectivity on-site indicators

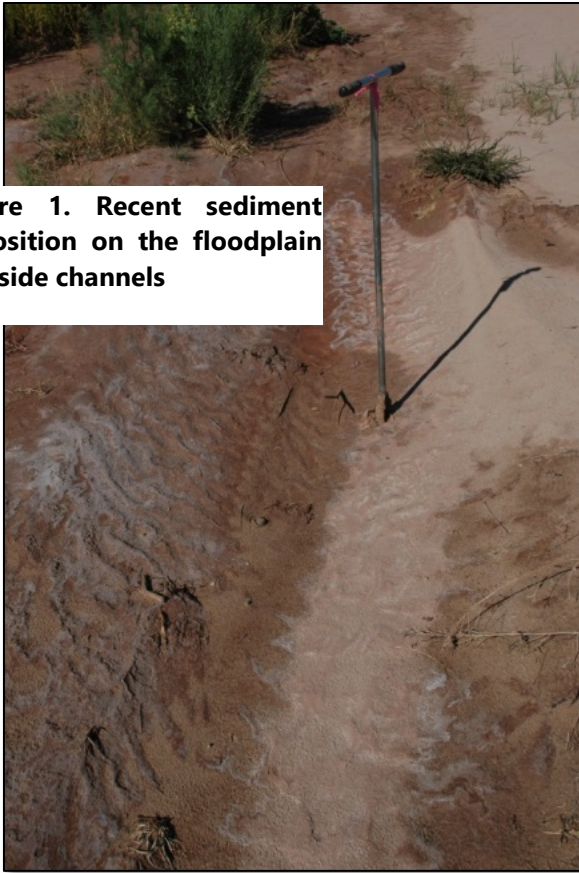
Figure 1. Recent sediment deposition on the floodplain and side channels

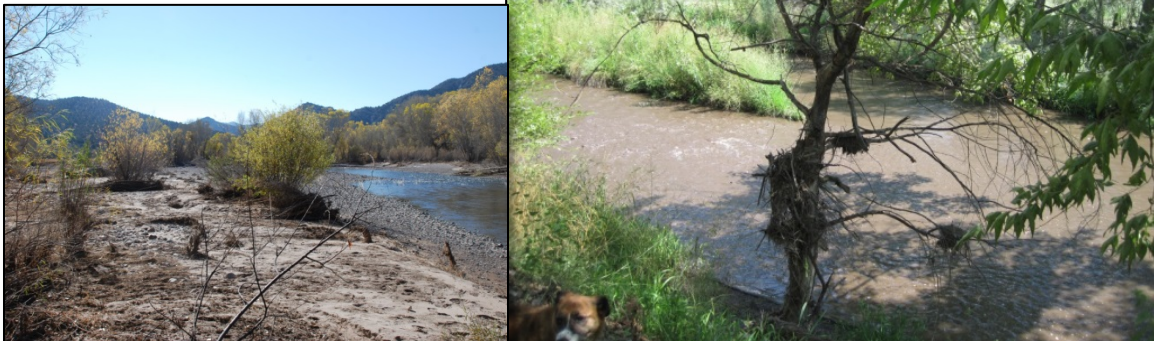
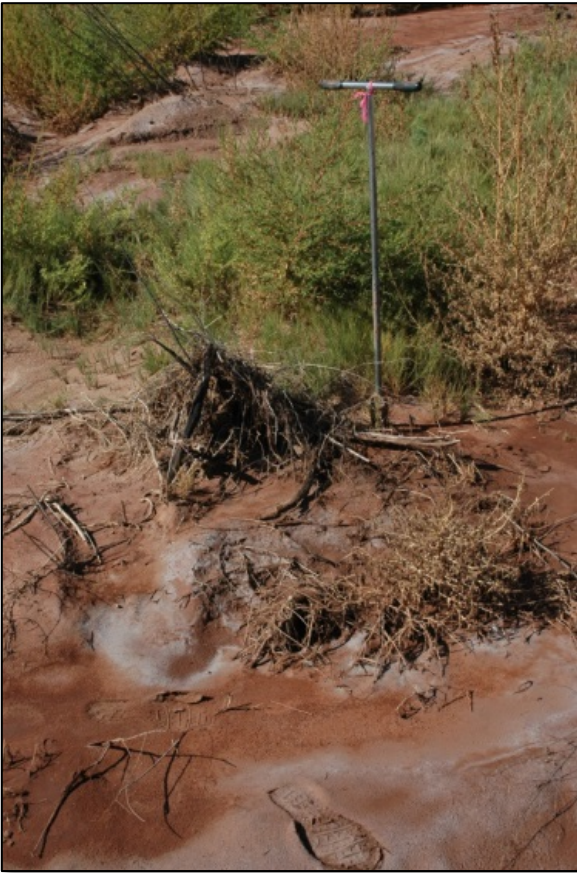
Figure 2. High wrack lines above the floodplain level

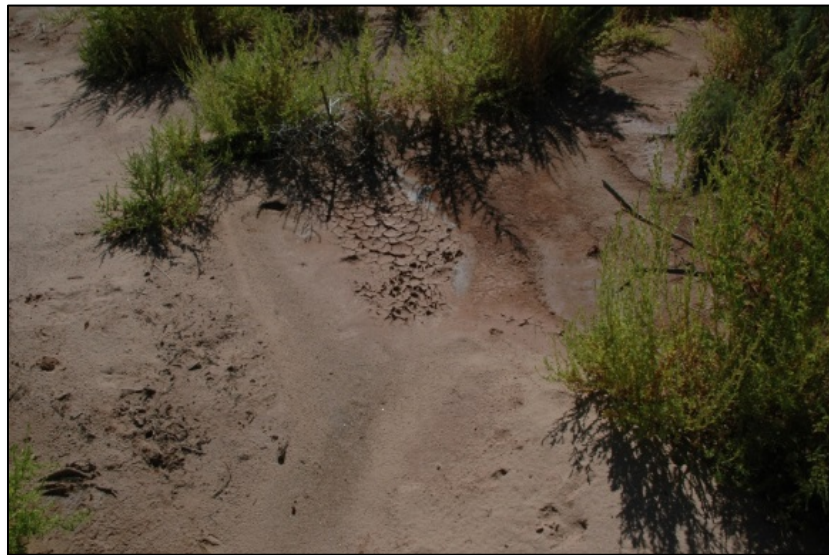
Figure 3. Recent fine debris deposited on the floodplain.
