***WATERSHED RESTORATION ACTION STRATEGY
(WRAS)***

UPPER RIO HONDO

Prepared by:
The Upper Hondo Watershed Coalition
2nd Edition: April, 2004

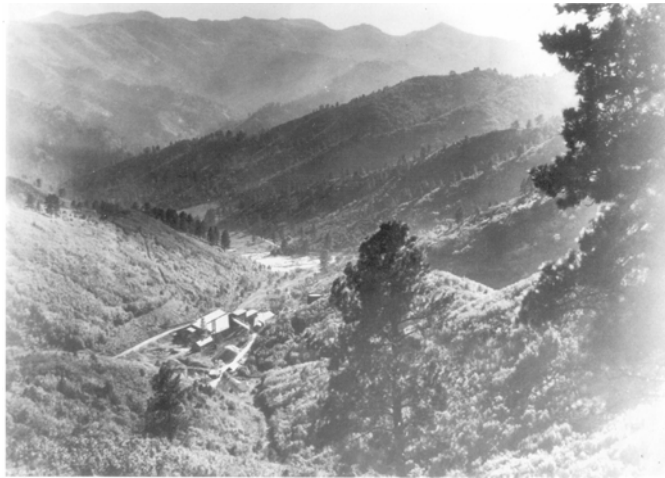
View of Parsons Mine, circa 1915. (Johnson Stearns Collection)

- The Smokey Bear District of the Lincoln National Forest (LNF), which blankets the western edge at the top of the watershed, is in a serious state of degradation. Extensive livestock grazing in the early 1900s and fire suppression over the past 85 years have created a forest that is not only extremely vulnerable to catastrophic wildfire, but also one that is contributing to a severe loss of soil water. According to M3 Research in a report dated September, 2001, “Early pre-settlement forest and woodland landscape in the Lincoln National Forest carried 20-70 trees per acre, had significant openings, and extensive grass dominated understories.

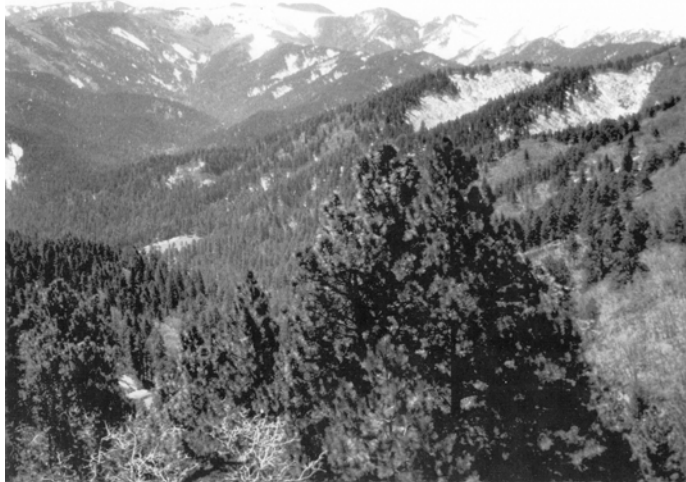
Same view of Parsons Mine, 1996 (E. Hollis Fuchs)

- Today the Lincoln National Forest is dominated by dense forests and woodlands with average densities of 200-250 trees per acre. The combined effects of loss of openings, closed overstory, soil moisture depletion and increased litter, have all but replaced the grass understories. Small fuel ladders are prominent throughout the forest. Seeps, springs, and wetlands have been diminished by soil moisture deficits. Aquifer recharge and/or contribution to stream flow have been reduced 5-15%. Losses in water, grasses, and openings have reduced biological diversity. Insect and disease impact has increased. As a result, **over 65% of the forest landscapes in the watershed are at moderate to high risk of loss to catastrophic wildfire.**

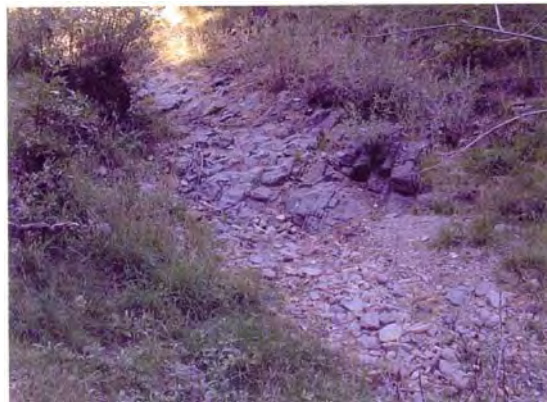
Eagle Creek, October 2, 2003. (Eagle Creek Conserv. Asso.)

- A persistent drought, combined with “mining” of water during this growth period has drawn many of the watershed’s aquifers down to critical levels. (Indeed, in the summer of 2002, the water table in the Eagle Creek Basin, which provides 65% of Ruidoso’s municipal water supply, was drawn down below the well screens of 3 of the 4 major wells). The result of this collision course is, of course, an acute shortage of water in the Upper Hondo Watershed.

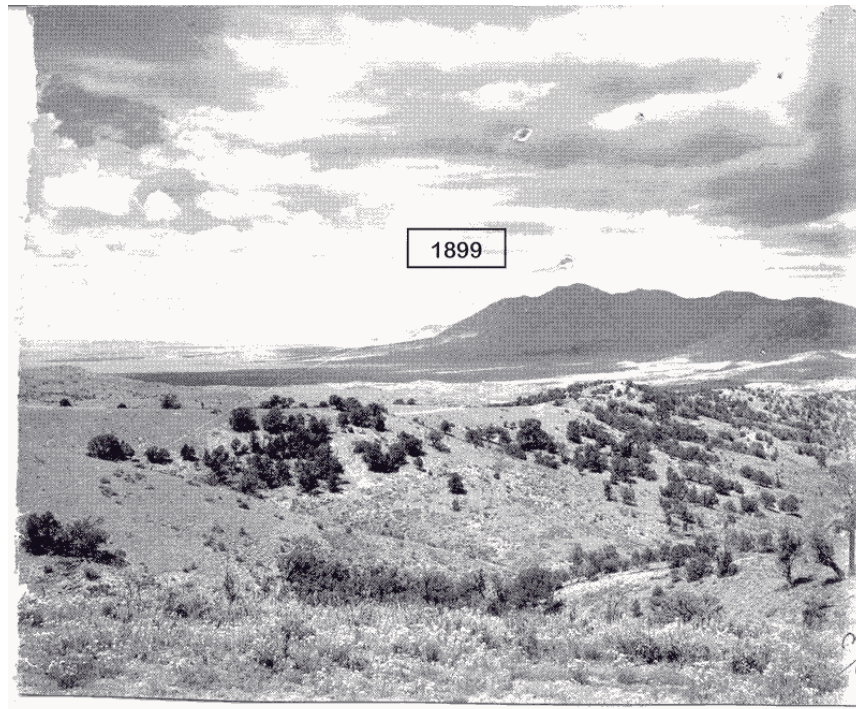
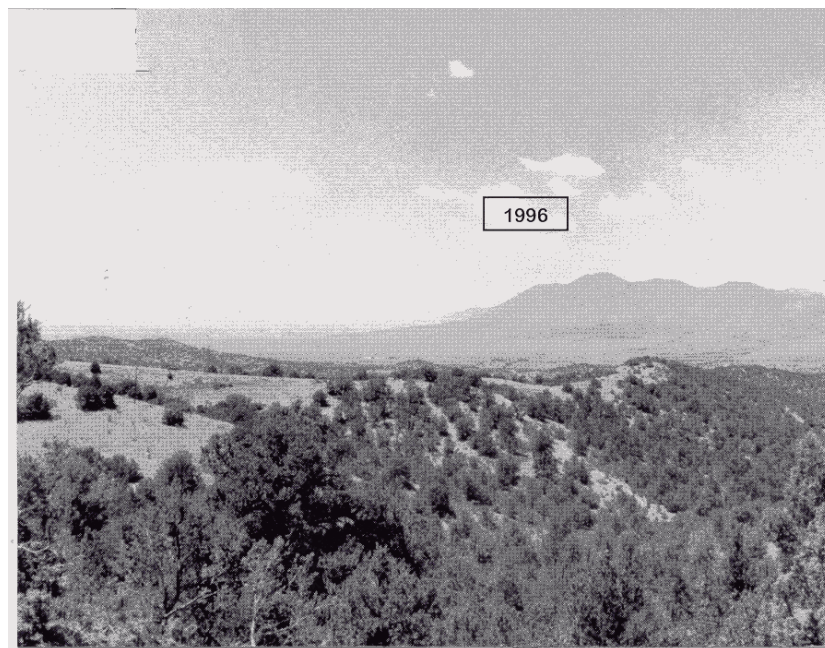
An area east of Vera Cruz Mountain photographed in 1899, top, experienced an invasion of junipers in the last 100 years

Credit: R.T. Hill, U.S. Geologic Survey, 1899

Credit: E. Hollis Fuchs, 1996.

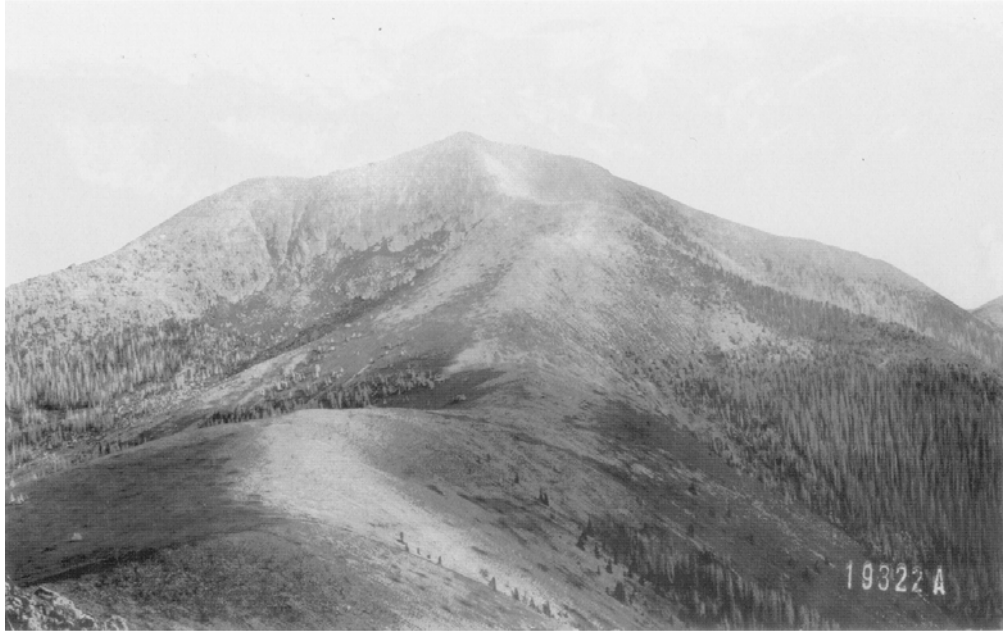
45A. Date: 1914. Credit: Rio Grande Historical Collections. Taken from Lookout Mountain, the highest point in Lincoln County, facing south, with White Mountain or Sierra Blanca (12,000 feet) in the background, on Mescalero Apache lands in Otero County. Trees appear to be covered with frost.

Lookout Mountain facing south to Sierra Blanca, 1914.

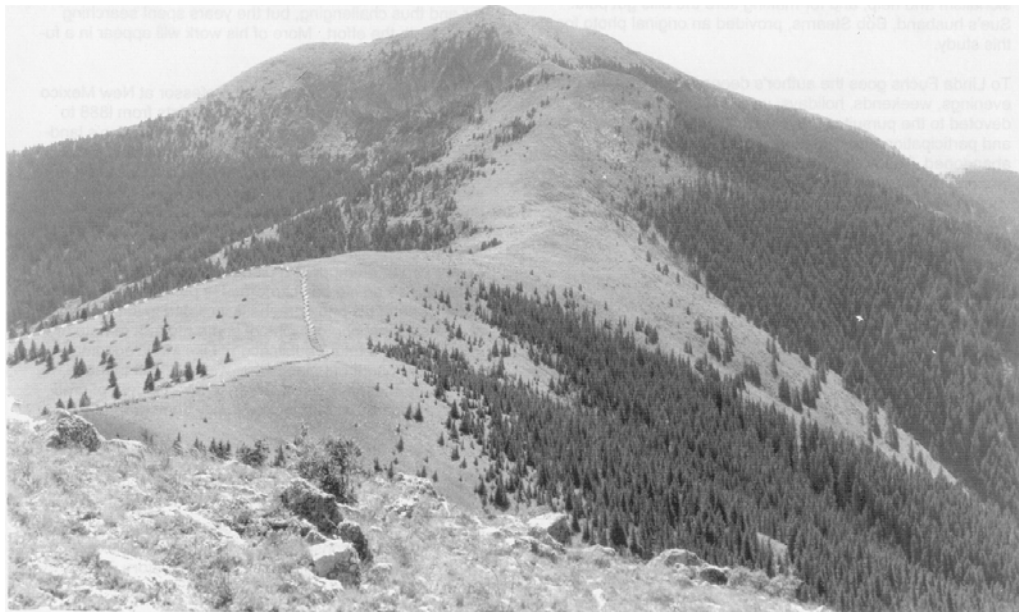
45B. Date: July, 1998. Credit: E. Hollis Fuchs, location found with help from Rick Hall and Roy Parker of Ski Apache. Compared to 1914, less area is covered with grass, while more area is covered by Mixed Conifers. Elevation of the photo point is about 11 600 feet

Lookout Mountain facing south the Sierra Blanca, 1998. Less grass, more mixed conifers.

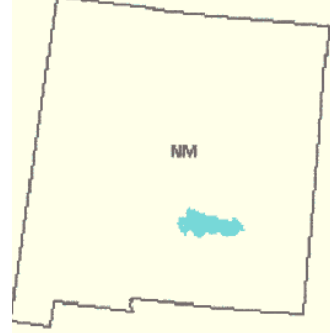
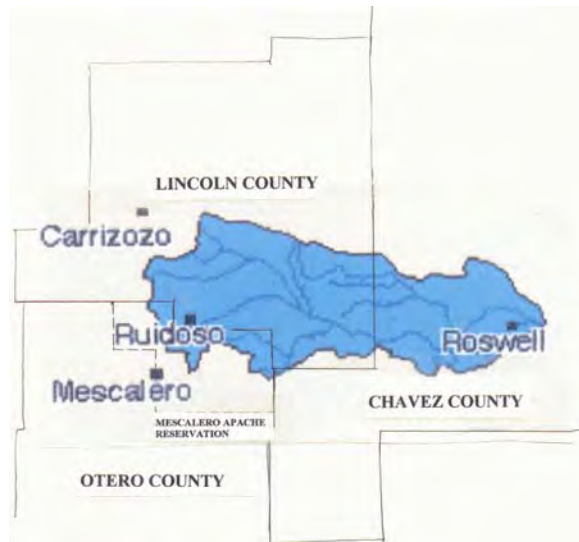
Location: The Rio Hondo Watershed is a sub-basin of the Lower Pecos and is located in South-Central New Mexico, bordered by the Sacramento Mountains on the west, the Capitan Mountains on the North, and Pajarita Mountain on the south. As shown below, 55% of the watershed is in Lincoln County, 12% is in the highlands of Otero County, and the remaining 33% is in downstream Chavez County. Its Hydrological Unit Area is (HUA) is #13060008. The Rio Hondo Watershed drains its 1,076,480 acres (1,674 square miles) into the Pecos River near Roswell, New Mexico.

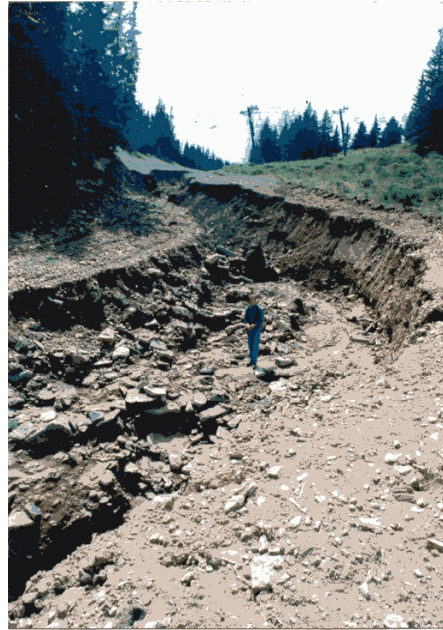
Deep Freeze Ski Run blowout, 1966 (RRA photo)

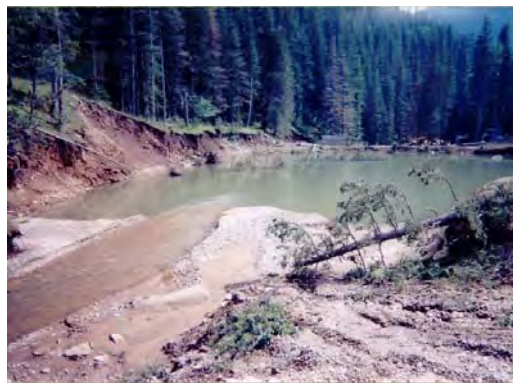
Sediment pond below Ski Apache, 2000 (RRA photo)

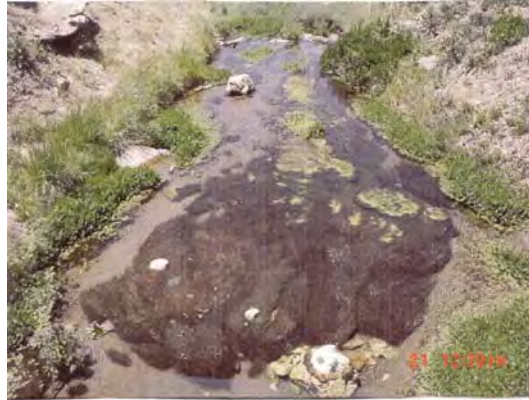
Nuisance Algae in Carrizo Creek, 2000. Credit: NMED

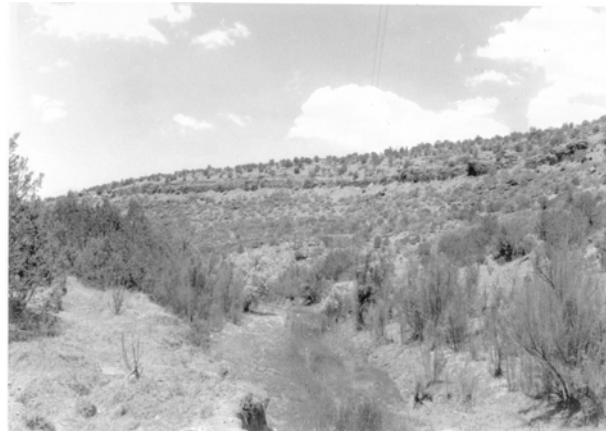
Invasive species attack Magado Creek, 1996 (E. Hollis Fuchs)

Like many watersheds in the southwestern states, the Upper Hondo watershed has also been invaded in the last 50 years by *Tamarix* (saltcedar), which has spread into nearly every perennial drainage in the watershed. This invasion has not only rapidly displaced native riparian forest and scrub communities by quickly creating saline soil conditions that native riparian species cannot tolerate, it has also drawn the water table significantly (*Tamarix* consumes water 35% more rapidly than native vegetation, lowering instream flows). *Tamarix* also fosters sedimentation and reduces the width and depth of river channels, reducing the water-holding capacity of waterways and increasing the frequency and severity of overbank flooding. Last, but not least, *Tamarix* provides poor habitat for

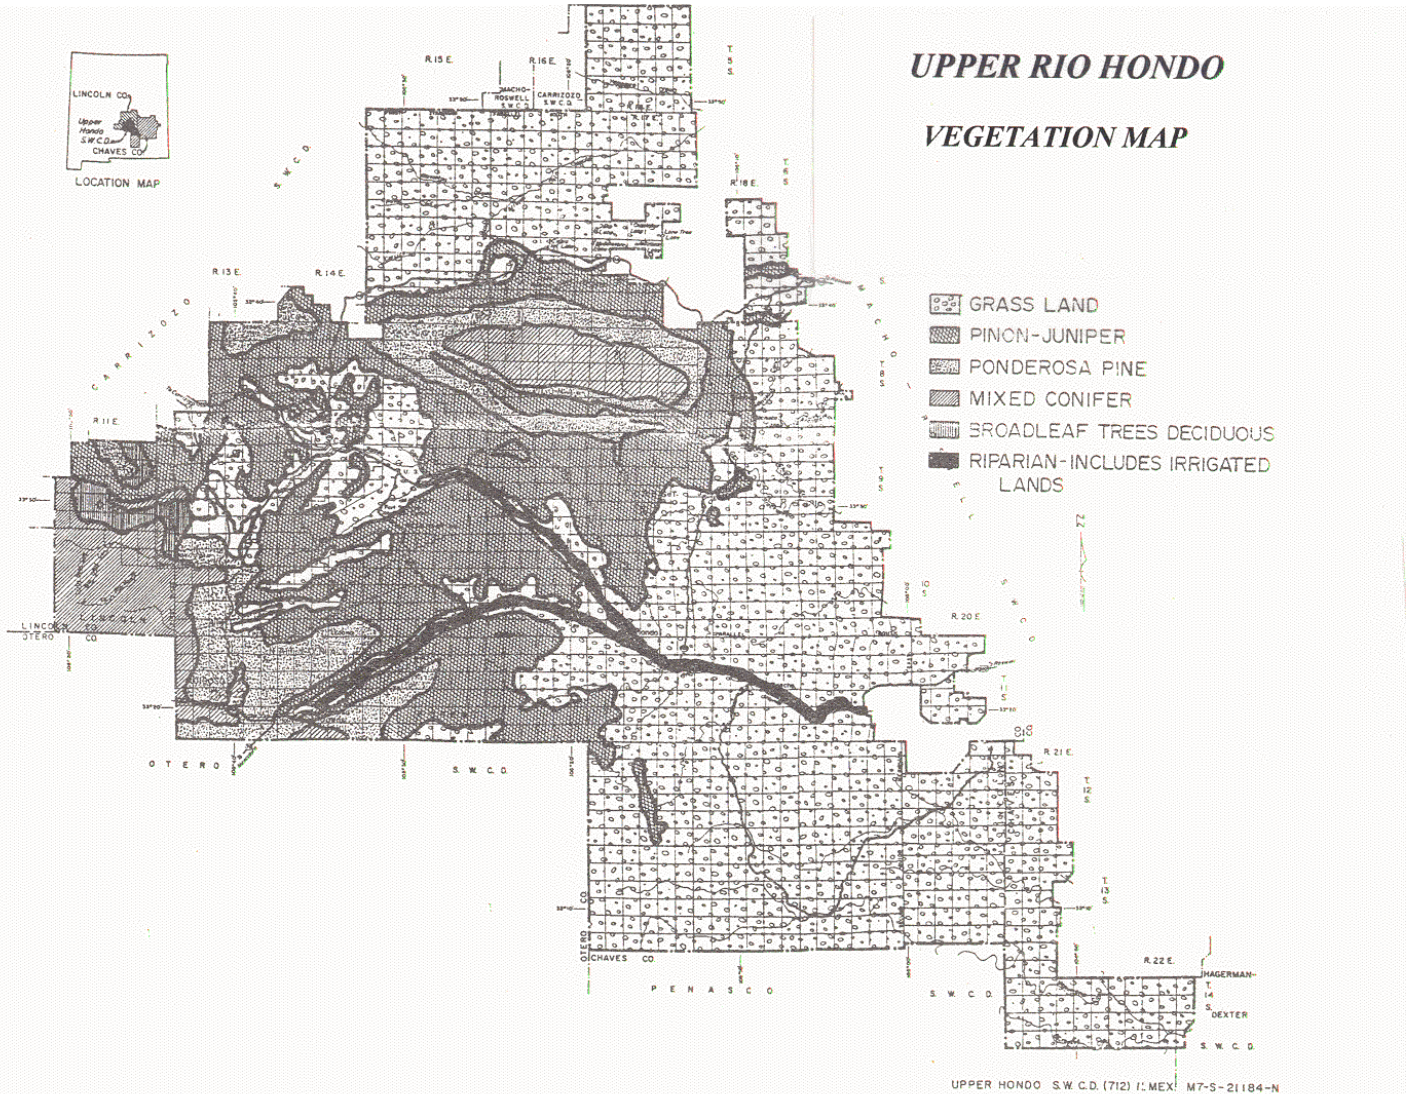
MAP A

UPPER RIO HONDO VEGETATION MAP

- GRASS LAND
- PINON-JUNIPER
- PONDEROSA PINE
- MIXED CONIFER
- BROADLEAF TREES DECIDUOUS
- RIPARIAN-INCLUDES IRRIGATED LANDS

Vegetation: Also from the Upper Hondo SWCD’s *Long Range Plan*, “There are three main plant communities in the Upper Hondo watershed. Grasslands predominate in the eastern part and in the broad valleys between the Sacramento and Capitan Mountains. Pinon-juniper savannah and woodland predominates on the limestone hills in the middle of the watershed and on the lower slopes of the mountains. Finally, Ponderosa pine and mixed conifer (Douglas fir, White fir, Southwestern white pine, and aspen) are found on the higher slopes. A small area near Nogal Peak is dominated by broadleaf deciduous trees, primarily Gambol oak with a smaller amount of New Mexico locust and canyon maple.

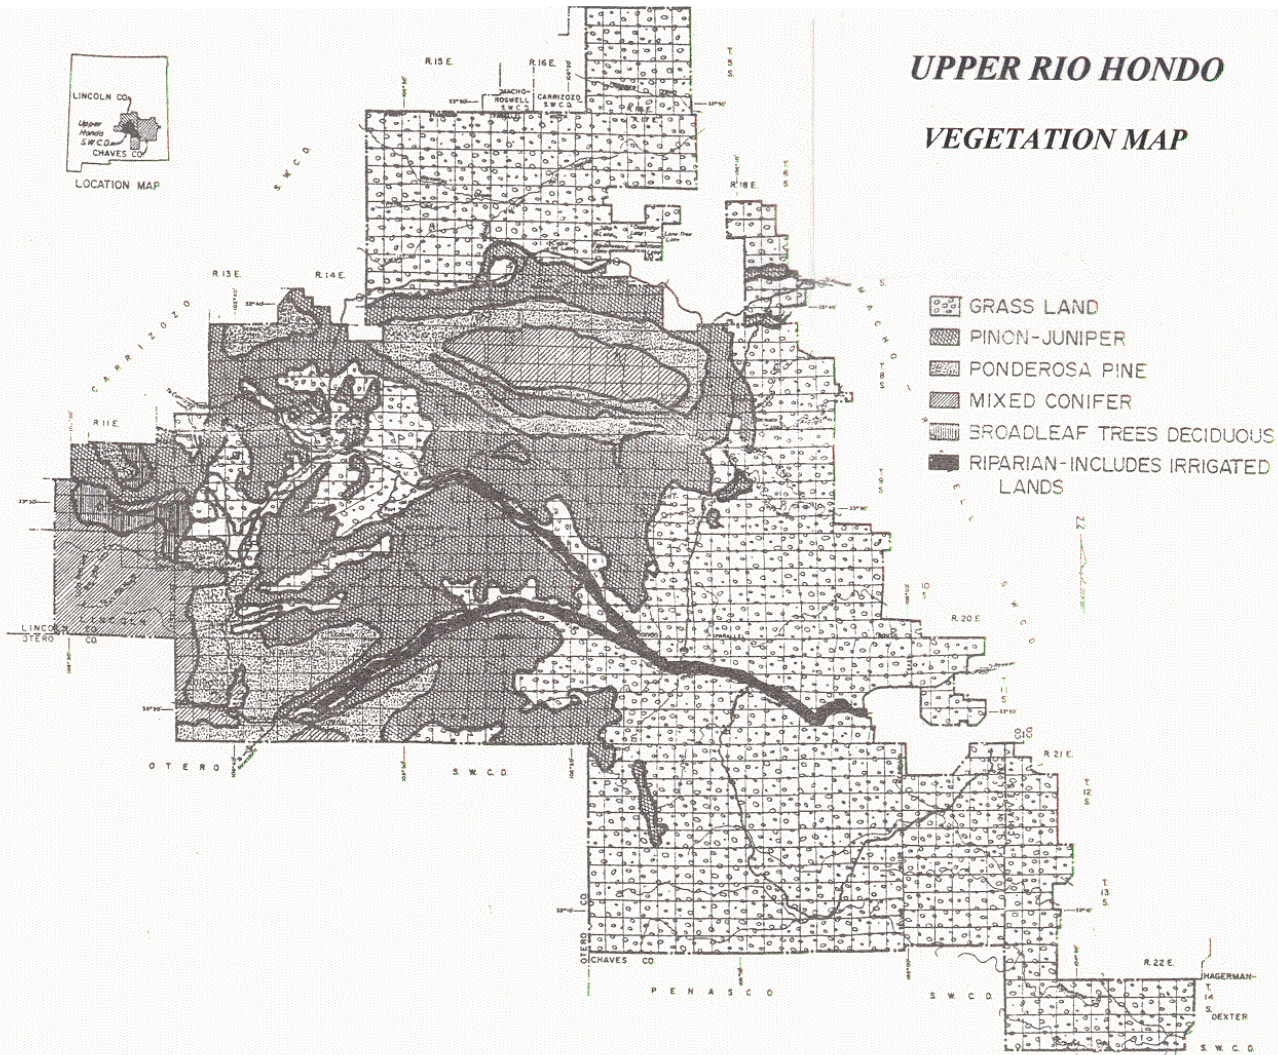
MAP B

UPPER RIO HONDO VEGETATION MAP

- GRASS LAND
- PINON-JUNIPER
- PONDEROSA PINE
- MIXED CONIFER
- BROADLEAF TREES DECIDUOUS
- RIPARIAN-INCLUDES IRRIGATED LANDS

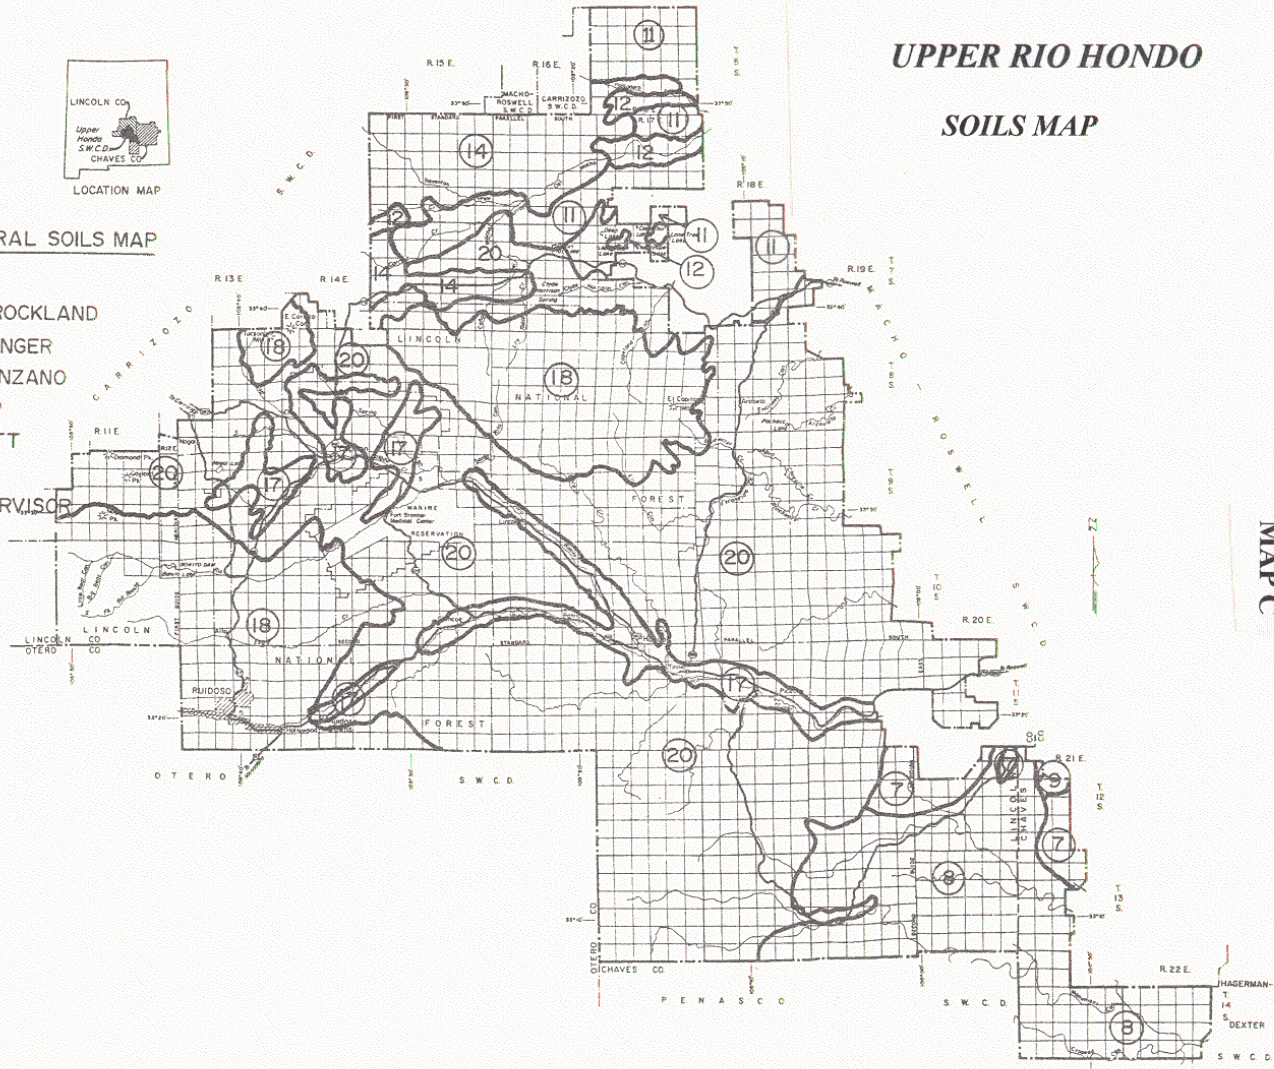
MAP C

LINCOLN COUNTY GENERAL SOILS MAP

- ⑦ ECTOR-CONGER
- ⑧ ECTOR-LIMESTONE ROCKLAND
- ⑨ REAGAN-ELFRIDA-CONGER
- ⑪ DEAMA-PASTURA-MANZANO
- ⑫ LIMESTONE OUTCROP
- ⑭ HARVEY-PASTURA-WITT
- ⑰ SAN MATEO
- ⑱ CABALLO-PESO-SUPERVISOR
- ⑳ DEAMA-LIMESTONE ROCK LAND

The third major association of soils is found in the Ruidoso, Hondo, and Bonito drainages and in broad valleys between the Sacramento and Capitan Mountains. These are generally deep loamy and clay loam soils in the Reventen, Manzano, and Remunda series on the valleys and side slopes, and Nogal, Bernal, and Stroupe stony loams on ridges and hills.” Map C shows the location of these soil associations.

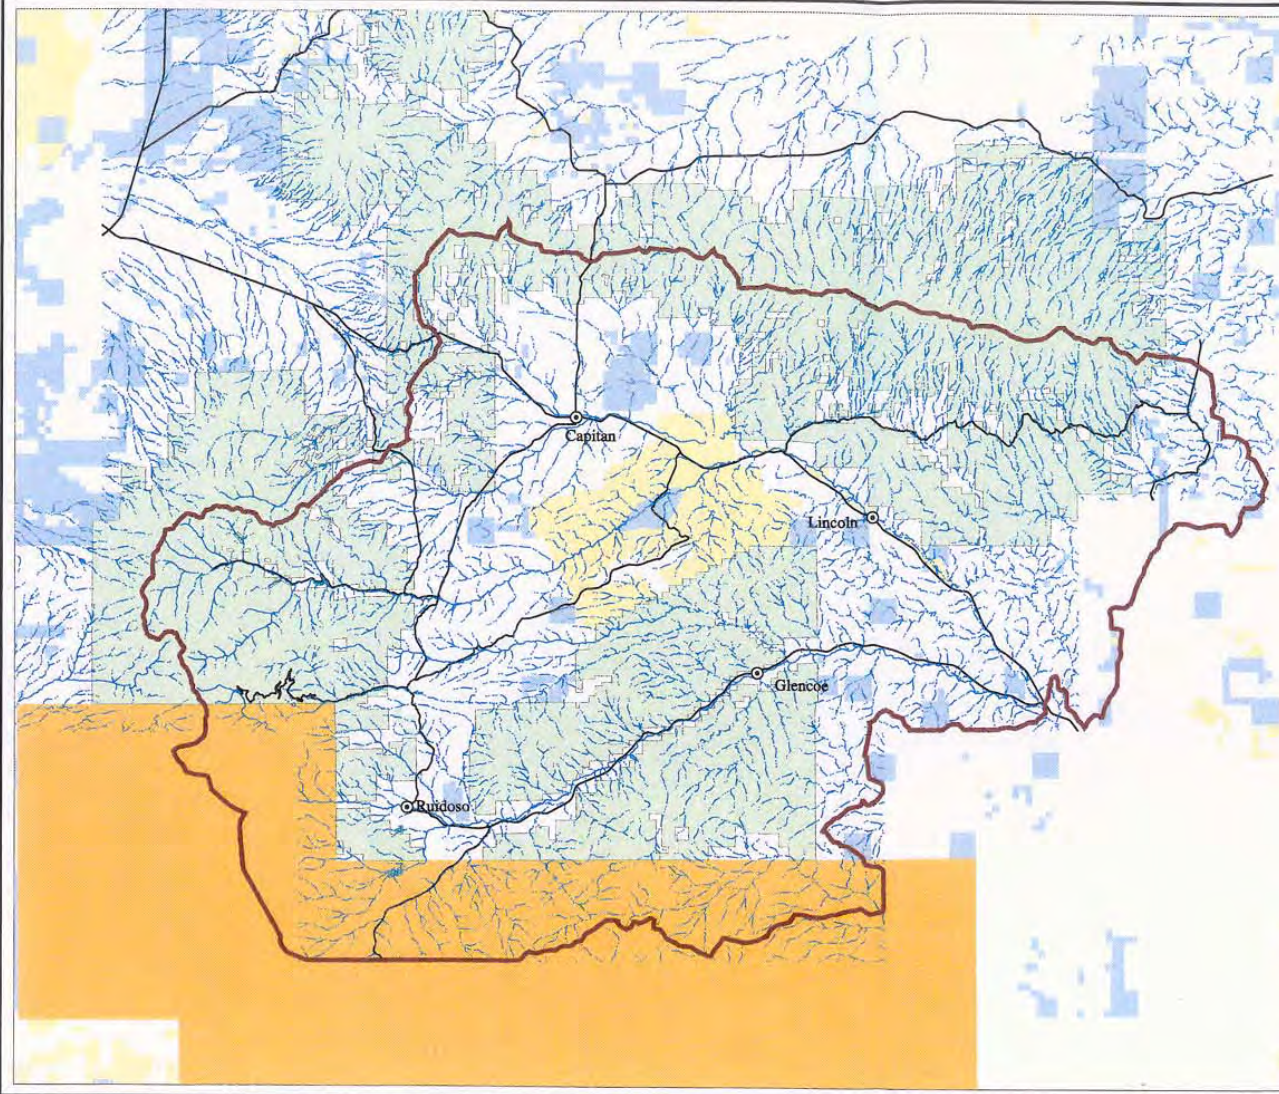
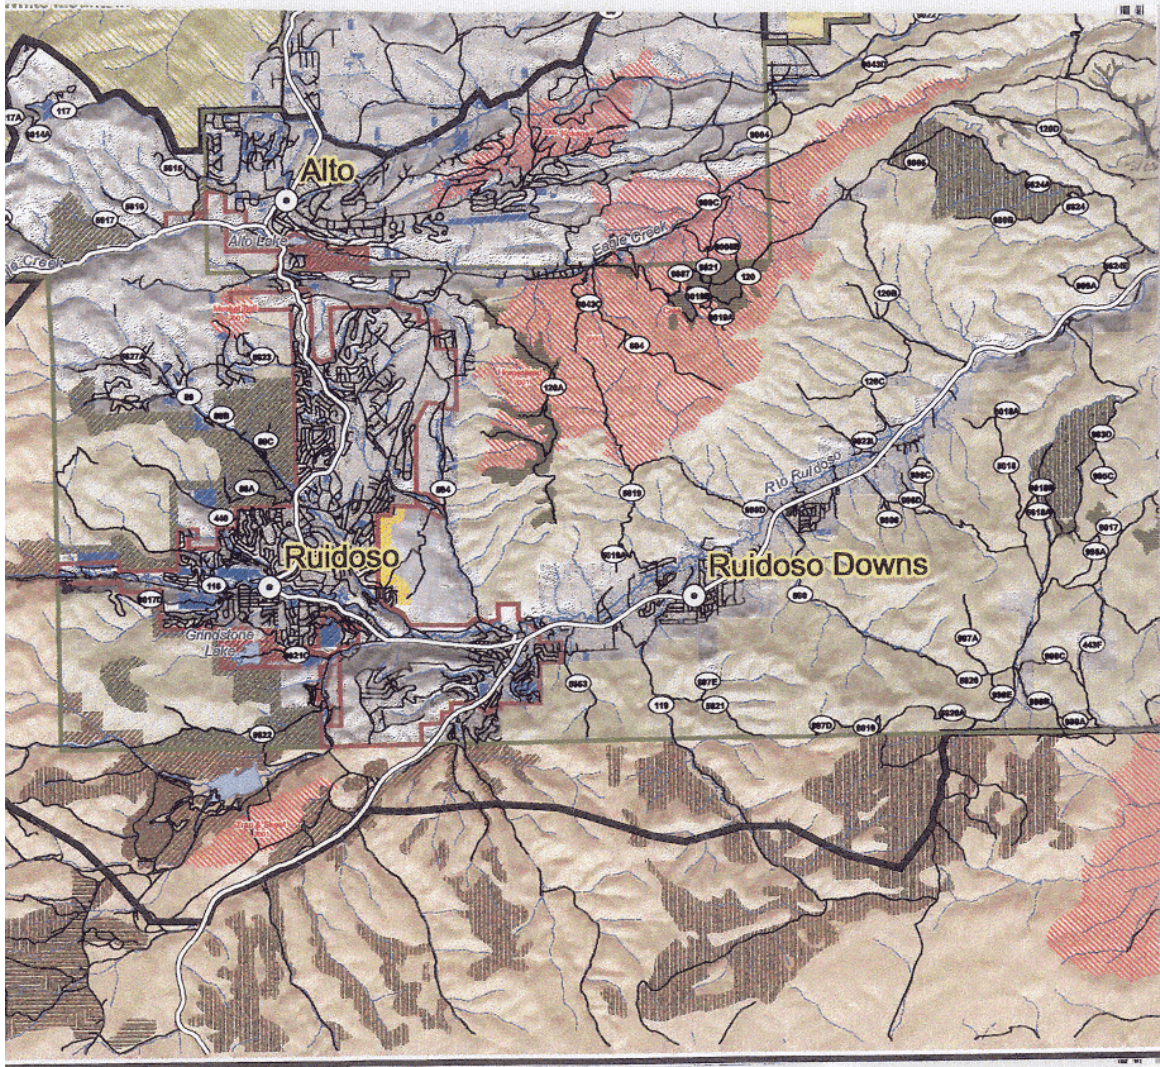
MAP E

Ruidoso WUI Map

- Given this milieu, considerable progress has been already been made in carving out a fire buffer zone around the Village of Ruidoso and other threatened areas (see

- And indeed, the fires have already started. Over past three years, the upper watershed has suffered no less than four catastrophic wildfires (see WUI map) and literally hundreds of smaller fires, as a result of the above conditions. The Cree Fire in May of 2000 not only burned 6,500 acres, but also came dangerously close to the Village of Ruidoso from the East. The Trap & Skeet Fire on the Mescalero Apache Reservation in June of 2001 burned 400 acres and came dangerously close to Ruidoso from the West. The Homestead Fire on the same weekend burned 200 acres and again threatened the Ruidoso from the east side. The Kokepelli Fire in late March of 2002 burned 1,092 acres and destroyed 29 high-dollar homes in Alto. High-intensity burns in these densely overgrown forests are now moonscapes of ash and sediment which threaten the water quality in the watershed. Indeed, as of this writing, according to the New Mexico State Forestry Division, Ruidoso remains the number one community in New Mexico potentially at risk to catastrophic wildfire. At the same time, as discussed herein, the Ruidoso Wildland Urban Interface Group is way out in front among communities dealing with catastrophic wildfire threats and has received numerous awards to that effect.
