Lee Ranch Mine Use Attainability Analysis

May 2018

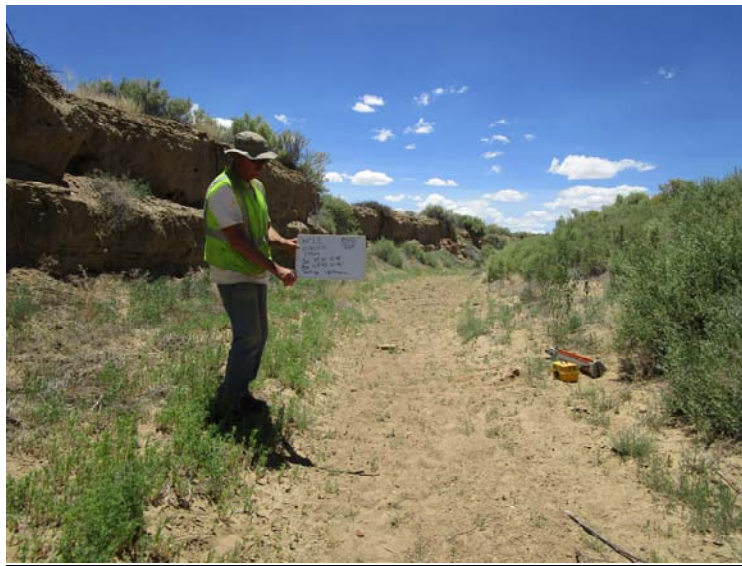
1 - HP11 upstream

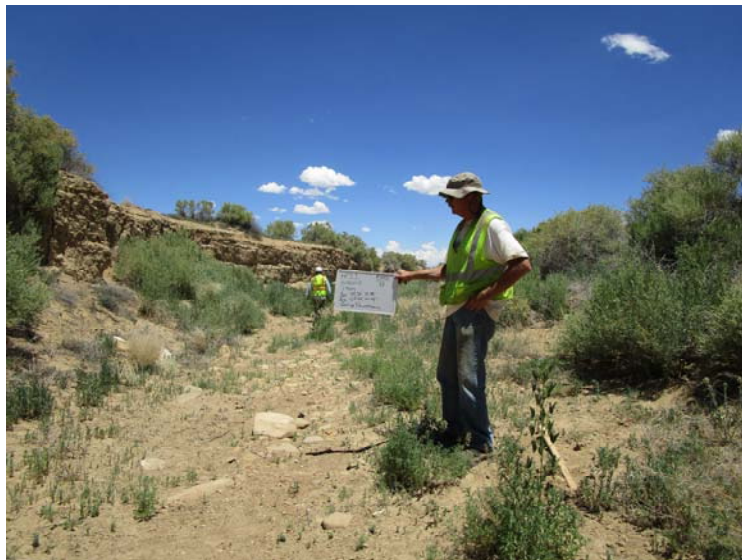
2 - HP11 downstream

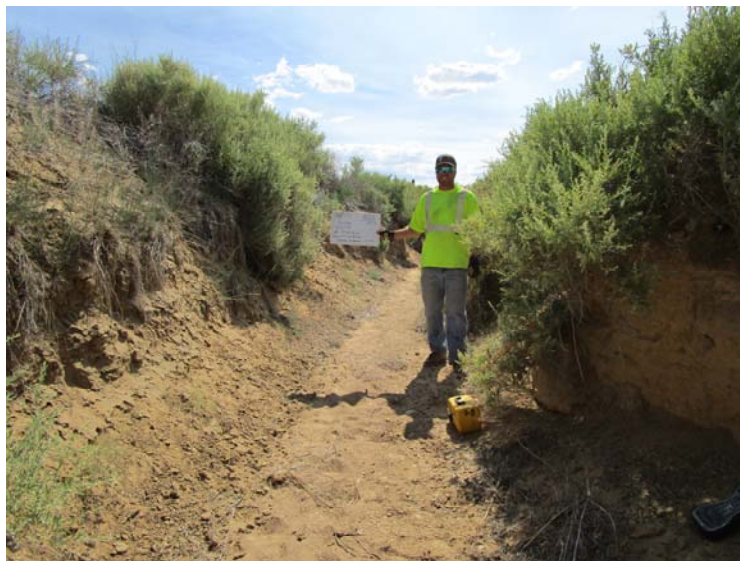
4 - HP13 upstream

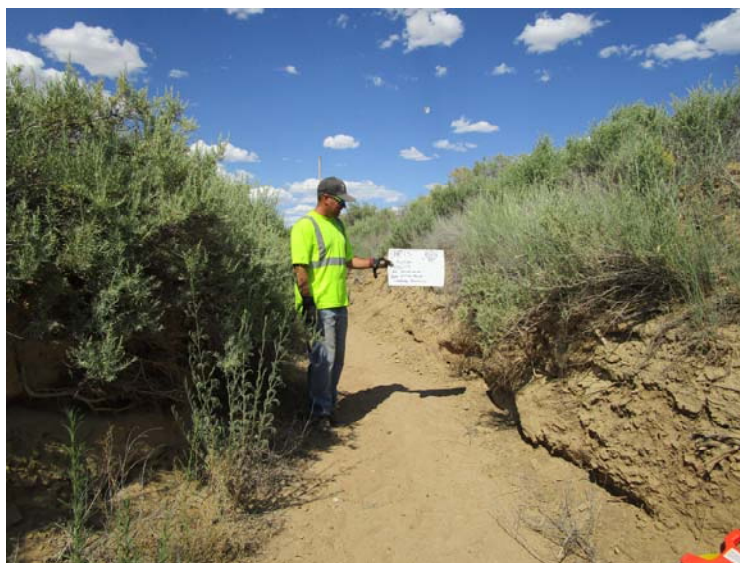
5 - HP13 downstream

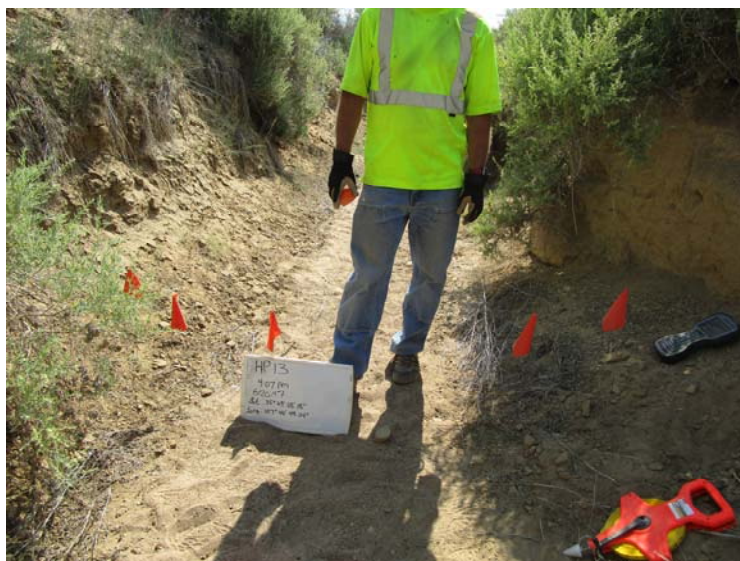
6 - HP13 bankfull width

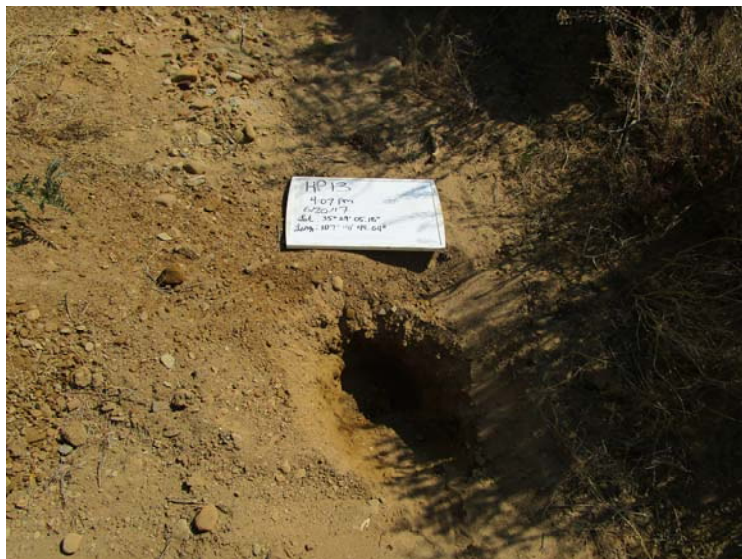
9 - HP13 soil profile (1)

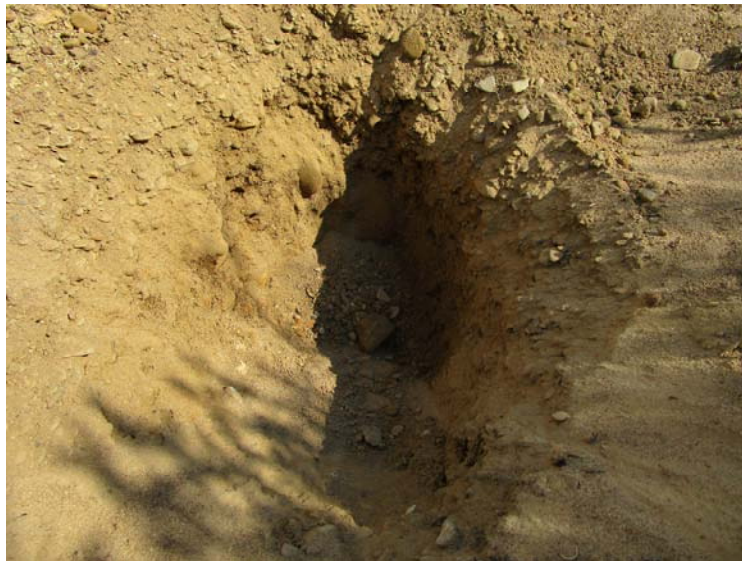
10 - HP13 soil profile (2)

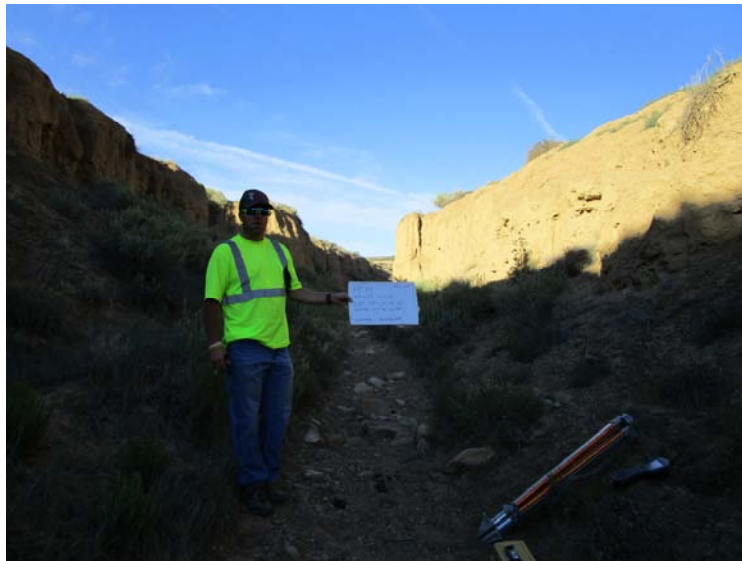
11 - HP14 upstream

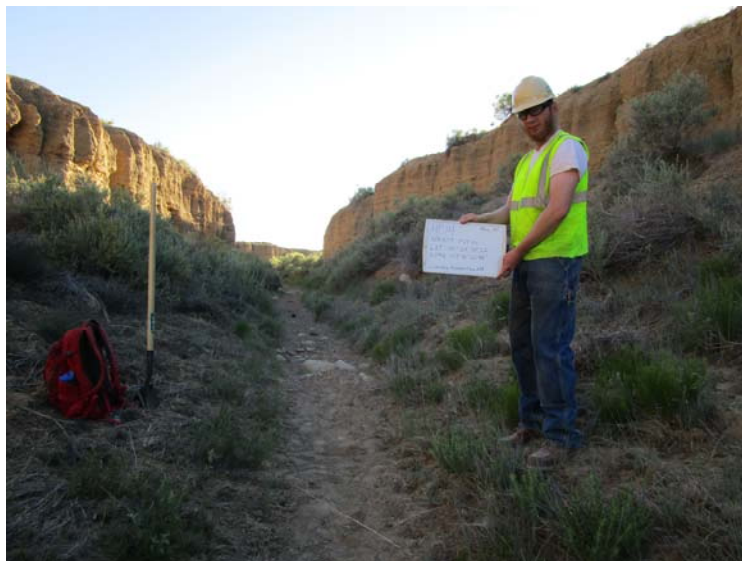
12 - HP14 downstream

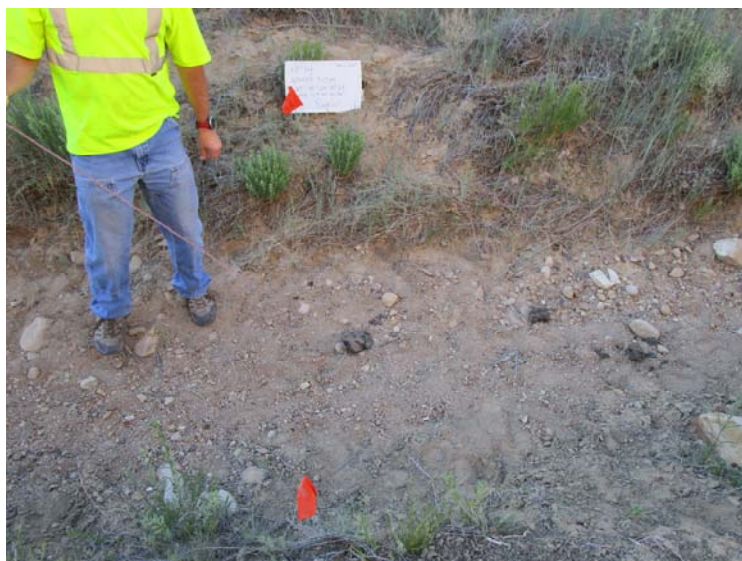
13 - HP14 bankfull position

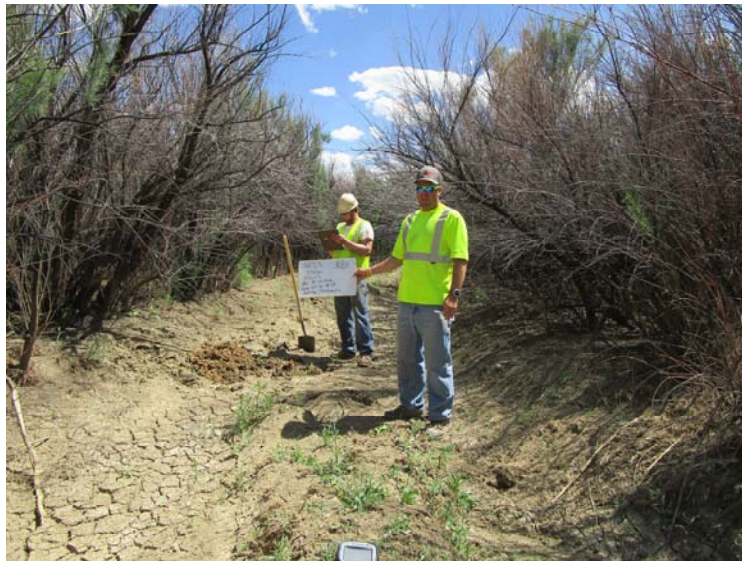
17 - HP15 upstream

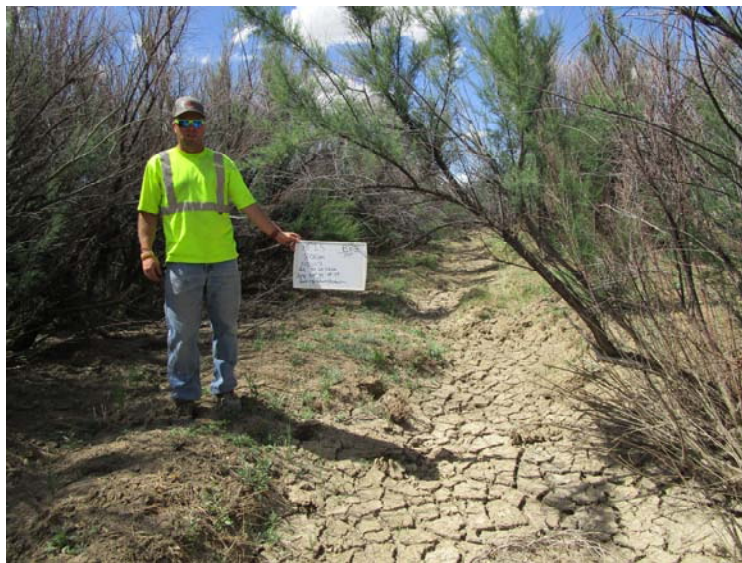
18 - HP15 downstream

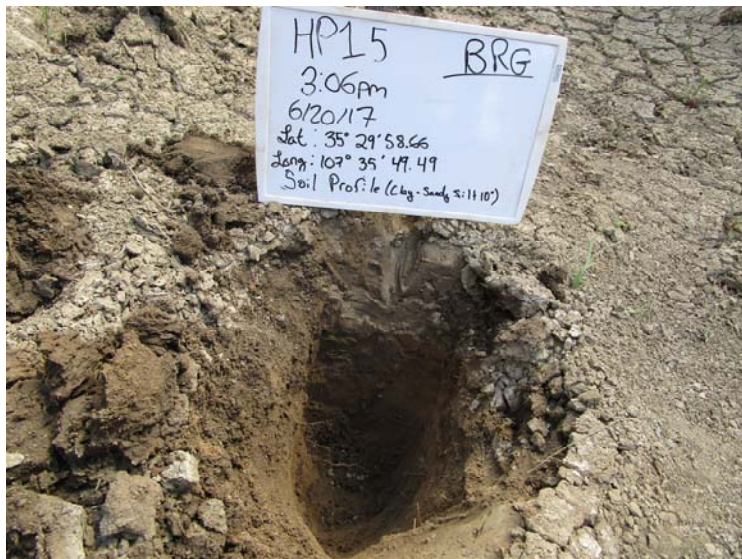
19 - HP15 soil profile (1)

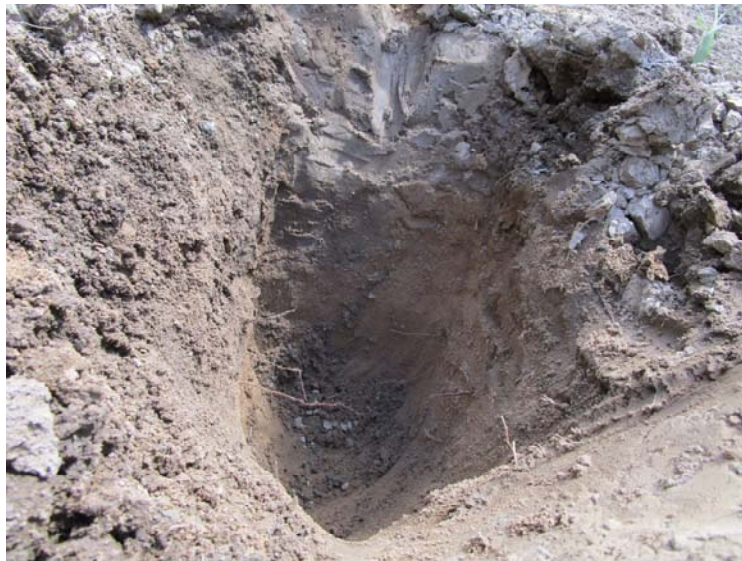
20 - HP15 soil profile (2)

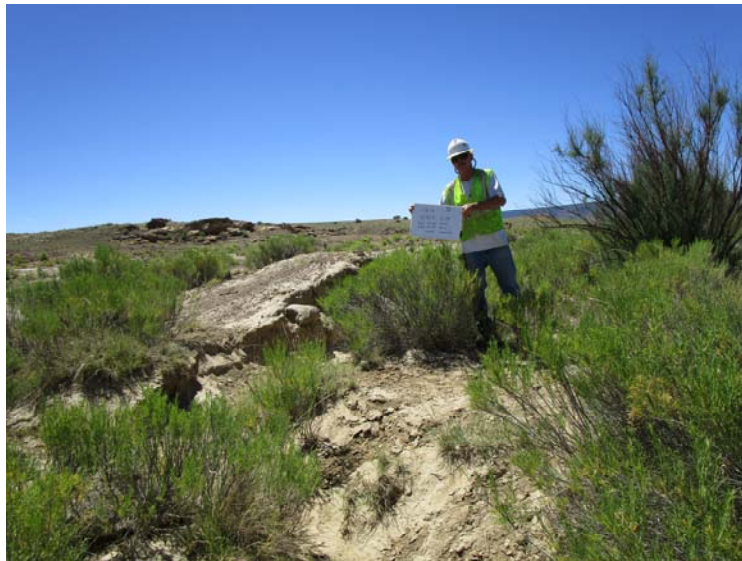
21 - HP16 upstream

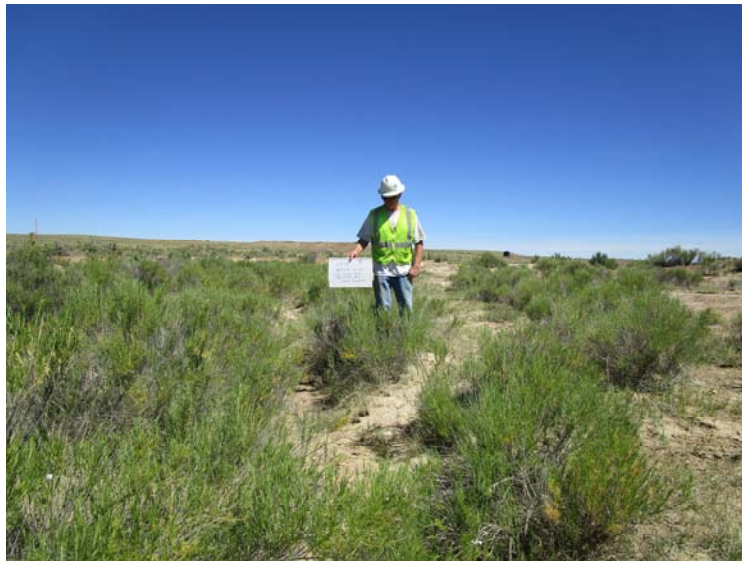
22 - HP16 downstream

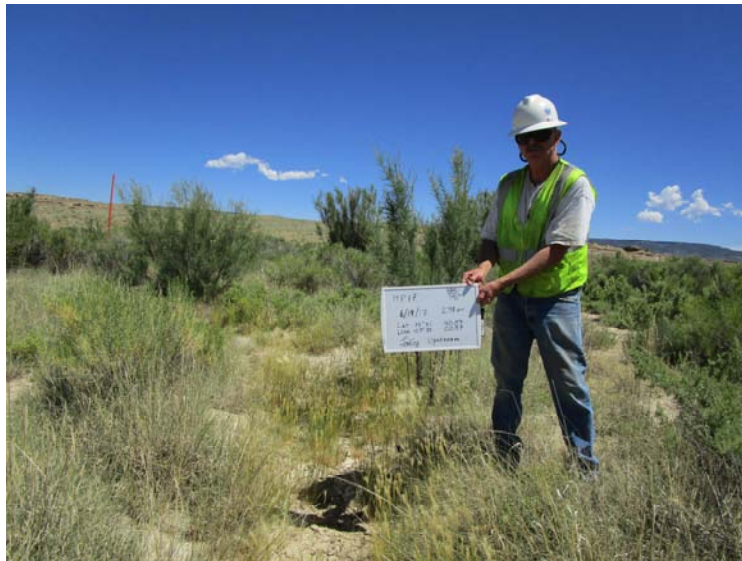
25 - HP17 upstream

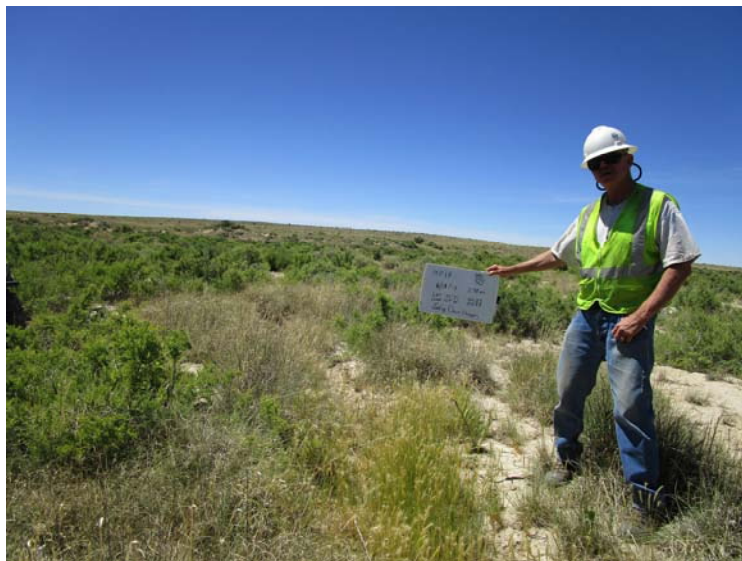
26 - HP17 downstream

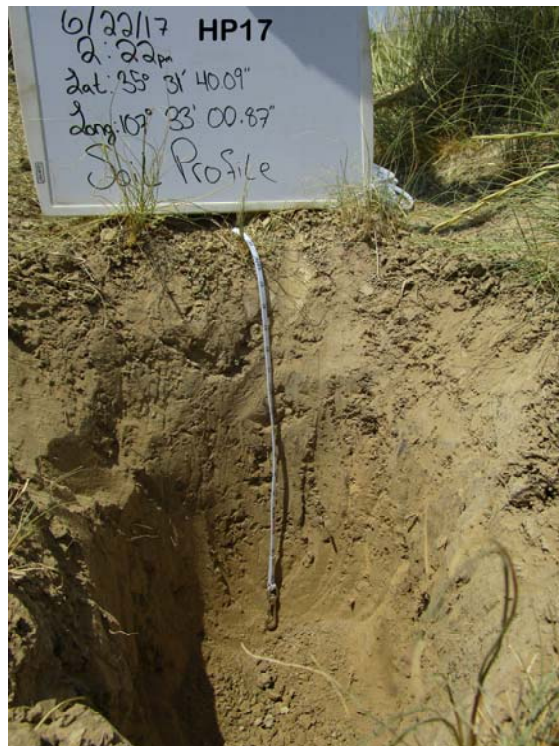
29 - HP17 soil profile

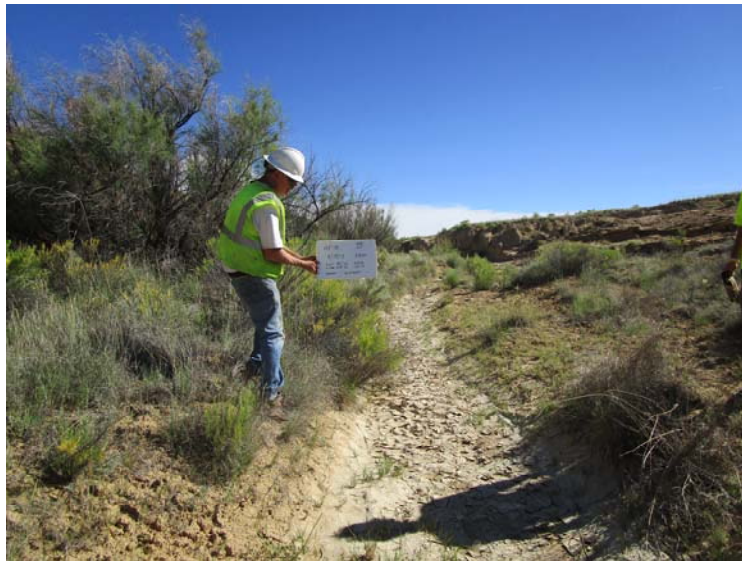
30 - HP18 upstream

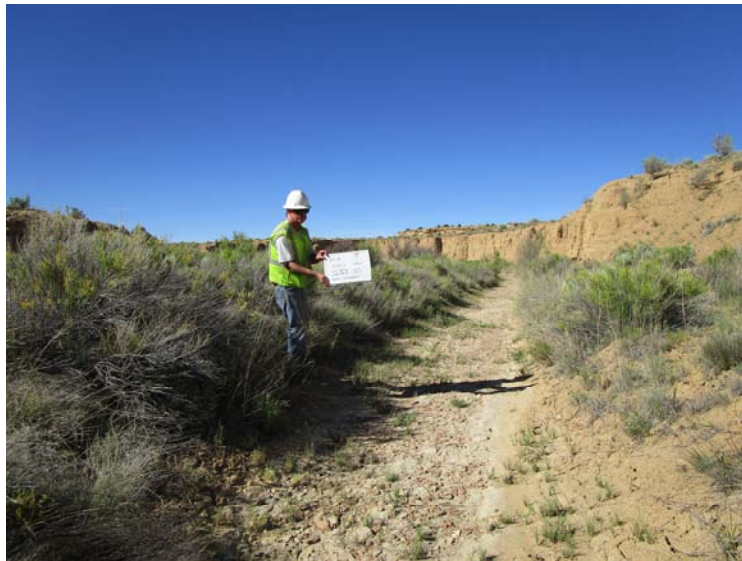
31 - HP 18 downstream

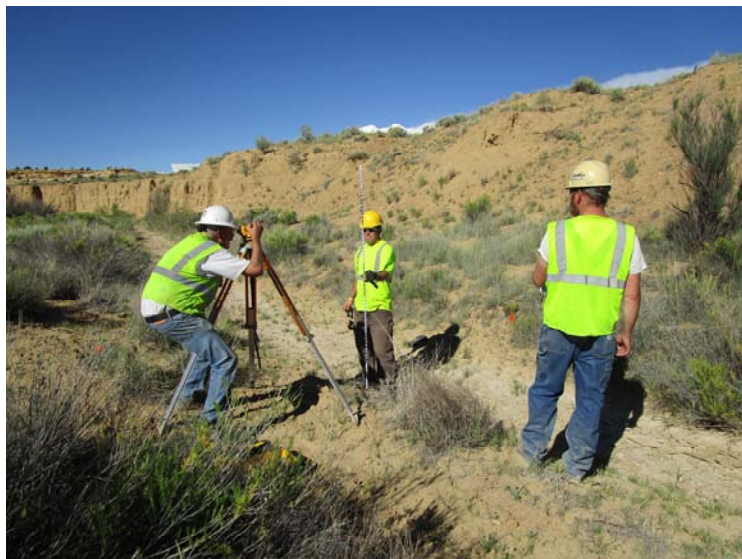
32 - HP18 survey

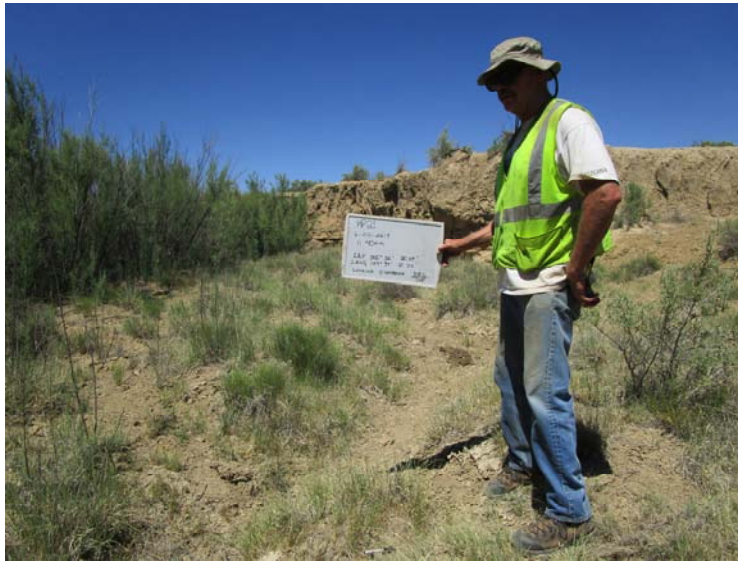
33 - HP21 upstream
